# TECHNICAL BULLETIN

LT310-001

Discovery II Td5 Poor Starting/Noisy Fuel Pump

Discovery Series II (LT)

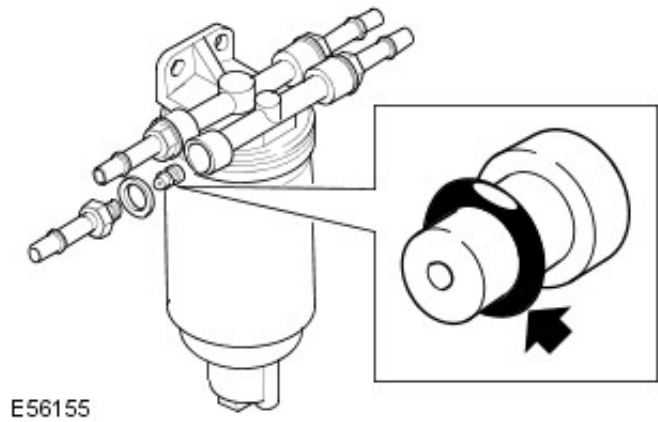
**Cause:** The O-ring seal on the fuel filter air bleed valve may be split, allowing air into the fuel system (If air is being introduced into the fuel system, it will make the primary fuel pump sound noisy).

**5** Withdraw the air bleed valve from inside the brass fitting. Inspect the O-ring and plastic body for splits and damage.

**6** If the O-ring is damaged, renew parts provided in the service repair kit.
