TECHNICAL BULLETIN
LTB00618NAS4
08 APR 2015

SECTION: 204-01

'Click' / 'Rattle' Noise From Engine Compartment When Driving

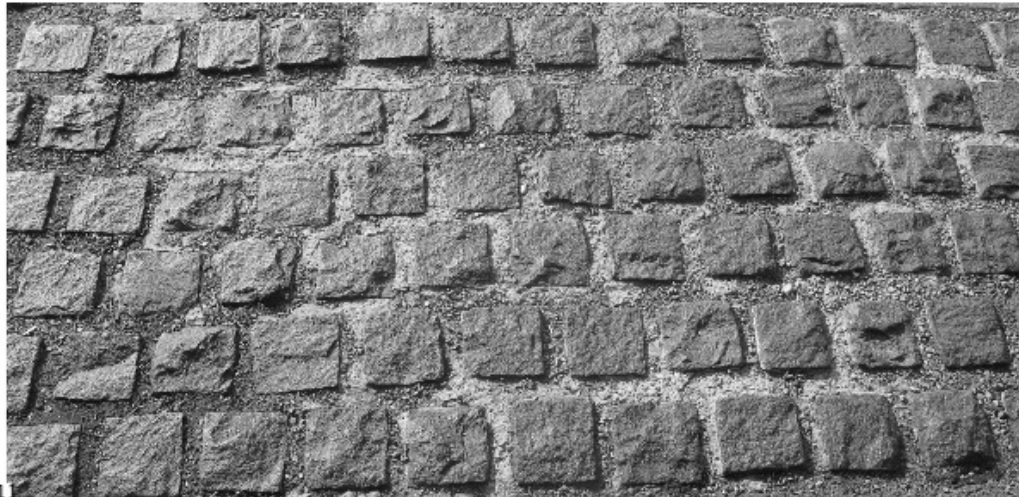
E15961

Situation: A 'click', 'rattle', or 'light vibration' noise may be heard when driving over an irregular road surface (cobble stone, bricks, etc. [see illustrations in Service Instruction steps 1 and 2]) at speeds up to 15 MPH (25 Km/h):

B. A 'rattle' noise when driving over an irregular road surface (cobble stone, bricks, etc. [see illustrations in Service Instruction steps 1 and 2]) until the road surface changes. The sound may also be described as a light vibration and can occur at any temperature or ambient condition.

1. Typical road surface that can generate the 'rattle' sound.

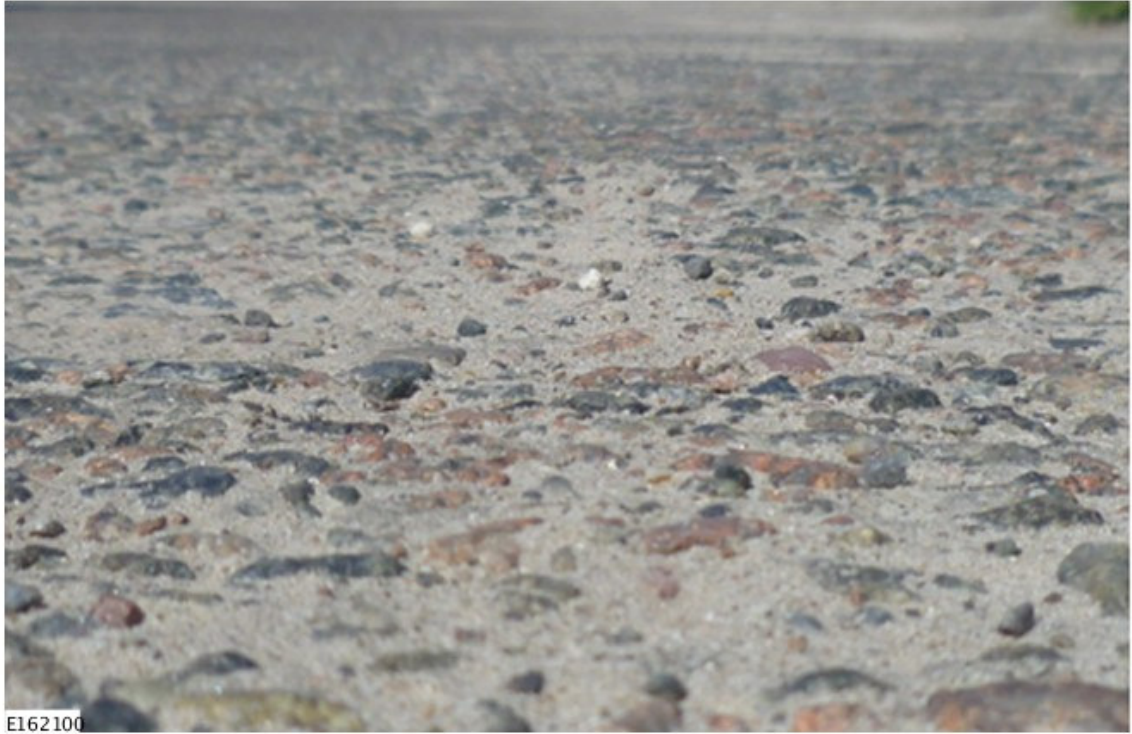
E162100

2. Typical road surface that can generate the

'rattle'
sound.
