TECHNICAL BULLETIN

LTB00080

SECTION: 303-03 (Cooling System - 26)

Range Rover (LM) - High Engine Speeds and/or Transmission Shift Problems

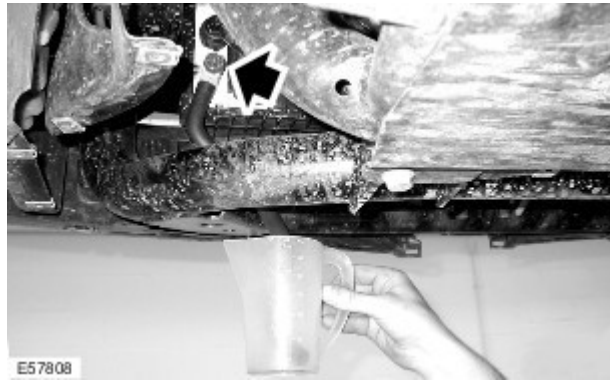
9.

The time taken to drain 250ml of coolant will indicate the existence of blockage within the low flow circuit of the radiator. For guidance, indicative times are listed:

New radiator (zero blockage) - 10 seconds to drain
250ml of coolant.

Used radiator (confirmed blockage and exhibiting
fault symptoms) - 1 minute 40 seconds to drain
250ml of coolant.

**NOTE:** Where a blockage of the low flow circuit of the radiator is confirmed, the radiator
MUST be replaced with a new unit, as it is not possible to clear the blockage.

If blockage of the radiator is confirmed, remove the radiator For additional information, refer to New
Range Rover Workshop Manual Section Cooling System - V8, Radiator (26.40.01).
