**Technical Service  
Information Bulletin**

# ECM CALIBRATION: SHIFT FEELING ENHANCEMENT

'02 – '03 ES 300 & '04 – '05 ES 330

TC004-03

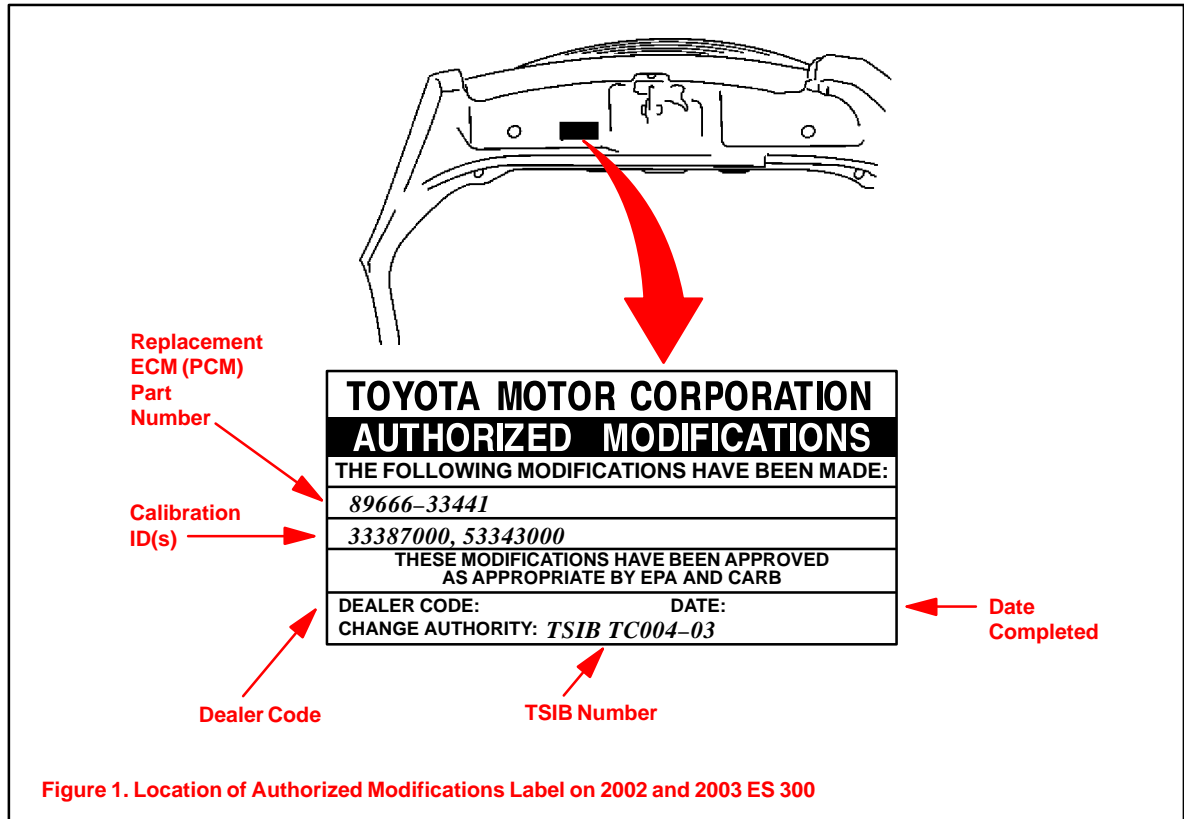
1. Check for the Authorized Modifications Label affixed to the vehicle in the location shown in Figure 1. Confirm if ECM (PCM) calibration has been updated. If not the latest ECM (PCM) calibration — go to step 2.

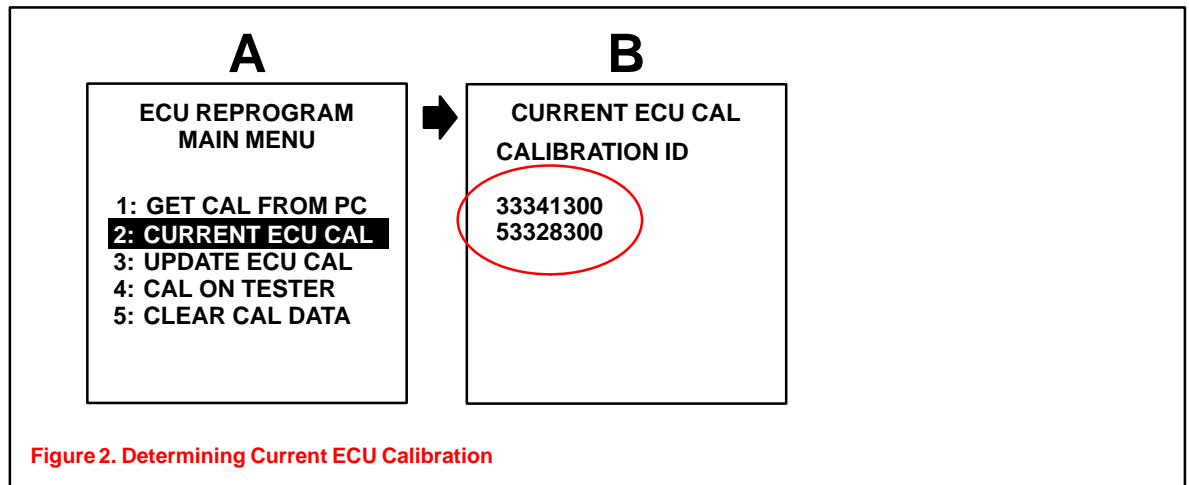
2. Connect the Diagnostic Tester to the vehicle and select CURRENT ECU CAL from the ECU REPROGRAM MAIN MENU. Determine the vehicle's current ECU calibration (see Figure 2).
  - The sample screen prints seen below are the 12.01a software version and may differ from subsequent software versions.

- If Calibration ID matches “Previous Calibration ID” as shown in Calibration Identification Chart on page 3, proceed with flash reprogramming.
- If Calibration ID matches “New Calibration ID” as shown in Calibration Identification Chart, this vehicle has already been programmed. Refer to TIS for diagnostic procedures applicable to any stored DTCs.

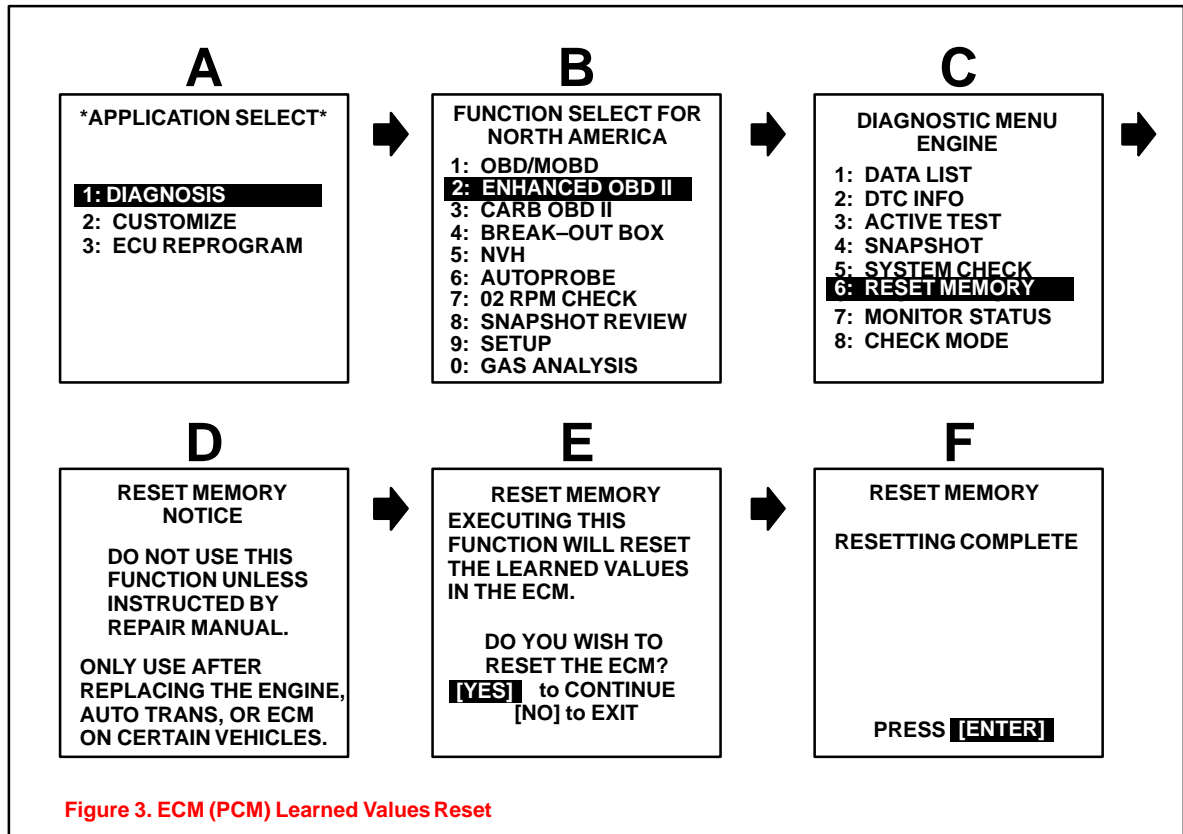
5. **Reset the ECM (PCM) learned values** using the diagnostic tester. Refer to the procedures below.
- The sample screen prints seen below are the 12.01a software version and may differ from subsequent software versions.

Failure to reset the ECM (PCM) memory will result in continued ATM shifting complaints.
