**Technical Service
Information Bulletin**

Title:
**ECM CALIBRATION UPDATE: M.I.L. "ON"
DTC P0300 - P0306 OR HARSH 2-3
SHIFT DURING ACCELERATION**
Models:
'02 GS 300, IS 300 & IS 300 SportCross

REVISÉD
EG004-02
ENGINE

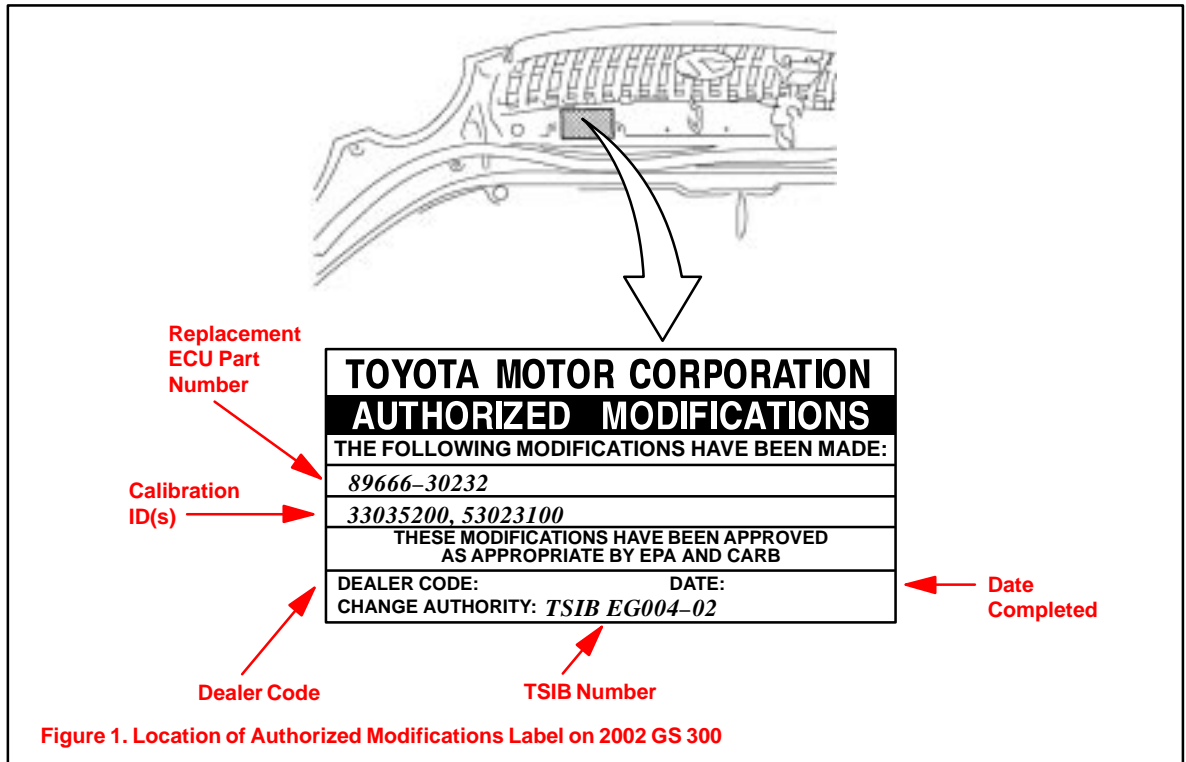
- If Freeze Frame data recorded the engine at operating temperature (above 160°F) or with "ENGINE RUN TIME" above 120 seconds, diagnose DTC (P0300 – P0306) using the vehicle Repair Manual.
- Check for the Authorized Modifications Label affixed to the vehicle in the location shown in Figure 1. Confirm if ECM (PCM) calibration has been updated. If not latest ECM (PCM) calibration – go to step 7.

4. Enter the required information on the Authorized Modifications Label and affix it to the vehicle at the location shown in Figure 1 (page 3). The Authorized Modifications Label is available through the MDC, P/N 00451–00001–LBL.
5. Reinstall the **ENG MAIN (electric fan)** relay (see Figure 3).
6. Reinstall the 3 relays for ABS/VSC system (see Figure 4).
7. Use the Diagnostic Tester to delete any ABS/VSC DTCs that may have been set during this repair procedure.
8. Calibration update is complete.

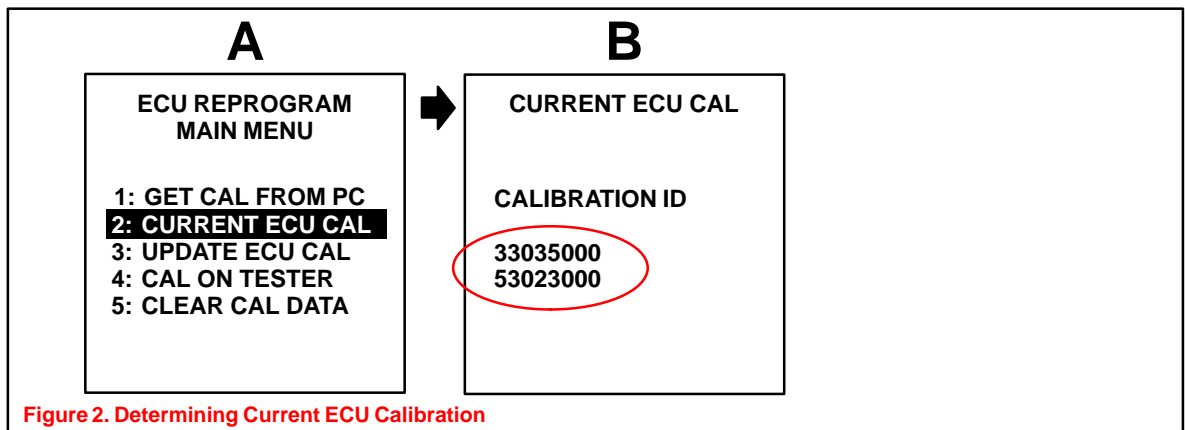
- Connect the Diagnostic Tester to the vehicle and select CURRENT ECU CAL from the ECU REPROGRAM MAIN MENU. Determine the vehicle's current ECU calibration (see Figure 2).

- If Calibration ID for both engine and transmission matches "Previous Calibration ID" as shown on page 2, proceed with flash reprogramming.
- If Calibration ID for both engine and transmission matches "New Calibration ID" as shown on page 2, this vehicle has already been reprogrammed. Refer to Repair Manual for diagnosis.
