Technical Service Information Bulletin

Title: ECM CALIBRATION UPDATE: HARSH 2-3 SHIFT DURING ACCELERATION

Models: '01 GS 300 & IS 300

ENGINE
EG005-02

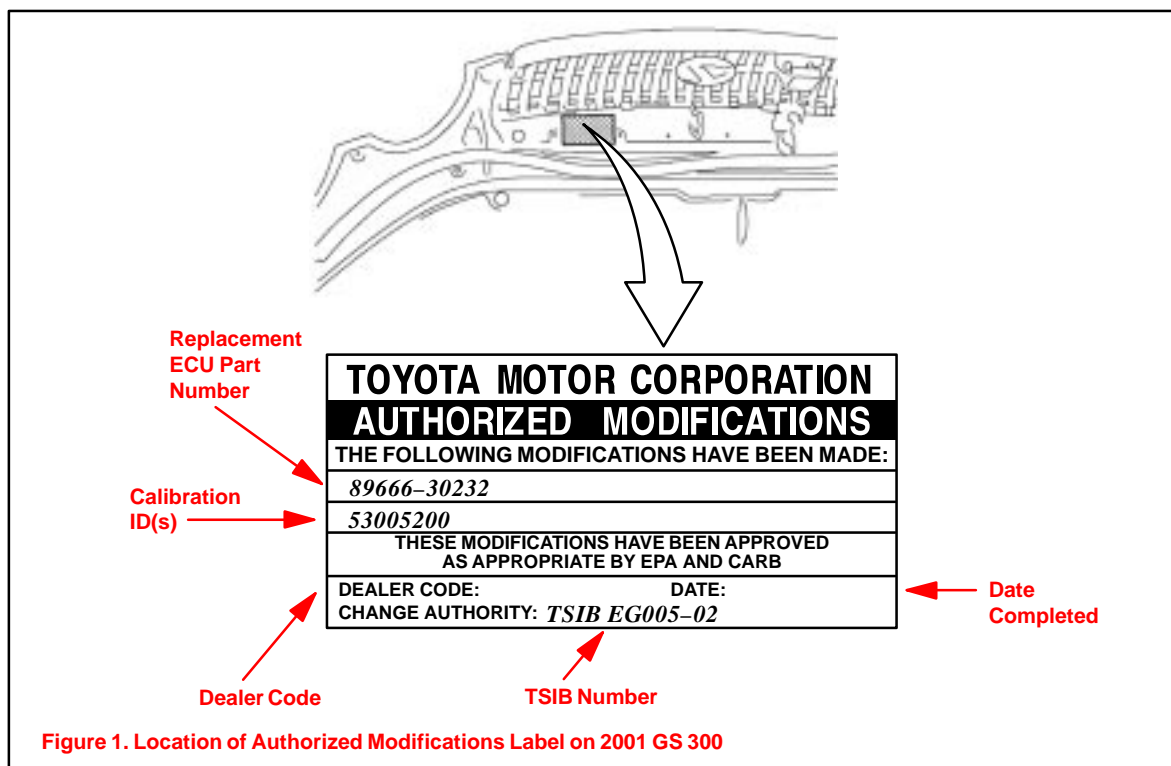
Figure 1. Location of Authorized Modifications Label on 2001 GS 300

1. Check for the Authorized Modifications Label affixed to the vehicle in the location shown in Figure 1. Confirm if ECM (PCM) calibration has been updated. If not latest ECM (PCM) calibration – **go to step 2.**

4. Enter the required information on the Authorized Modifications Label and affix it to the vehicle at the location shown in Figure 1 (page 2). The Authorized Modifications Label is available through the MDC, P/N 00451-00001-LBL.
5. Reinstall the **ENG MAIN (electric fan)** relay (see Figure 3).
6. Reinstall the 3 relays for ABS/VSC system (see Figure 4).
7. Use the Diagnostic Tester to delete any ABS/VSC DTCs that may have been set during this repair procedure.
8. Calibration update is complete.

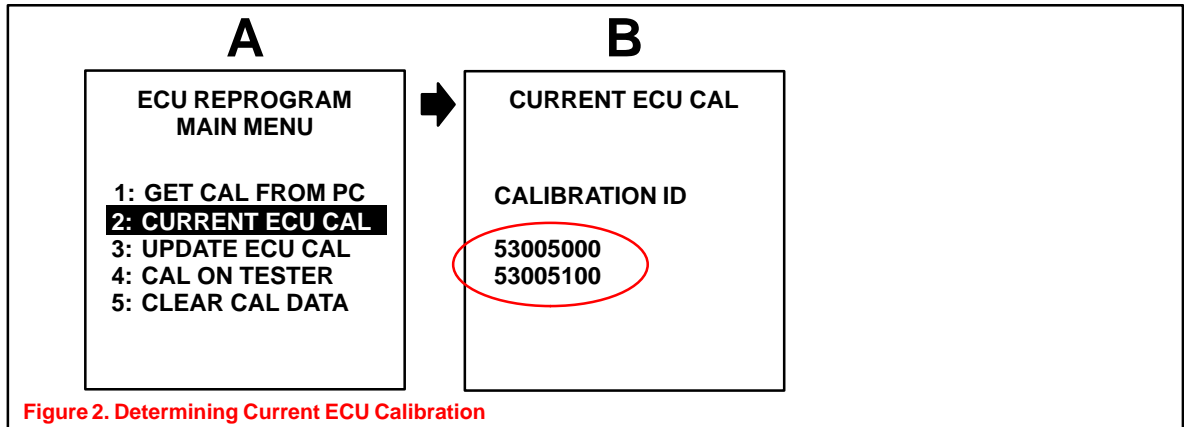
Figure 2. Determining Current ECU Calibration

2. Connect the Diagnostic Tester to the vehicle and select CURRENT ECU CAL from the ECU REPROGRAM MAIN MENU. Determine the vehicle’s current ECU calibration (see Figure 2).

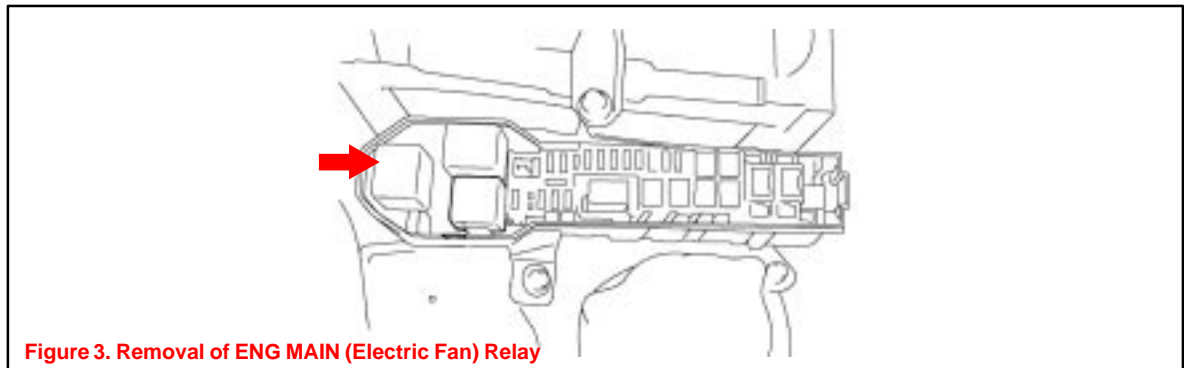
Figure 3. Removal of ENG MAIN (Electric Fan) Relay

1. Remove the **ENG MAIN (electric fan)** relay (see Figure 3).

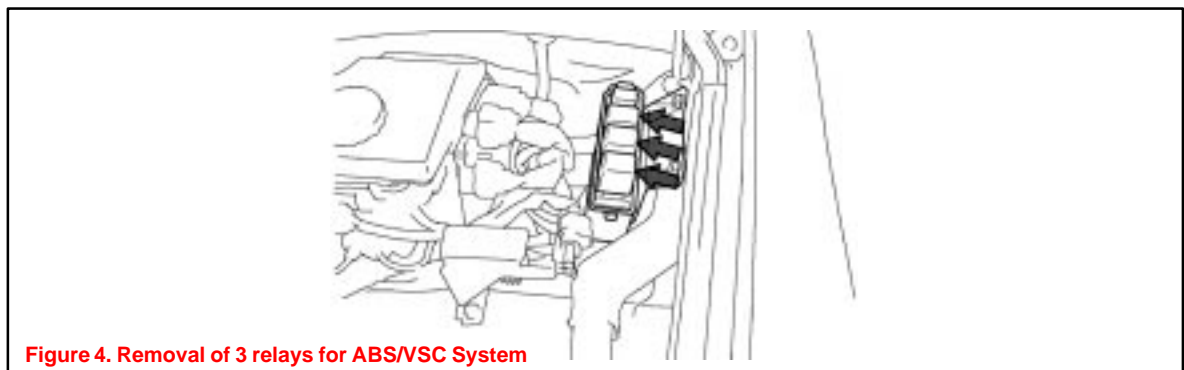
Figure 4. Removal of 3 relays for ABS/VSC System

2. Remove the 3 relays for the ABS/VSC system (see Figure 4).

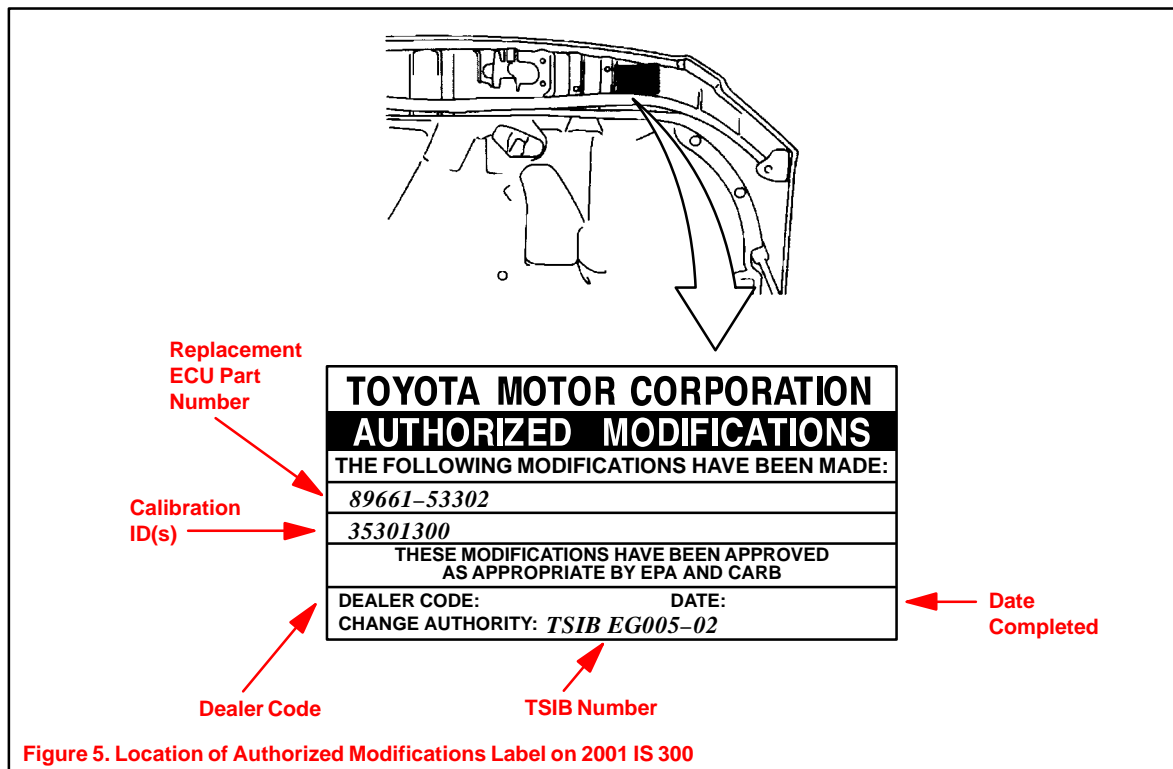
1. Check for the Authorized Modifications Label affixed to the vehicle in the location shown in Figure 5. Confirm if ECM calibration has been updated. If not latest ECM calibration – **go to step 2.**

3. Enter the required information on the Authorized Modifications Label and affix it to the vehicle at the location shown in Figure 5 (page 4). The Authorized Modifications Label is available through the MDC, P/N 00451-00001-LBL.
4. Reconnect the 2 electric fan connectors disconnected in step 1 (Figure 6).
5. Calibration update is complete.

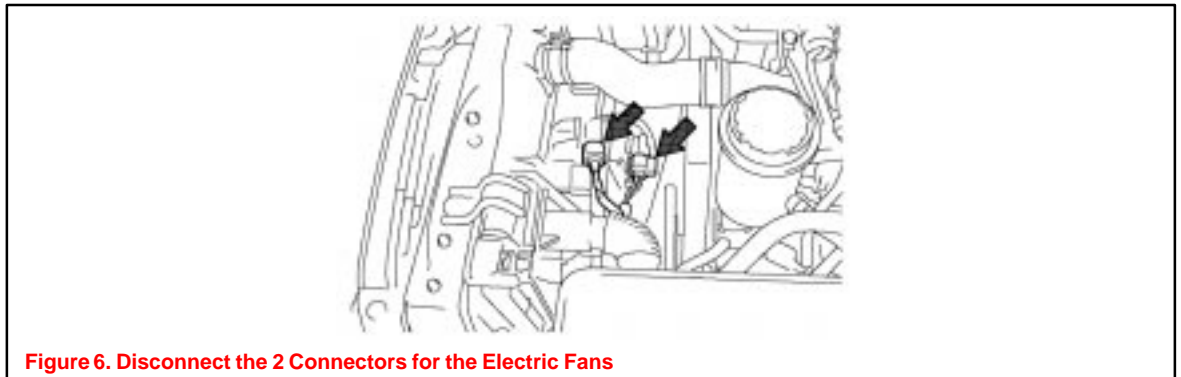
1. Disconnect the 2 connectors for the electric fans (see Figure 6).
