Instrument Panel Rattle

Service Category Vehicle Interior

Section Interior Panels/Trim

YEAR(S)	MODEL(S)	ADDITIONAL INFORMATION
2006 – 2007	GS300, GS350, GS430, GS450H

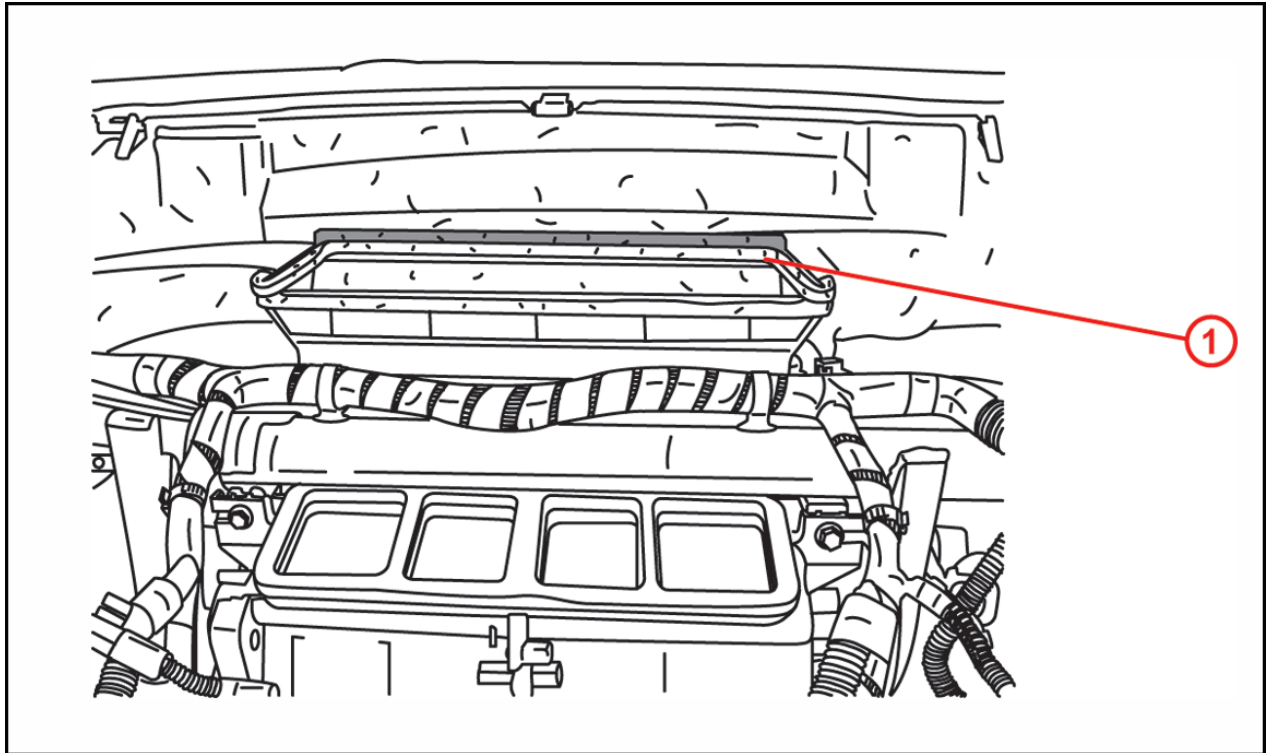
1	Felt Location
----------	---------------

4. Apply felt along the defroster nozzle lip as shown in Figure 2.

Felt Size:

Length: 29 cm (11.42 in.)

Width: 14 mm (0.55 in.)

Thickness: 0.5 mm (0.02 in.)

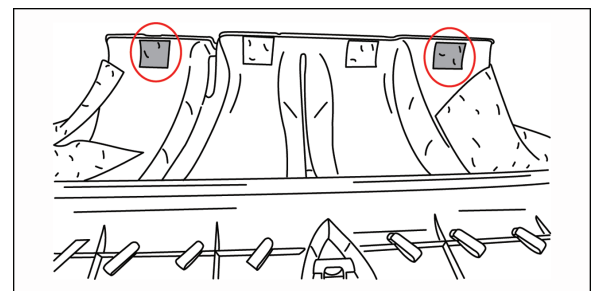
NOTE
Instrument panel pad is shown upside down.

5. Apply foam to the instrument pad HVAC duct as shown in Figure 3.

Foam Size:
Length: 30 mm (1.18 in.)
Width: 30 mm (1.18 in.)
Thickness: 5 mm (0.20 in.)

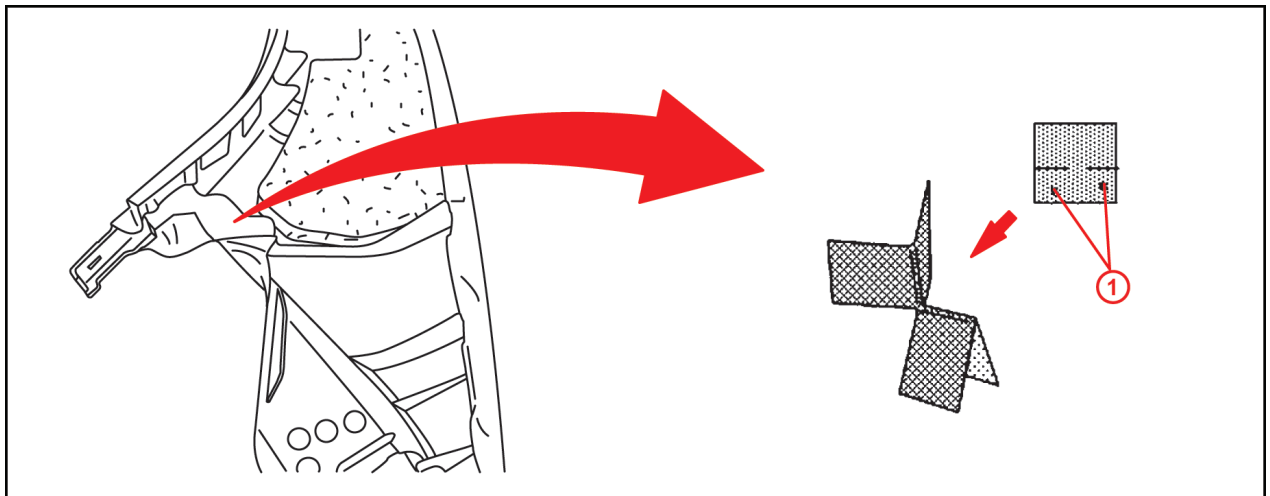
1	Slit
----------	-------------

1. Add felt to the "A" pillar garnish ribbing as shown in Figure 4.

Felt Size:

Length: 10 mm (0.39 in.)

Width: 10 mm (0.39 in.)

Thickness: 0.5 mm (0.02 in.)
