Technical Service Information Bulletin

Title: BACK WINDOW GLASS CREAK Models: '06 GS 300 & GS 430

NVH
NV002-05

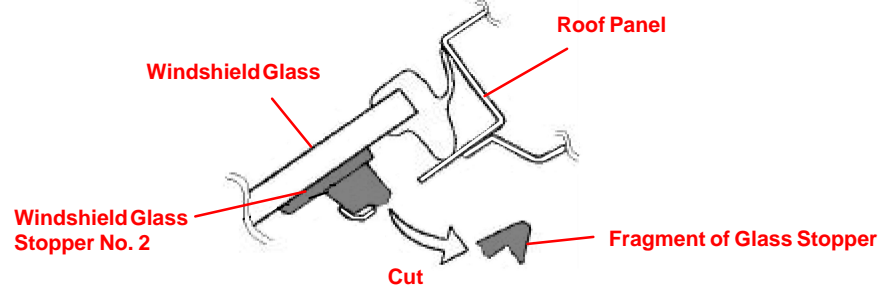
Figure 2

Introduction Some 2006 model year GS 300 and GS 430 vehicles may experience a creak noise coming from the upper portion of the back window glass. The source of this noise may be the two glass stoppers (locating pins) bonded to the top of the glass, rubbing against the body. A production countermeasure has been implemented beginning with VIN numbers listed below. Vehicles prior to the countermeasure VIN can be corrected by removal of a portion of each stopper.

3. Cut off the tip of the back window glass stopper, located at each upper corner of the rear glass. (Refer to Figures 2 and 3.)
