**Technical Service
Information Bulletin**

Title:
SHIFT LOCK ASSEMBLY
Models:
'01 – '02 LS 430 & '02 SC 430

**ELECTRICAL
EL011-02**

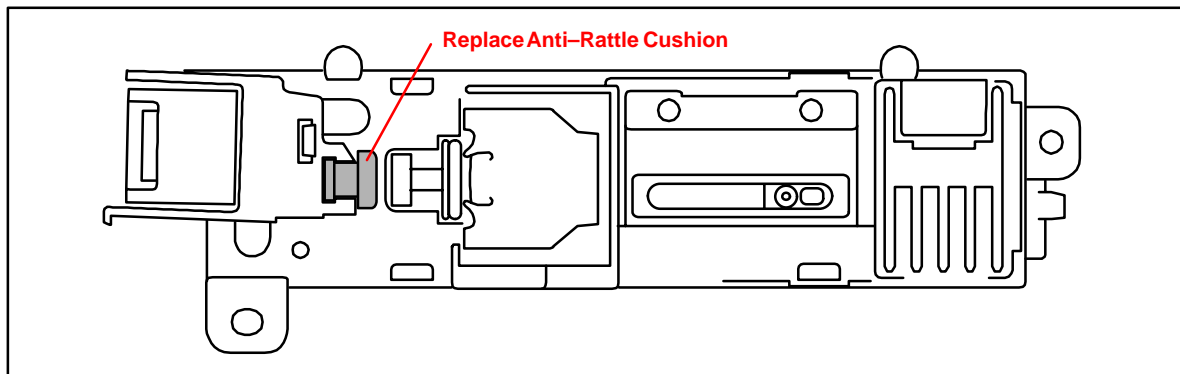
Introduction Some customers may complain that intermittently, their vehicle will not shift out of park after depressing the brake pedal. A component in the shift lock assembly, the Shift Lever Anti-Rattle Cushion, has been changed to help prevent this condition.

3. Remove the original shift lever anti-rattle cushion and replace with the new part, as shown in the illustrations.

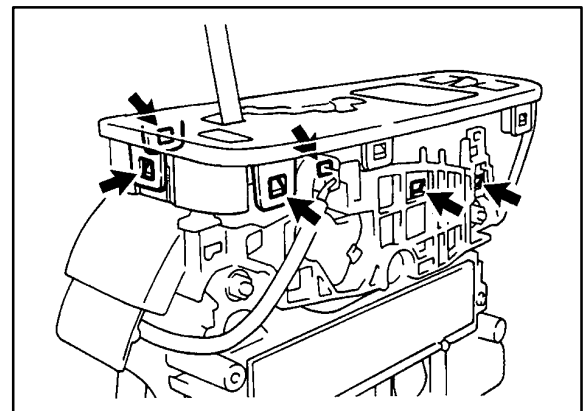
The clear plastic tabs on the front are very fragile.

3. Remove shift position indicator.
 - A. Remove shift lever knob.
 - B. Remove shift position indicator.
