### Technical Service Information Bulletin

January 7, 2004

## TILT/TELESCOPIC STEERING NOISE/SMOOTHNESS IMPROVEMENT

'98 – '03 LX 470

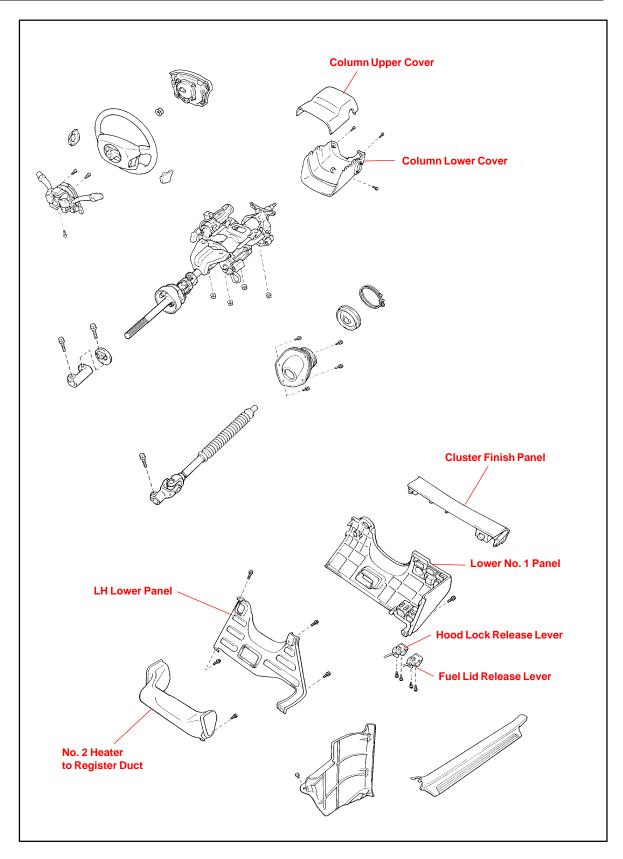
Steering Column Components

Some 1998 – 2003 model year LX470 vehicles may experience steering column noise. The cable has been replaced with a universal joint to reduce the steering column noise. Follow the repair procedures described below.
