# MIL "ON" P019023 - High Pressure Fuel Sensor Signal Stuck Low

**Service Category** Engine/Hybrid System

YEAR(S)	MODEL(S)	ADDITIONAL INFORMATION
2015 - 2016	NX200T

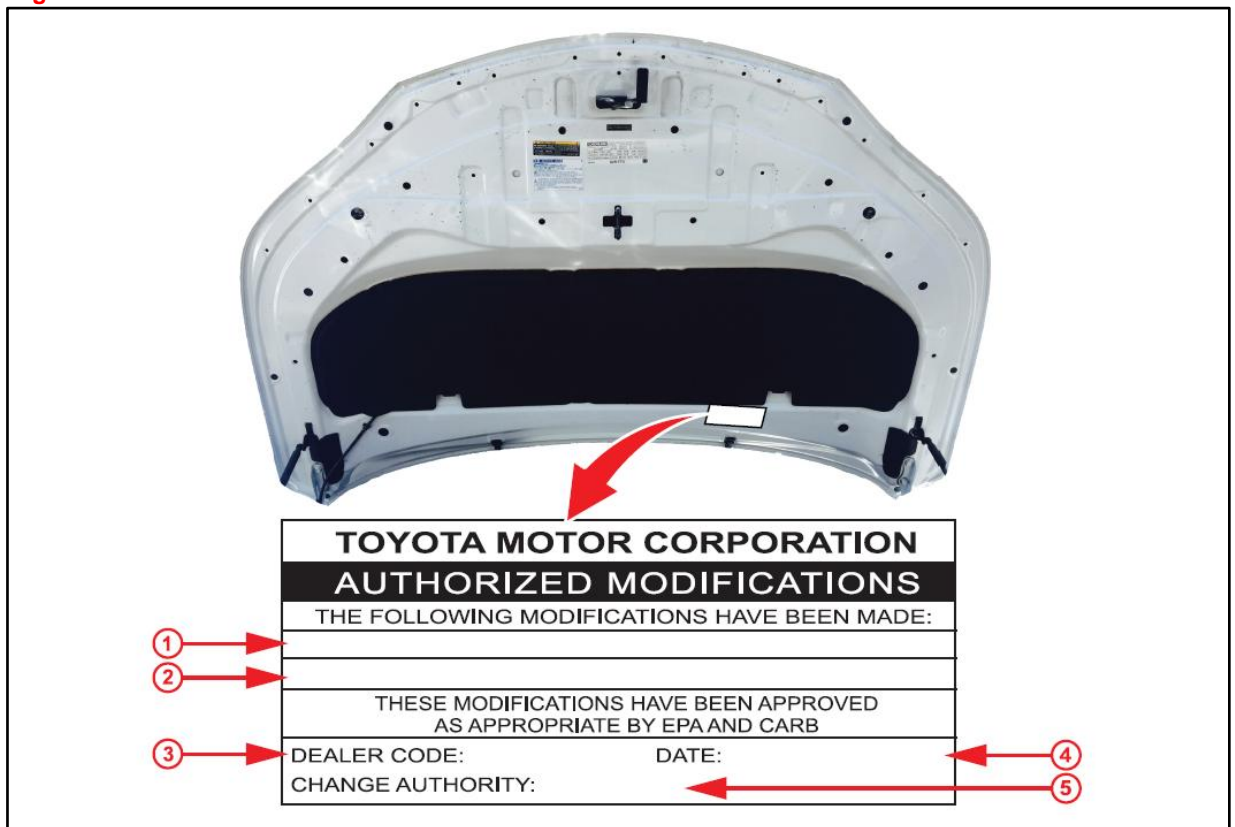
**Figure 1. Location of Authorized Modifications Label on 2015 – 2016 NX 200t**

2. Check for the Authorized Modifications Label affixed to the vehicle in the location shown below. Confirm if the ECM (PCM) calibration has been updated.  
Is the calibration ID listed NOT the latest ECM (PCM) calibration?
  - **YES** — Go to step 3.
  - **NO** — This bulletin does NOT apply. Continue diagnosis using the applicable Repair Manual.

4. Install the Authorized Modifications Label.
  - A. Using a permanent marker, enter the following information on the label:
    - ECM part number [*Refer to the **Parts Information** section for the **NEW PART NUMBER***]
    - Calibration ID(s) [*Refer to the **Calibration Information** section for the **NEW CALIBRATION ID***]
    - Dealer Code
    - Repair Date
    - Change Authority [**This bulletin number**]
  - B. Affix the Authorized Modifications Label to the vehicle at the location shown in Figure 1. The Authorized Modifications Label is available through the MDC, P/N 00451-00001-LBL.
5. Test drive the vehicle to confirm the DTC does not reset.
