**Technical Service  
Information Bulletin**

**TONNEAU COVER LATCH RATTLE**

'04 – '06 RX 330, '06 – '07 RX 400h, &  
'07 RX 350

NVH  
NV001-07

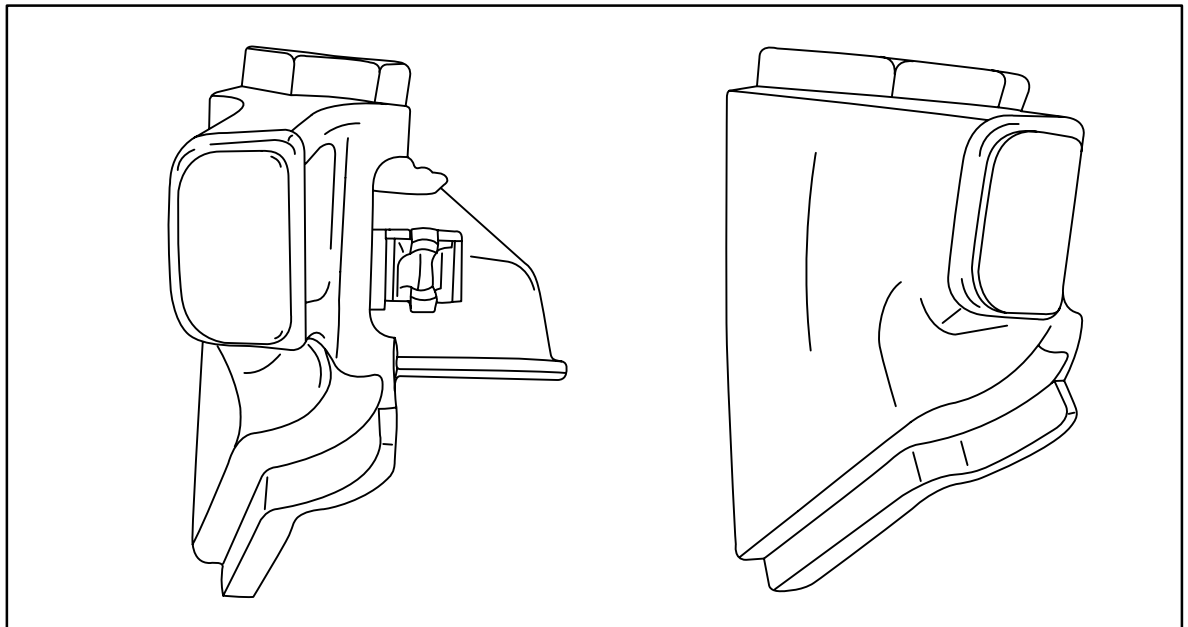
**Introduction** Some customers may experience a rattle noise from the rear of the vehicle when going over bumps. This problem is due to lack of insulation and excessive clearance between the tonneau cover locks and the back door trim spacers. Perform the following procedure to correct this condition.

4. Replace the back door trim spacer RH and LH with a NEW one.
