Subject: ROUGH IDLE, LACK OF POWER, AND/OR MIL ON WITH DTC P2177/P2187 (FUEL SYSTEM LEAN)	Bulletin No: 01-022/08
	Last Issued: 04/02/2008

BULLETIN NOTE

This bulletin supersedes the previous bulletin issued on 03/27/08. The REPAIR PROCEDURE has been revised.

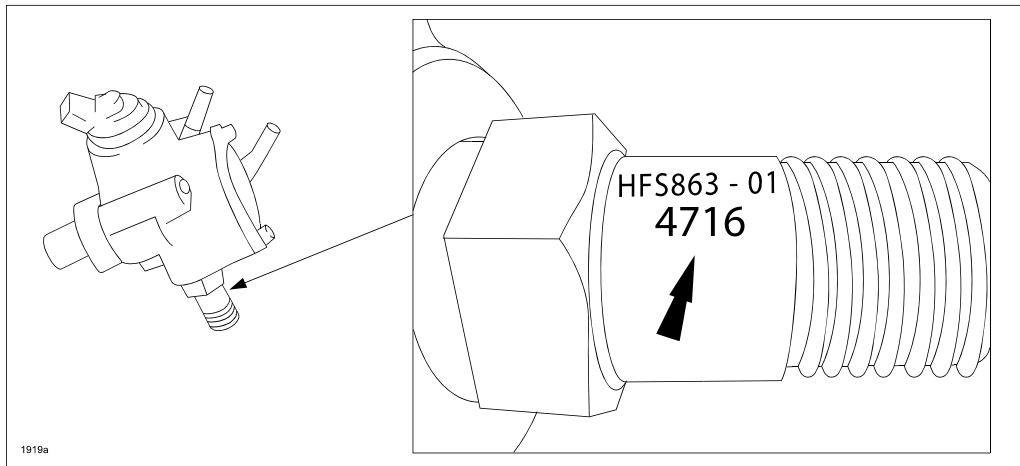
- If the history indicates part number L3K9-13-35ZB was used during a repair, use the following illustration to inspect the production date of the high-pressure fuel pump. Replace it if the production date is before March 26, 2007.

Date of production is marked as a 4 digit code “YMDD” at the pipe.

Y for Year	4 for 2004....7 for 2007
M for Month	1 for Jan....9 for Sept, X for October, Y for Nov, Z for Dec
DD for Date	01 for 1st of month....31 for 31st of month
Example	“4Z16” means Dec 16, 2004; 7608 means June 8, 2007

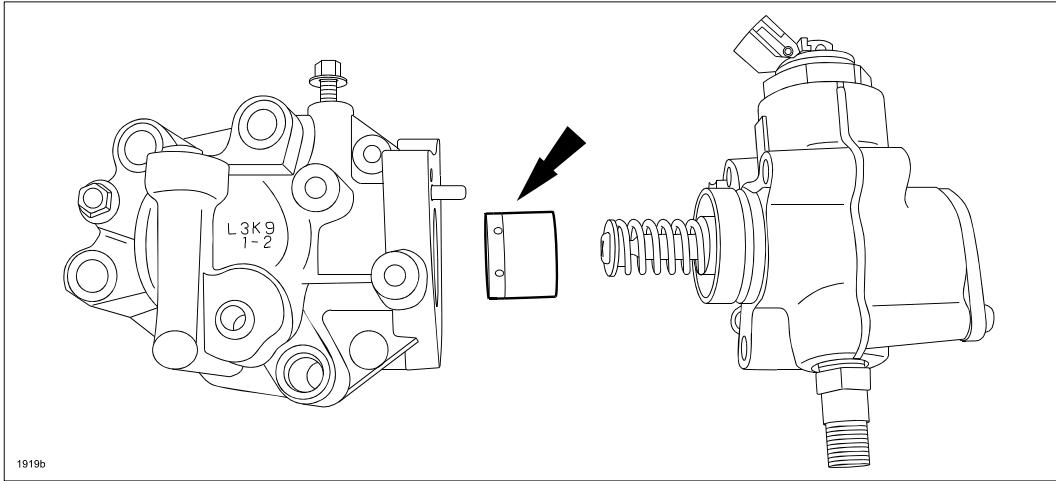
CAUTION: When replacing the high-pressure fuel pump, it is very important to make sure that the tension collar is present before reinstalling the pump. Failure to do so will result in excessive engine noise and the subsequent failure of the high-pressure fuel pump and its cam lobes.
