Service Bulletin

Subject: 2013-2014 CX-5 - SQUEAKING / GRINDING NOISE FROM REAR BRAKES	Bulletin No:	04-005/15
	Last Issued:	12/04/2015

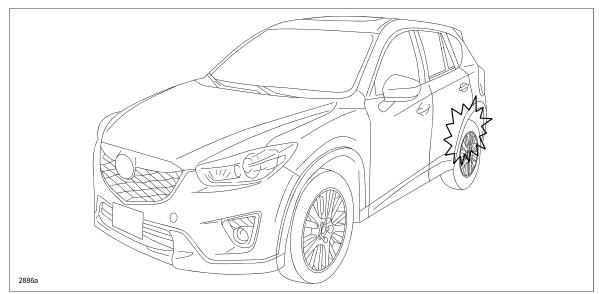
Some vehicles may exhibit a squeaking / grinding noise from the rear brakes. This noise may be caused by the wear indicators of prematurely worn **outer** rear brake pads.

NOTE: The inner rear brake pads will only show a little wear. This condition only affects the outer rear brake pad(s).

During usage of the vehicle in areas where road salt is used, the **outer** rear brake pad(s) may become stuck due to corrosion. This may cause brake dragging and premature wear to the **outer brake pad(s) only**.

The treatment of the brake pad back plate has been changed to eliminate this concern.
