Subject: BLOWER MOTOR STAYS ON AFTER KEY OFF	Bulletin No: 07-003/11
	Last Issued: 05/26/2011

2007-2010 CX-9 built before JM3 TB**** A* 227576 (May 17, 2010)

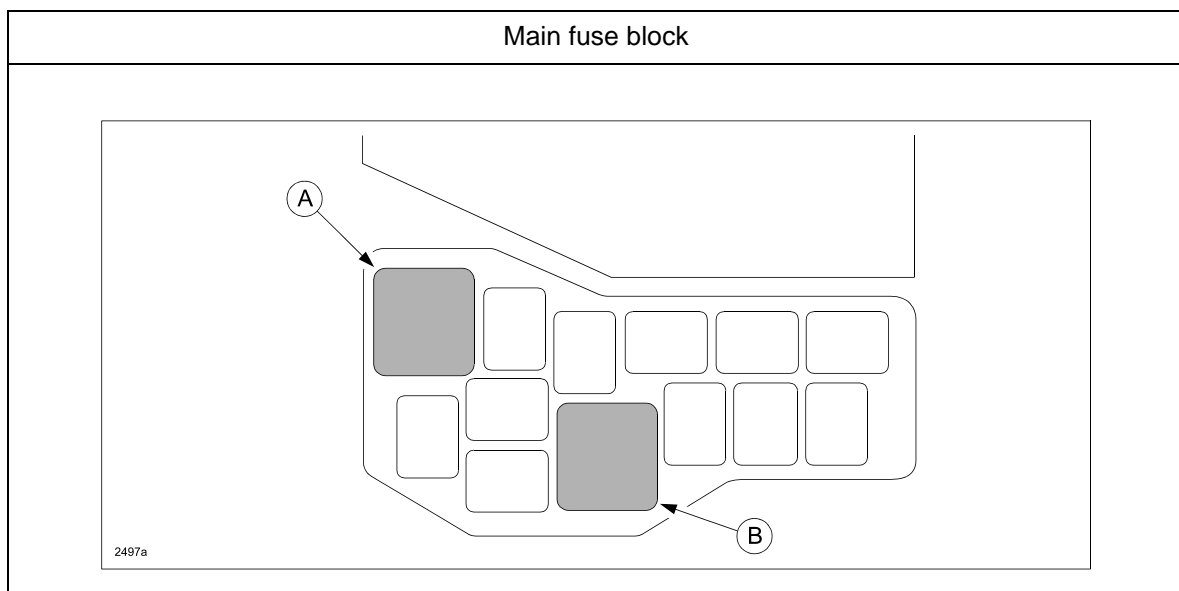
Some vehicles may experience the front or rear blower motor staying on intermittently after ignition key is switched to the off position. The condition may be difficult to duplicate. This may be caused by a faulty front and/or rear blower motor relay. A new and improved blower motor relay has been developed to correct this concern.

If customer complains about an intermittent front or rear blower motor operation after ignition key is switched to the off position, replace both front (A) and rear (B) blower motor relays.
