<b>Subject:</b>  ABNORMAL HEATER PERFORMANCE AT IDLE	<b>Bulletin No:</b> 07-001/06
	<b>Last Issued:</b> 3/13/2006

2006 MX-5 vehicles with VINs lower than JM1 NC\*\*\*\* 60 111258 (produced before December 22, 2005)

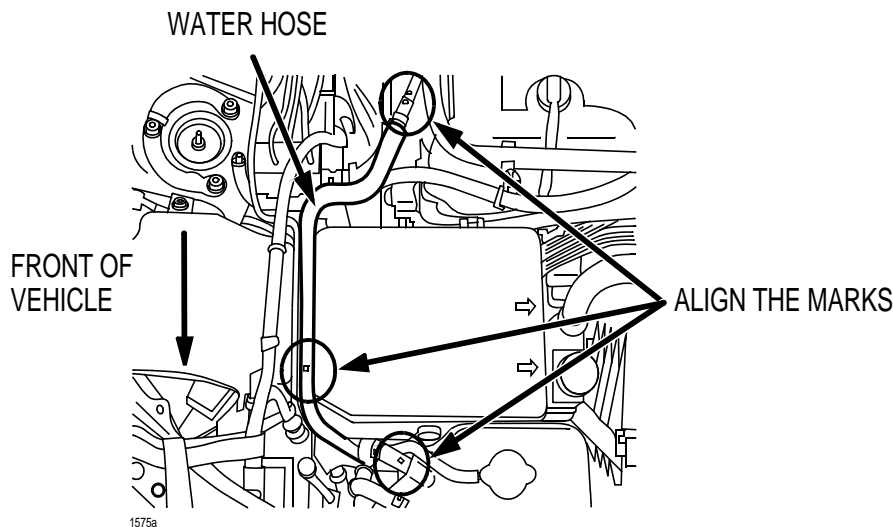
Some customers that park their vehicle on a decline or brake hard during cold engine conditions may experience abnormal heater performance at idle. This condition can be the result of air moving up from the radiator sub-tank through the thermostat housing and becoming trapped in the heater core and/or its supply lines.

- If the engine is very hot and the water hose is compressed, be careful when removing the cooling system cap. Wrap a thick cloth around it and slowly turn it counterclockwise to the first stop. Step back while the pressure escapes before proceeding with any repair.
1. Verify customer concern.
  2. Remove the water hose.
  3. Align each mark and fit a modified water hose.
