Subject: POWER RETRACTABLE HARD TOP (PRHT) - RATTLE FROM WINDSHIELD HEADER AND ROOF PANEL WHILE DRIVING	Bulletin No: 09-035/08
	Last Issued: 10/15/2008

2007-2008 MX-5 PRHT vehicles with VINs lower than JM1 NC**** ** 148630 (built before January 11, 2008)

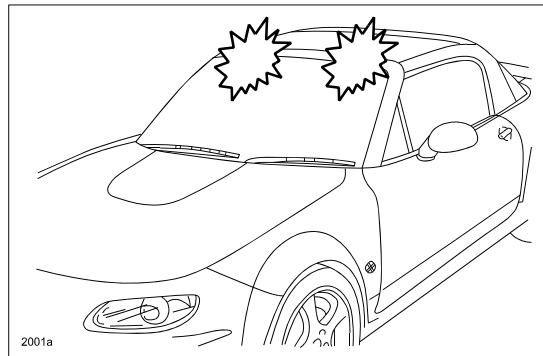
On some vehicles the windshield header and roof panel may rattle while driving. The cause is the latching force between the top lock and striker is not sufficient. As a mass-production change, the latching force has been increased.
