| <b>Subject:</b><br><b>SUNROOF WATER LEAK AFTER HIGH PRESSURE CAR WASH</b> | <b>Bulletin No:</b> 09-014/13 |
| | <b>Last Issued:</b> 05/03/2013 |

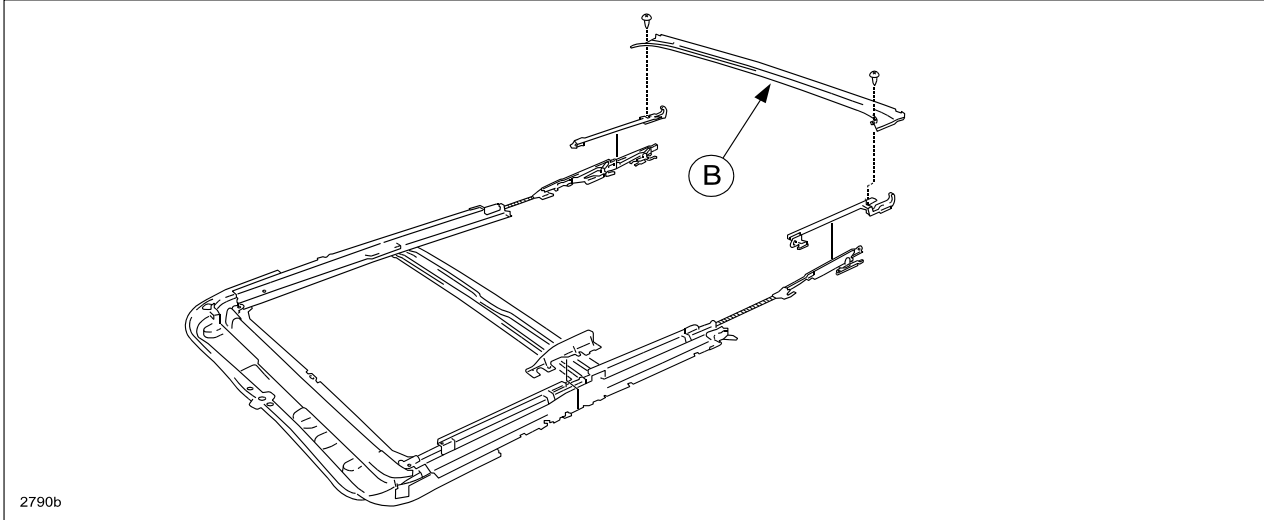
2790b

Some customers may experience a water leak from the sunroof after washing the vehicle with a high-pressure car wash system. High pressure water from the car wash may drip from the drip rail and leak into the cabin.

3. Replace the drip rail (B). Refer to MS3 online or Workshop Manual:
  - Mazda6 - (section 09-15 SUNROOF UNIT DISASSEMBLY/ASSEMBLY).
  - CX-5 - (section 09-15 SUNROOF UNIT DISASSEMBLY/ASSEMBLY).
  - CX-9 - (section 09-15 SUNROOF UNIT DISASSEMBLY/ASSEMBLY).
