| Subject: OIL SEEPAGE FROM TRANSFER CASE | Bulletin No: 03-001/08 |
| | Last Issued: 01/09/2008 |

2006-2007 Mazdaspeed6 vehicles with VINs lower than JM1GG12L*7*108052 (produced before July 1, 2006)

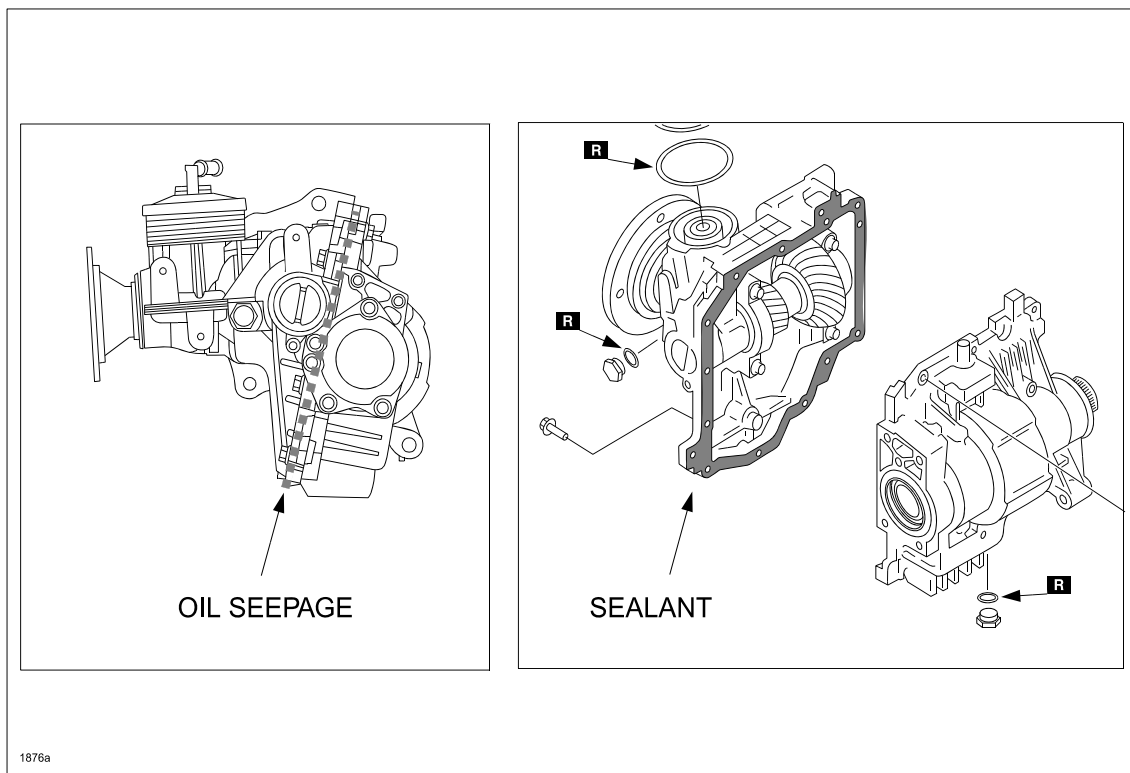
Some vehicles may experience oil seepage from the transfer case in the following location.

This may be caused by insufficient cleaning of the mating surfaces of the front and rear cases before applying sealant.

Customers having this concern should have their vehicle repaired using the following repair procedure.
