Subject: UNUSUAL NOISE FROM STEERING SHAFT WHEN TURNING STEERING WHEEL	Bulletin No: 06-001/07
	Last Issued: 02/22/2007

2003 - 2007 Mazda6

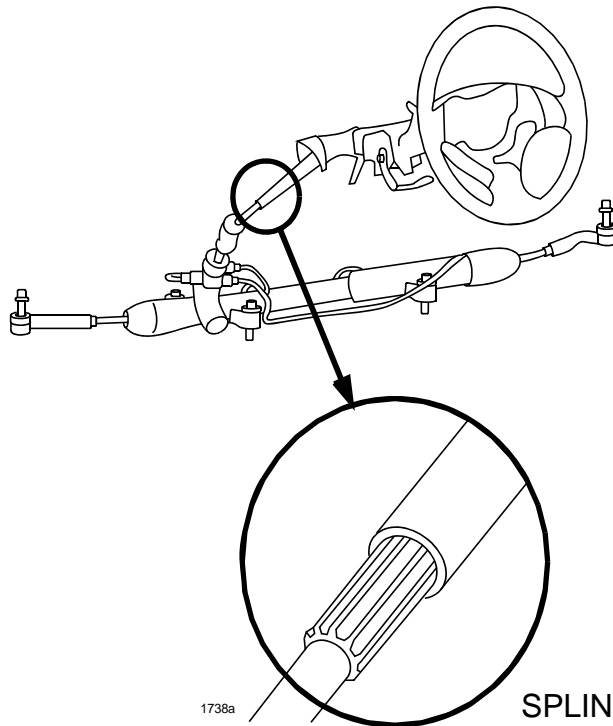
On some vehicles, the steering shaft may make an unusual clunk noise during acceleration while the steering wheel is turned. The intermediate shaft splines in the steering column may be lacking lubrication and causing the clunk noise.
