Subject: CAMSHAFT TICKING NOISE	Bulletin No: 01-031/07
	Last Issued: 07/13/2007

Some vehicles equipped with a 3.0L engine may exhibit a ticking noise from the left bank cylinder head while the engine is running at normal operating temperature.

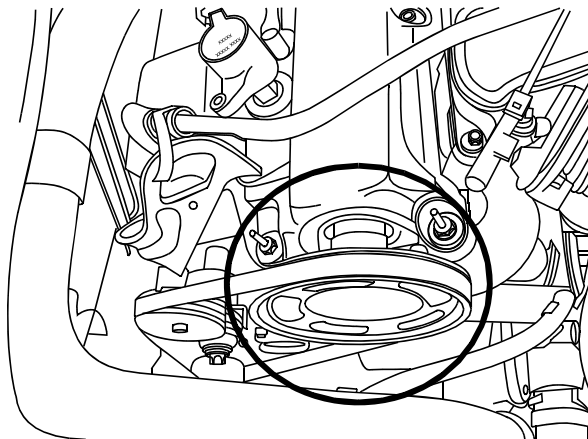
1572g

WATER PUMP DRIVEN BY INTAKE CAMSHAFT PULLEY

1. Verify the water pump is driven by the INTAKE camshaft pulley.

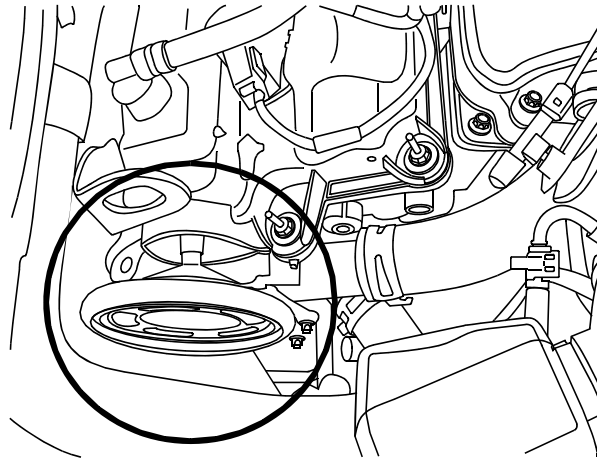
1572h

WATER PUMP DRIVEN BY EXHAUST CAMSHAFT PULLEY

1. Verify the water pump is driven by the EXHAUST camshaft pulley.
