Technical Service Bulletin

SUBJECT: OIL LEAKAGE FROM FRONT OIL SEAL OF CRANKSHAFT			No: TSB-16-11-003
			DATE: November, 2016
			MODEL: See below
CIRCULATE TO:	<input type="checkbox"/> GENERAL MANAGER	<input checked="" type="checkbox"/> PARTS MANAGER	<input checked="" type="checkbox"/> TECHNICIAN
<input checked="" type="checkbox"/> SERVICE ADVISOR	<input checked="" type="checkbox"/> SERVICE MANAGER	<input checked="" type="checkbox"/> WARRANTY PROCESSOR	<input type="checkbox"/> SALES MANAGER

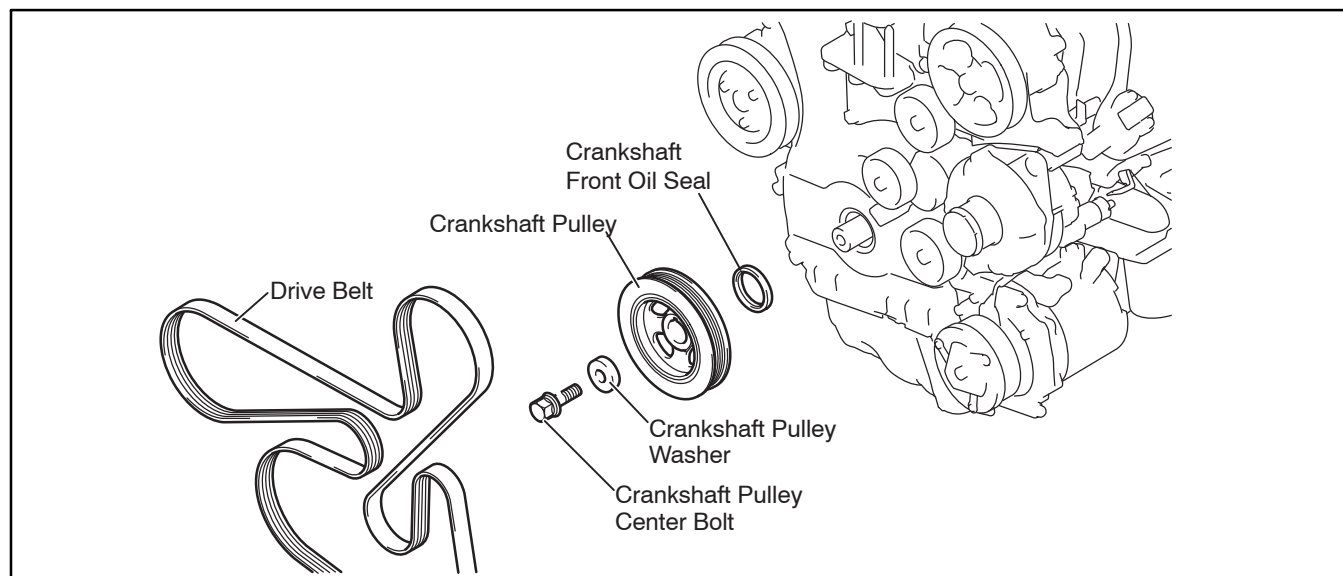
Some vehicles may exhibit oil leakage from the front oil seal on the crankshaft. This may be due to the durability of the oil seal against foreign material, such as sand, which can damage the front main lip of the oil seal, allowing oil leakage to occur.

1. Remove the crankshaft pulley. Follow instructions in the Service Manual, group 11–Engine → Engine Mechanical → Crankshaft Pulley → Removal and Installation.
2. Inspect for oil leakage from the front seal of the crankshaft. Follow instructions in the Service Manual, group 11–Engine → Engine Mechanical → Crankshaft Oil Seal → Removal and Installation. If leakage is confirmed, replace the front oil seal with a new part.

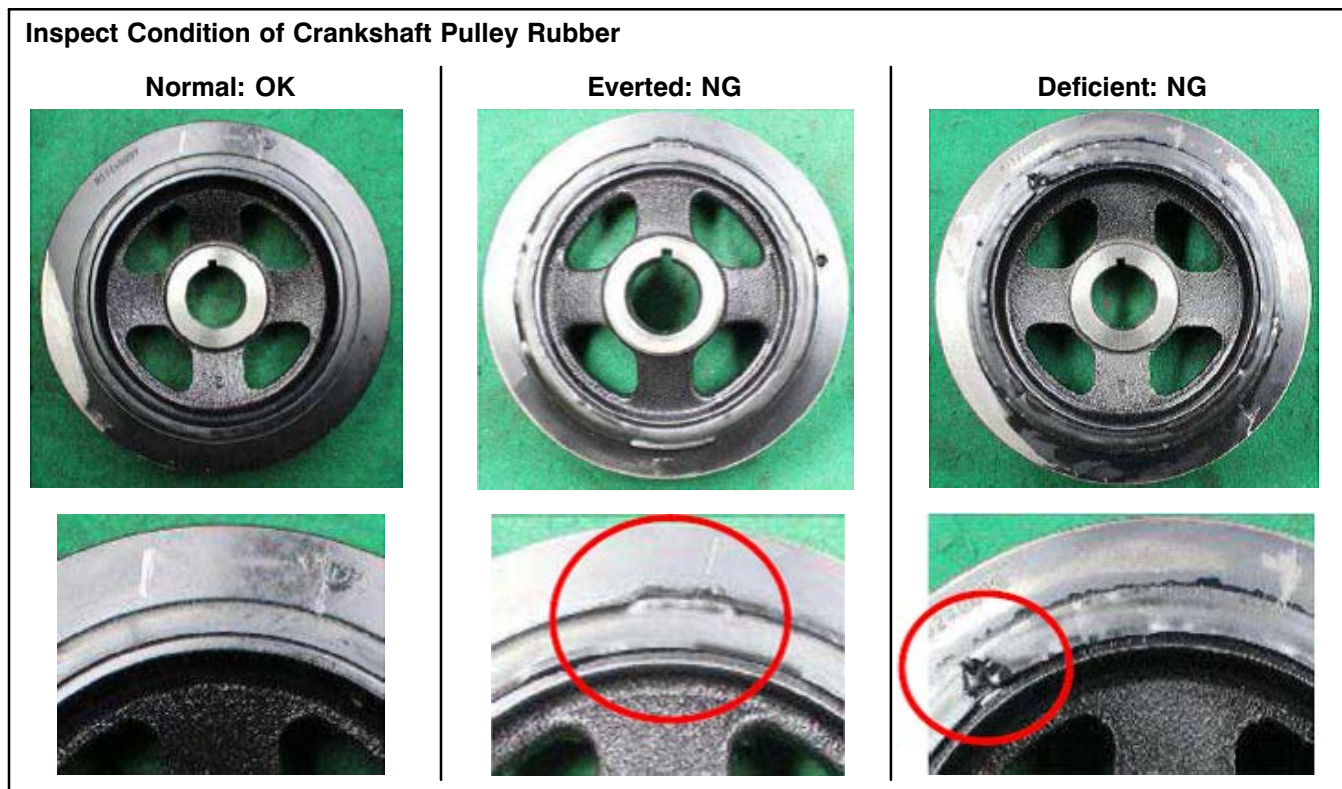
3. Inspect the rubber of the crankshaft pulley. Refer to the sample photos below.

- If the rubber of the crankshaft pulley is everted and/or deficient due to oil leakage, replace the crankshaft pulley with a new part.
- If the rubber of the crankshaft pulley appears normal, clean it with a clean cloth and reuse it.

⚠ CAUTION Do not use any cleaning agents to clean the rubber of the crankshaft pulley. Cleaning agents can deteriorate the rubber and cause future cracking and damage.
