# SERVICE BULLETIN

Classification: AT15-015d	Reference: NTB15-086d	Date: August 9, 2016
------------------------------	--------------------------	-------------------------

## 2013-2016 ALTIMA AND 2014-2016 ROGUE; MIL ON WITH DTC P0776, P1715 MAY HAVE HESITATION AND/OR LACK OF POWER

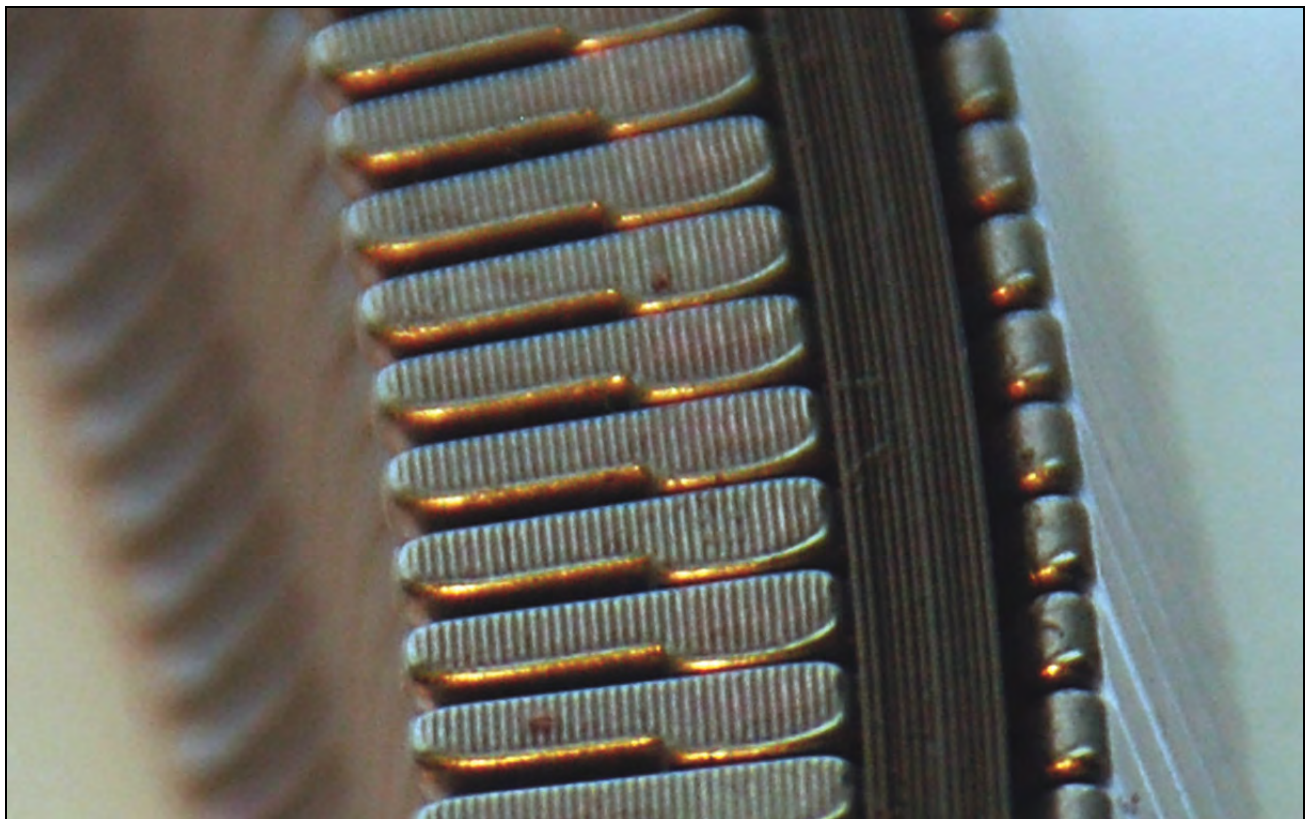
Figure 10: Close-up of section to be inspected

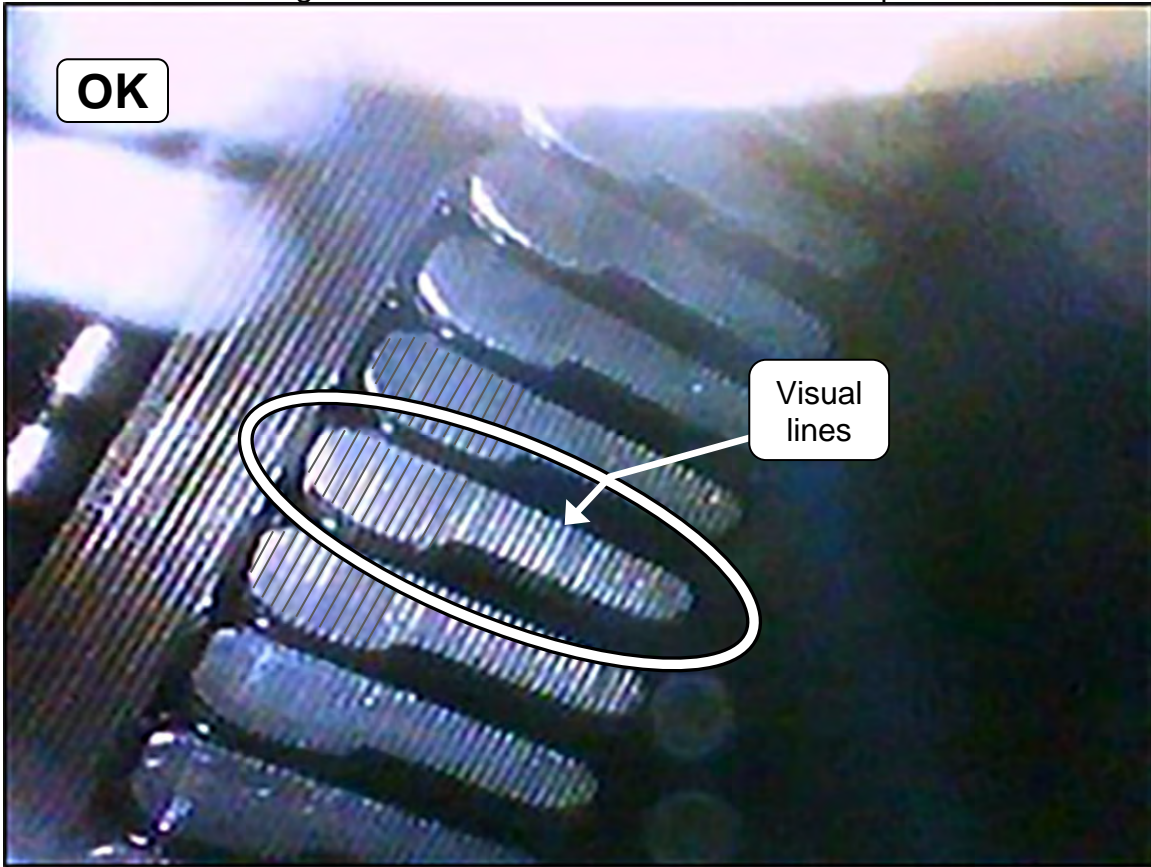
Figure 11: Belt is OK

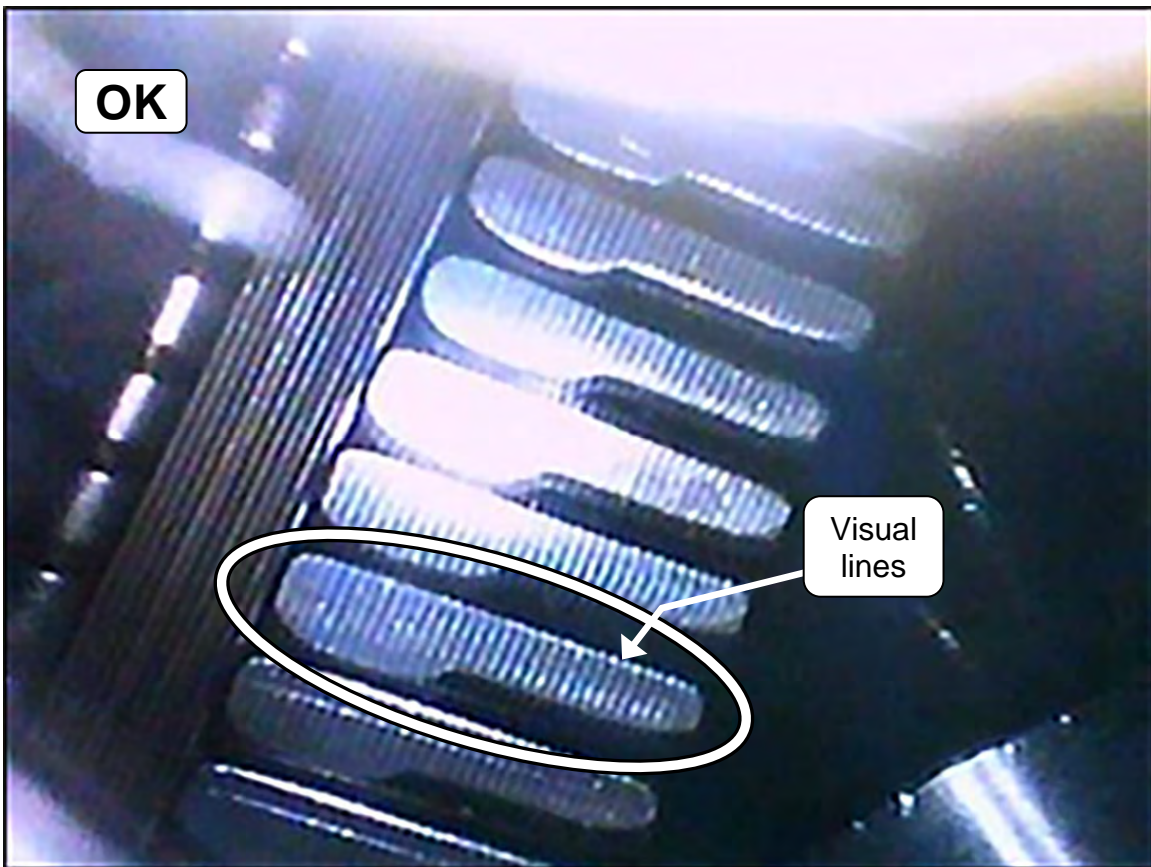
Figure 12: Belt is OK

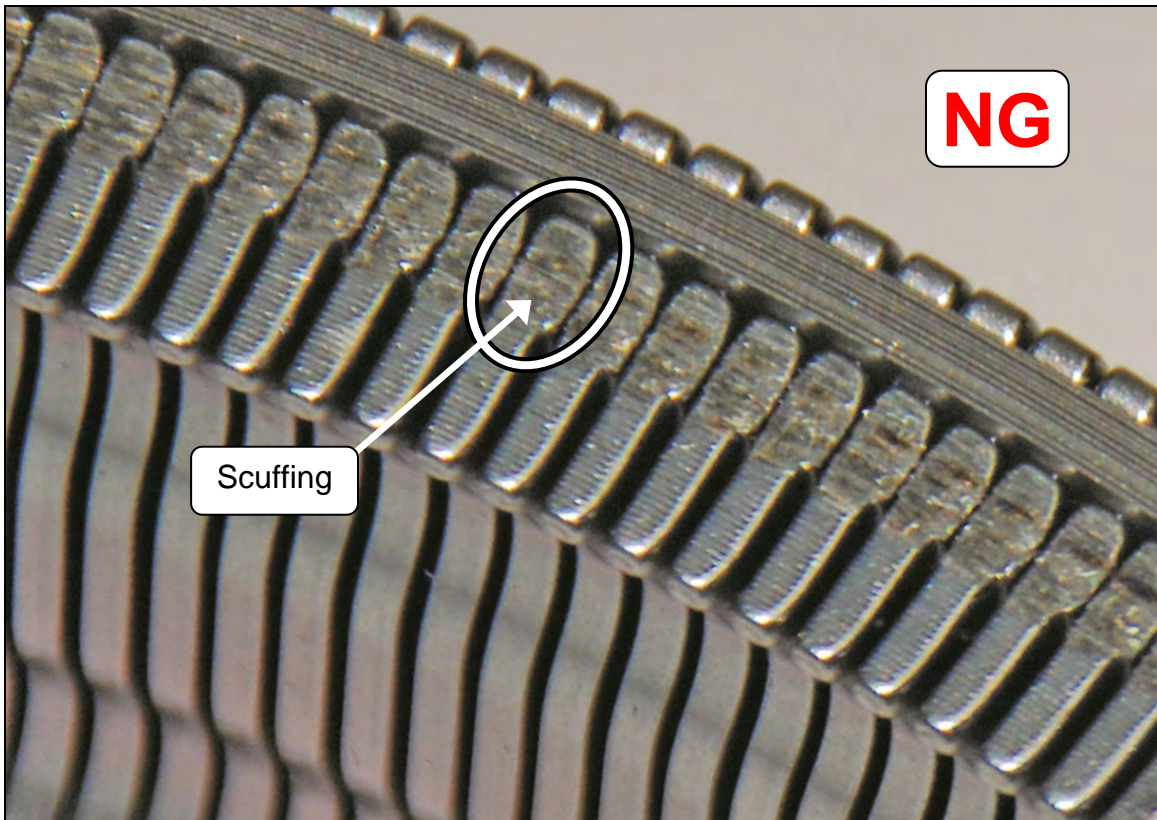
Figure 13: Example of NG belt

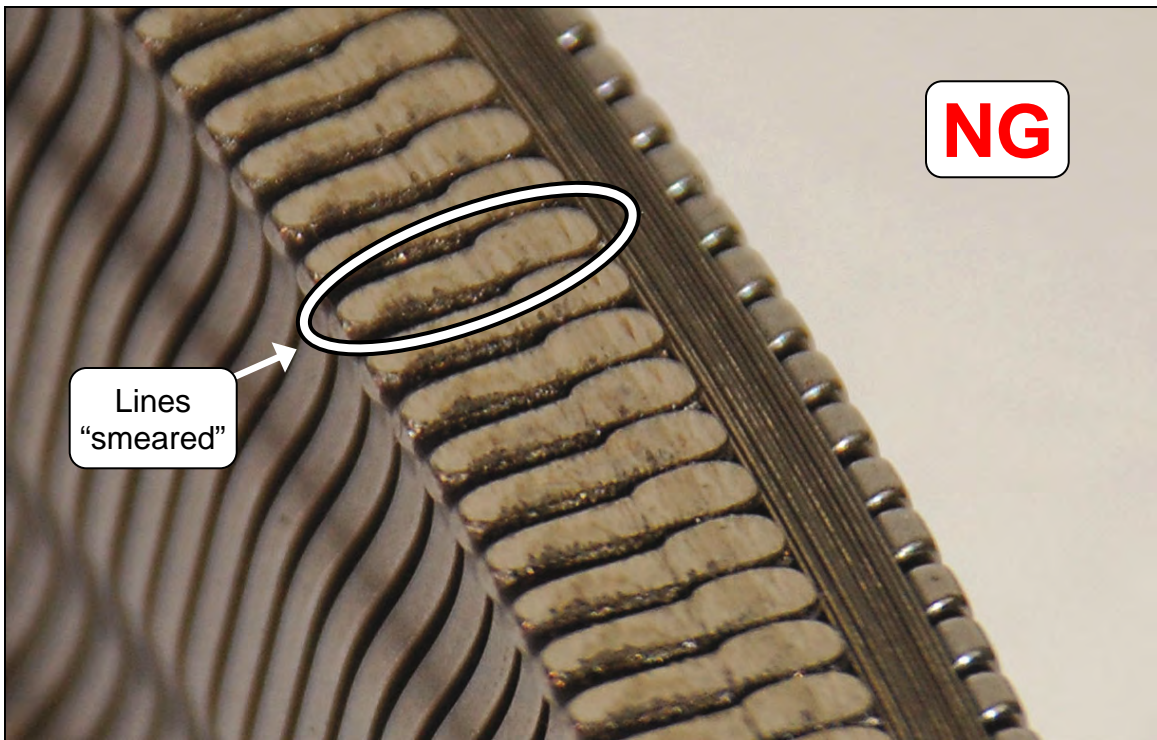
Figure 14: Example of NG belt

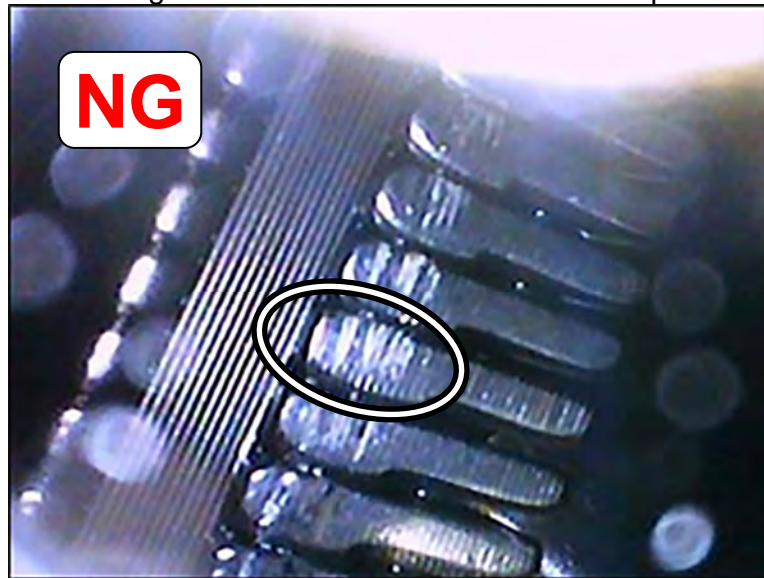
Figure 15: Example of NG belt

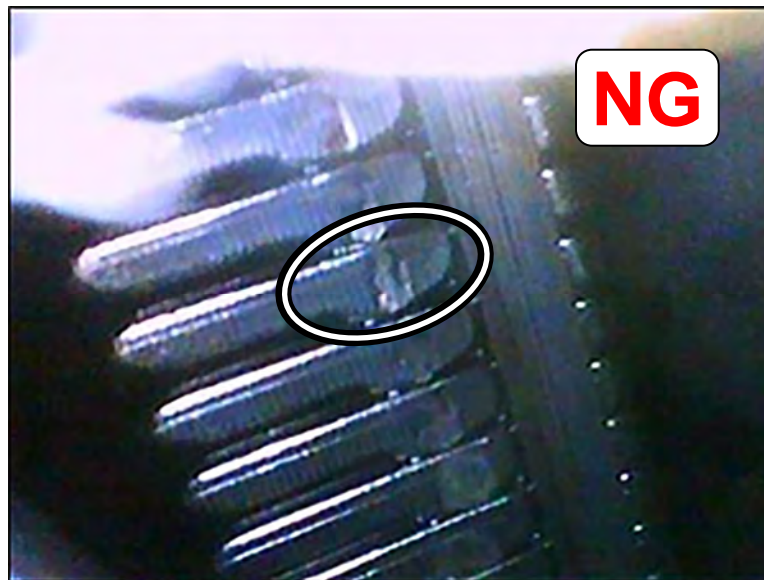
Figure 16: Example of NG belt

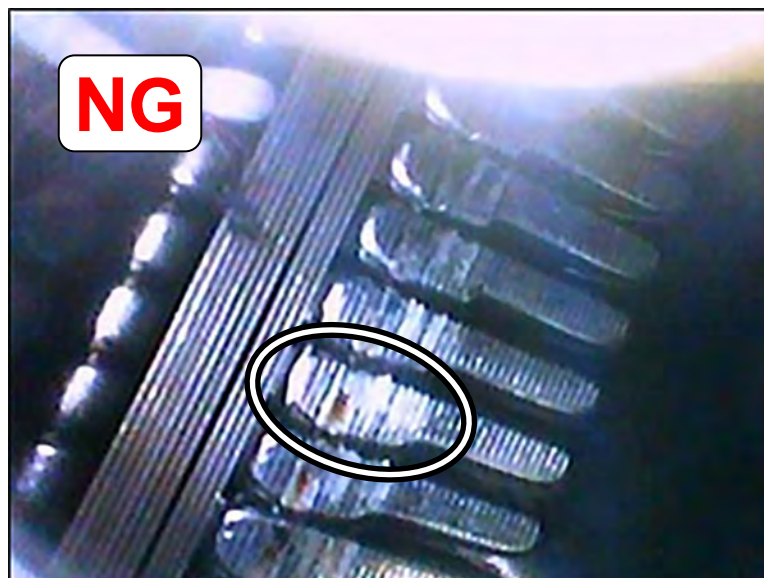
Figure 17: Example of NG belt
