SERVICE BULLETIN

Classification: EM09-007	Reference: NTB09-128	Date: November 16, 2009
-----------------------------	-------------------------	----------------------------

PATHFINDER / XTERRA / FRONTIER; BUZZING / WHINING NOISE FROM TIMING CHAIN AREA

APPLIED VEHICLES: 2005-2010 Pathfinder (R51) VQ40 engine ONLY
2005-2010 Xterra (N50)
2005-2010 Frontier (D40) VQ40 engine ONLY

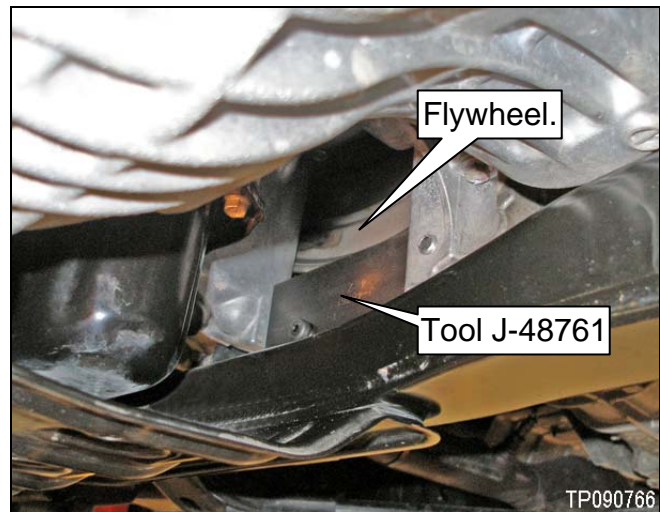
- Before removing the crankshaft pulley, set it to 0° Top Dead Center (TDC).
- Use Tool J-48761 to secure the flywheel / flex plate when removing the crankshaft pulley and camshaft sprockets. Figure 1 shows J-48761 installed on an AWD vehicle.

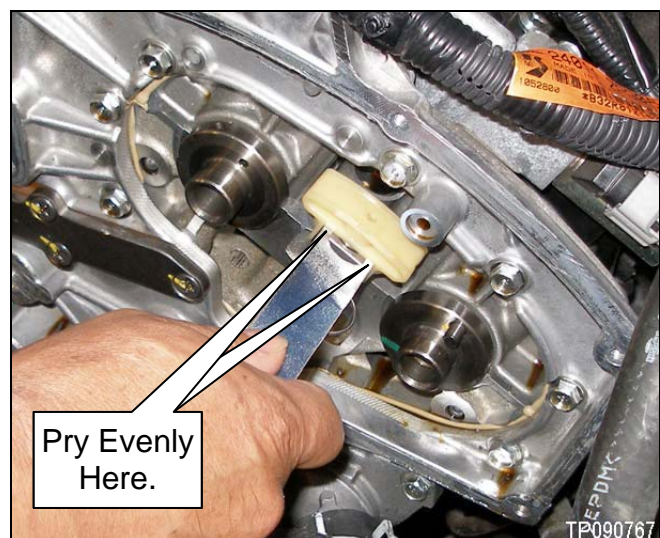
Figure 2

- Remove the Secondary Timing Chain Tensioner Shoes (shoe) by evenly prying with a couple pocket screwdrivers or suitable tool where shown in Figure 2.

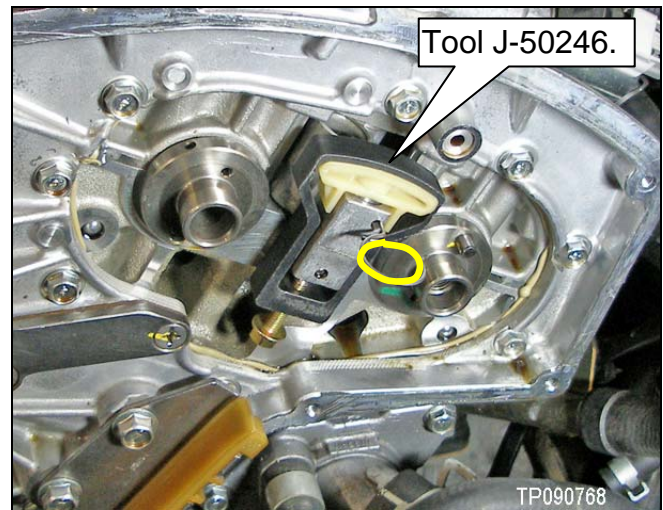
- If the crankshaft is determined to be 360° off from 0° TDC on #1 cylinder compression stroke after removing the front timing chain case (front cover), put the crankshaft pulley back on, and then rotate the crankshaft 360° (when camshaft and crankshaft sprocket mating marks are aligned).
- Use the chain tensioner pins (pin) from Tool Kit J-50246 to hold all three (3) chain tensioner plungers. Figure 3 on Page 5 shows a pin used on B2 tensioner.

5. Install the new shoes to the tensioners with Tool J-50246 (see Figure 3).

- Tighten the bolt until the shoe is fully seated.

CAUTION: Tighten the bolt no more than necessary.
