# SERVICE CAMPAIGN BULLETIN

NTB13-002

## VOLUNTARY SERVICE CAMPAIGN 2013 PATHFINDER TCM REPROGRAM

**APPLIED VEHICLES:** 2013 Pathfinder (R52)

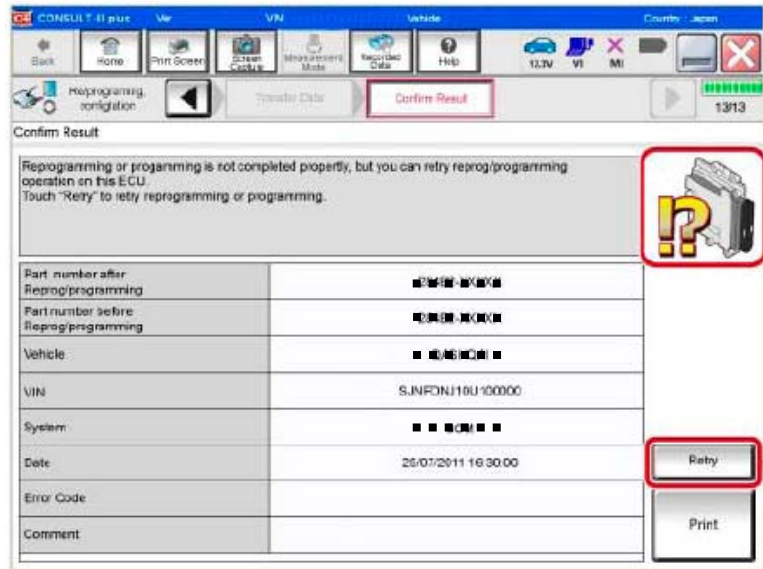
Figure 5

If reprogramming does not complete and the “!?” icon displays as shown in Figure 5:

- Check battery voltage (12.0–15.5 V).
- Ignition is ON, engine OFF.
- External Bluetooth® devices are OFF.
- All electrical loads are OFF.
- **Select retry and follow the on screen instructions.**
- “Retry” may not go through on first attempt and can be selected more than once.

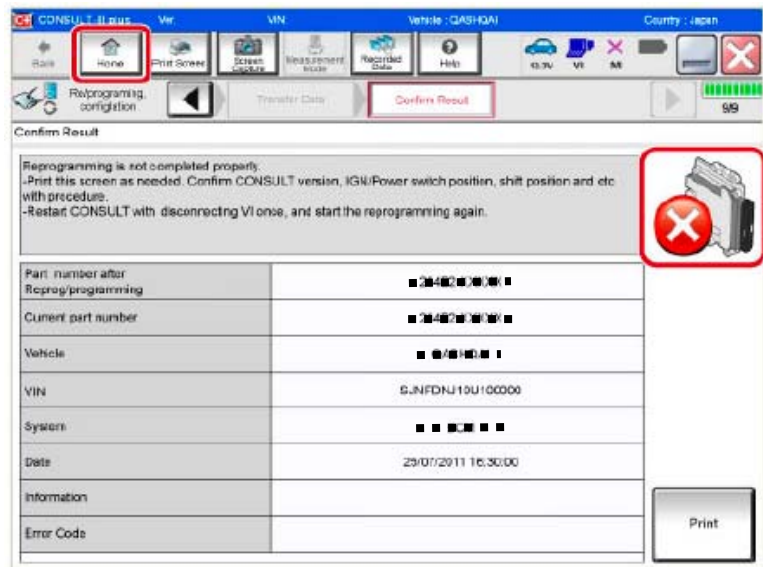
Figure 6

If reprogramming does not complete and the “X” icon displays as shown in Figure 6:

- Check battery voltage (12.0 – 15.5 V).
- CONSULT A/C adapter is plugged in.
- Ignition is ON, engine OFF.
- Transmission is in Park.
- All C-III plus / VI cables are securely connected.
- All C-III plus updates are installed.
- **Select Home, and restart the reprogram procedure from the beginning.**
