SERVICE BULLETIN

Classification: AT13-007a	Reference: NTB13-064a	Date: June 13, 2013
------------------------------	--------------------------	------------------------

2013 ALTIMA V6 SEDAN AND PATHFINDER SHUDDER FROM TORQUE CONVERTER LOCK UP CLUTCH

APPLIED VEHICLES: 2013 Altima Sedan (L33) with V6 engine only
2013 Pathfinder (R52)

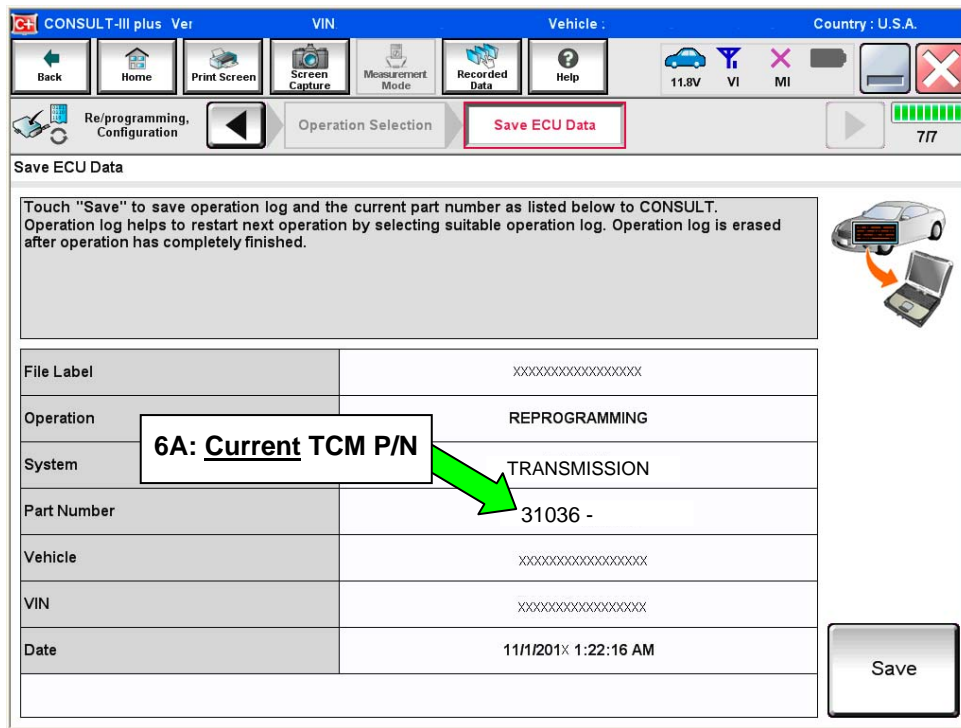
Figure 2

6. When you get to the screen shown in Figure 2, confirm this bulletin applies as follows.

A. Find the TCM **Part Number** and write it on the repair order.

B. Compare the P/N you wrote down to the numbers in the **Current TCM Part Number** column in **Table A** below.

- If there is a match, this reprogramming applies. Continue with the reprogramming procedure.
- If there is not a match, this reprogramming is not needed.

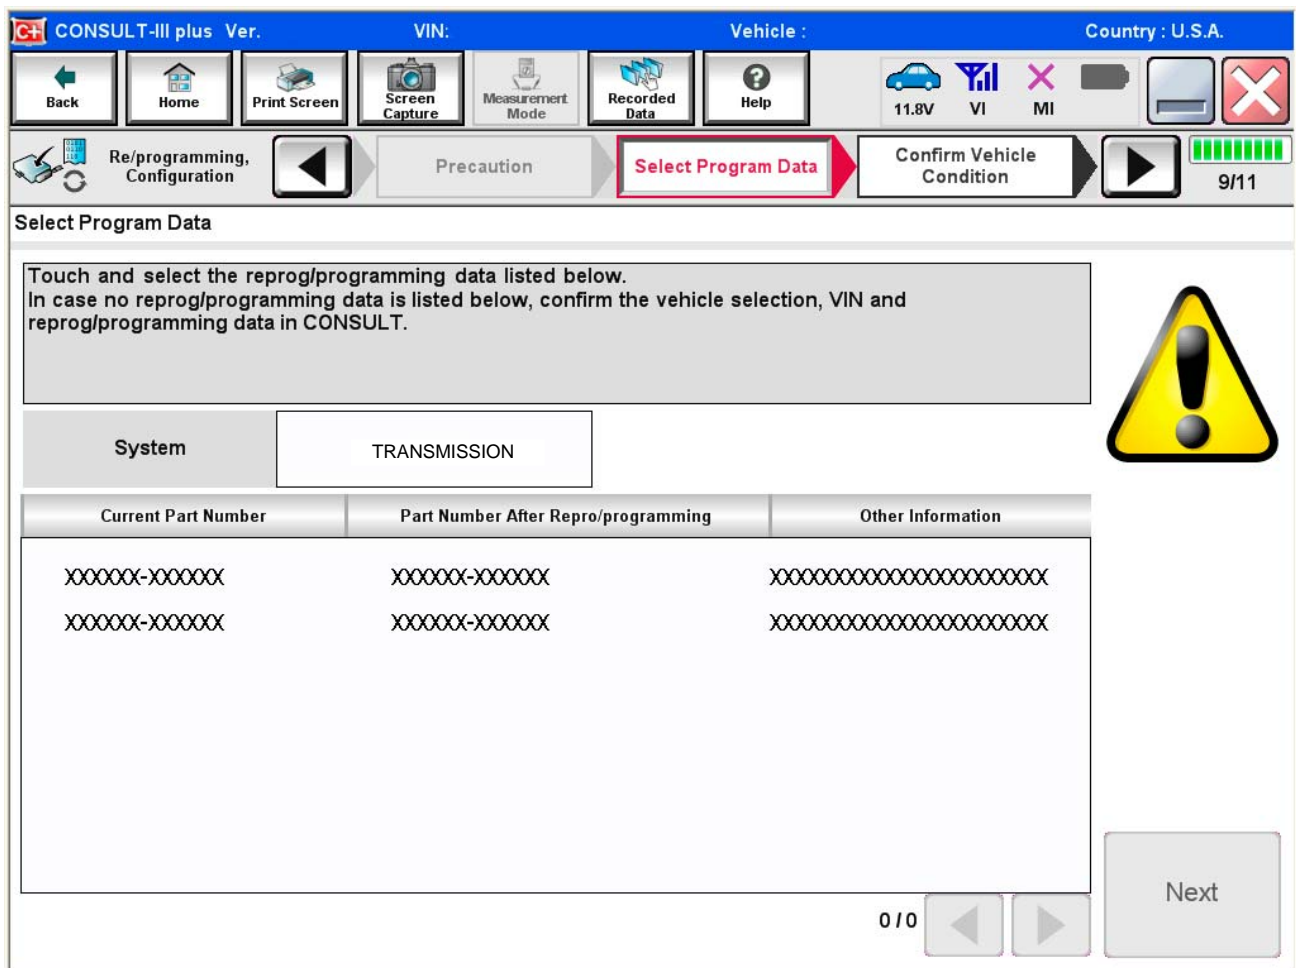
- In some cases, more than one new P/N for reprogramming is available.
 - In this case, the screen in Figure 3 displays.
 - Select and use the reprogramming option that **does not** have the message “Caution! Use ONLY with NTBXX-XXX”.
- If you get this screen and it is blank (no reprogramming listed), it means there is no reprogramming available for this vehicle. Close C-III plus and refer back to ASIST for further diagnosis.
