S-SB-0032-12

## MIL "ON" DTC P0017 or P0019

YEAR(S)	MODEL(S)	ADDITIONAL INFORMATION
2013	FR-S

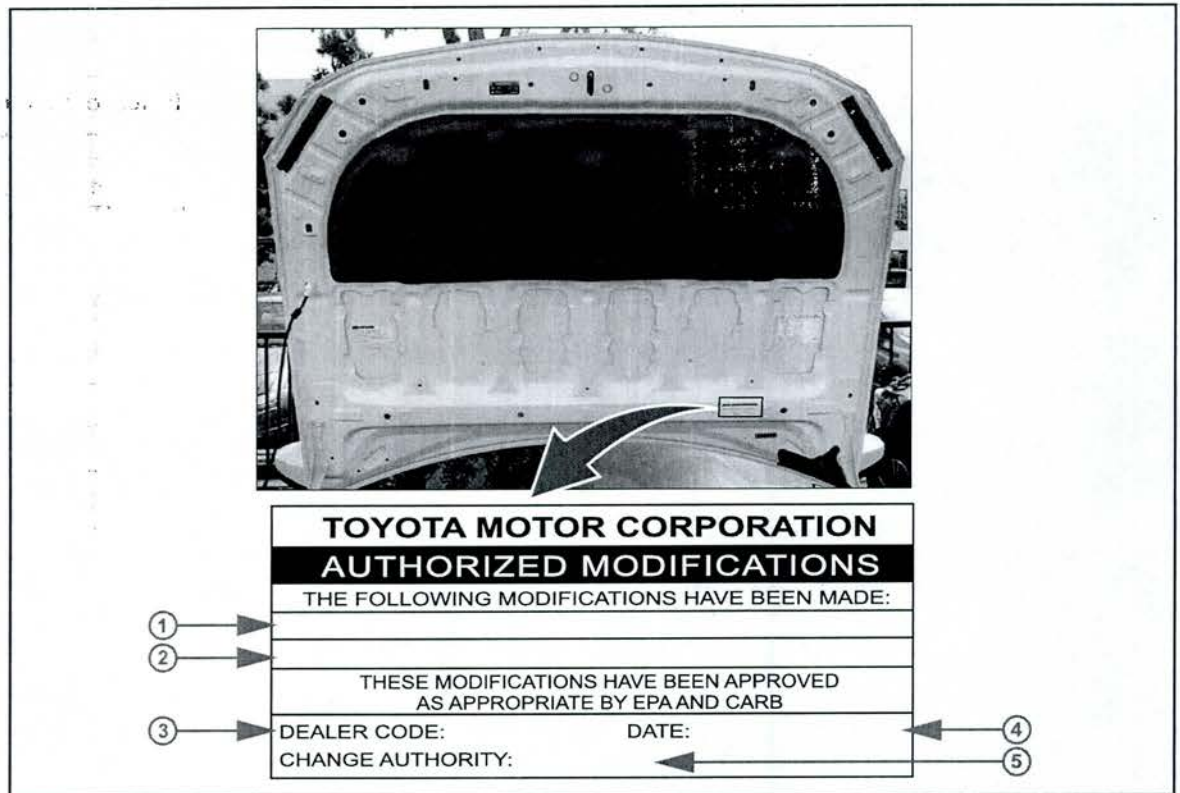
Figure 2. Location of Authorized Modifications Label on 2013 FR-S

- A. Check for the Authorized Modifications Label affixed to the vehicle in the location shown in Figure 2. Confirm if the ECM (PCM) calibration has been updated. If the calibration ID listed is NOT the latest ECM (PCM) calibration — go to step 4.B.

##### (2) Affix the Authorized Modifications Label to the vehicle at the location shown in Figure 2. The Authorized Modifications Label is available through the MDC, P/N 00451-00001-LBL.
