Service Bulletin

Subject: ROUGH IDLE WITH MIL ON AND DTC P0015 / P0524	Bulletin No: 01-009/14
	Last Issued: 09/03/2014

Subject: CRACKING NOISE FROM WINDSHIELD AND/OR REAR WINDOW	Bulletin No: 09-025/14
	Last Issued: 09/03/2014

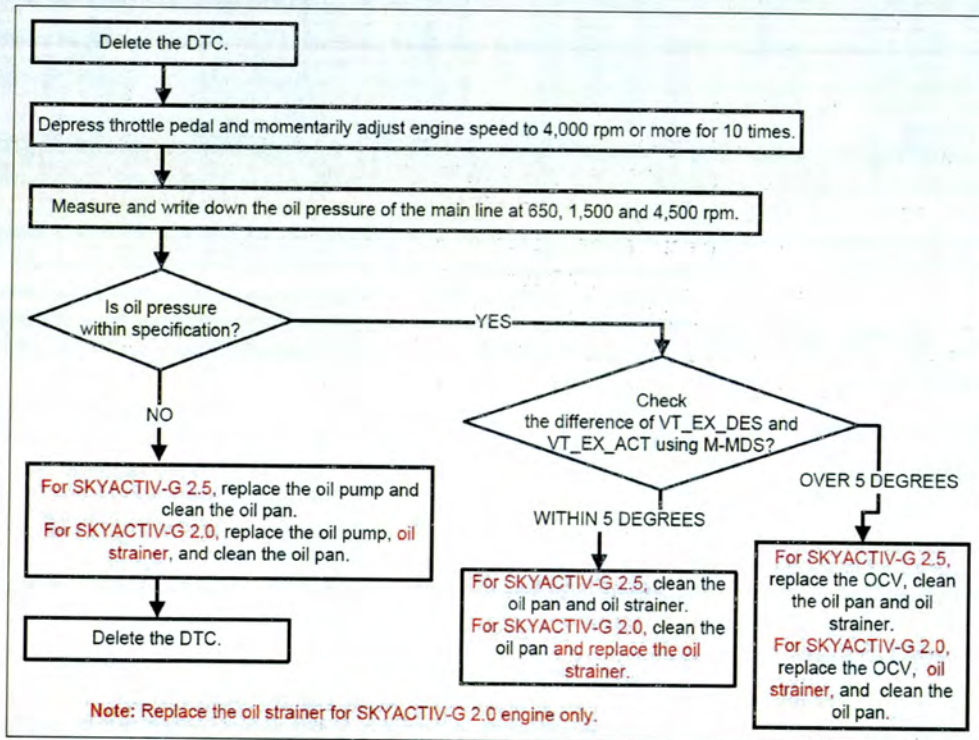
Only P0015 is stored:

Some vehicles may experience a rough idle with the MIL on and DTC P0015 / P0524 stored in memory.

This is caused by a drop in engine oil pressure due to a piece of foreign object stuck on the oil pump pressure relief valve or OCV. The temporary entry of the foreign object triggers a MIL illumination, but rough idle will not be produced until a later time.

1. Delete the DTC.
2. Depress the throttle pedal and momentarily adjust the engine speed to 4,000 rpm or more for 10 times.
3. Measure the main line oil pressure at 650 rpm, 1,500 rpm and 4,500 rpm. Refer to MS3 online instructions or Workshop Manual section 01-11 OIL PRESSURE INSPECTION.
 - a. Connect M-MDS to monitor ECT, OIL_TEMP and RPM.
 - b. Start the engine and turn off all electrical loads such as A/C, headlights, etc.
 - c. Warm up the engine until ECT and OIL_TEMP reach 90 °C (194 °F) or more.
 - d. Turn off all electrical loads such as A/C and headlights.
 - e. Wait until RPM on IDS becomes stable at 650 rpm. DO NOT read RPM on the tachometer in the vehicle.
 - f. Measure and write down the main oil line pressure at 650 rpm, 1,500 rpm and 4,500 rpm.

RPM	Normal oil pressure
650	50 kpa (7 psi) or more.
1,500	110-175 kpa (16.0 - 25.3 psi)
4,500	300-430 kpa (43.6 - 62.3 psi)

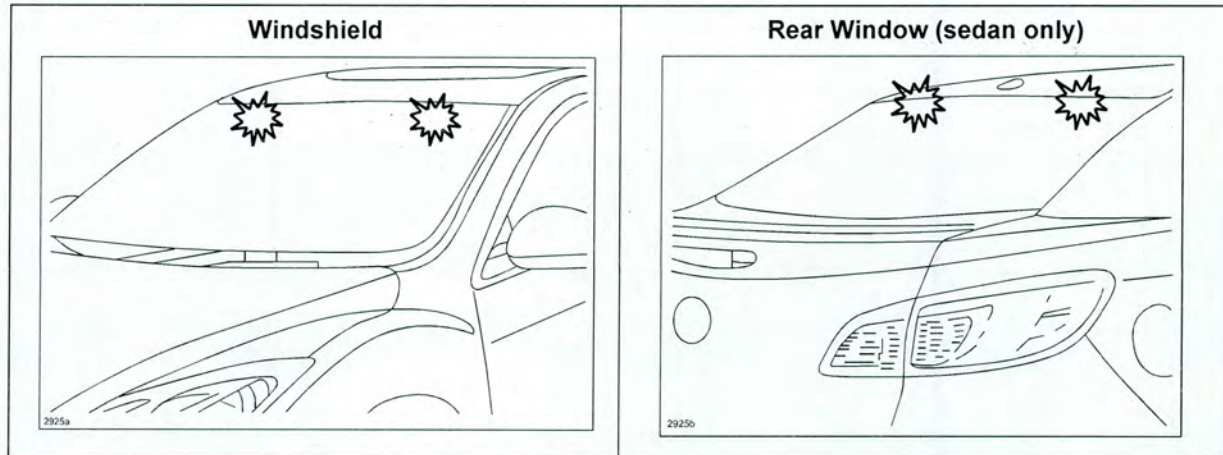
Some vehicles may exhibit a cracking noise originated at the positioning pins near the top corners of the windshield and/or rear window when driving on uneven road surface. This happens when the ambient temperature is approximately 14 °F (-10 °C) or lower and the vehicle cabin has not yet warmed up. The noise is caused by the windshield and/or rear window locating stopper contacting the panel.
