SERVICE BULLETIN RELEASE - 03/05/2014

05-004/14 - MULTI-MODEL - WHINING NOISE FROM AUTOMATIC TRANSAXLE

Subject: WHINING NOISE FROM AUTOMATIC TRANSAXLE	Bulletin No: 05-004/14
	Last Issued: 03/05/2014

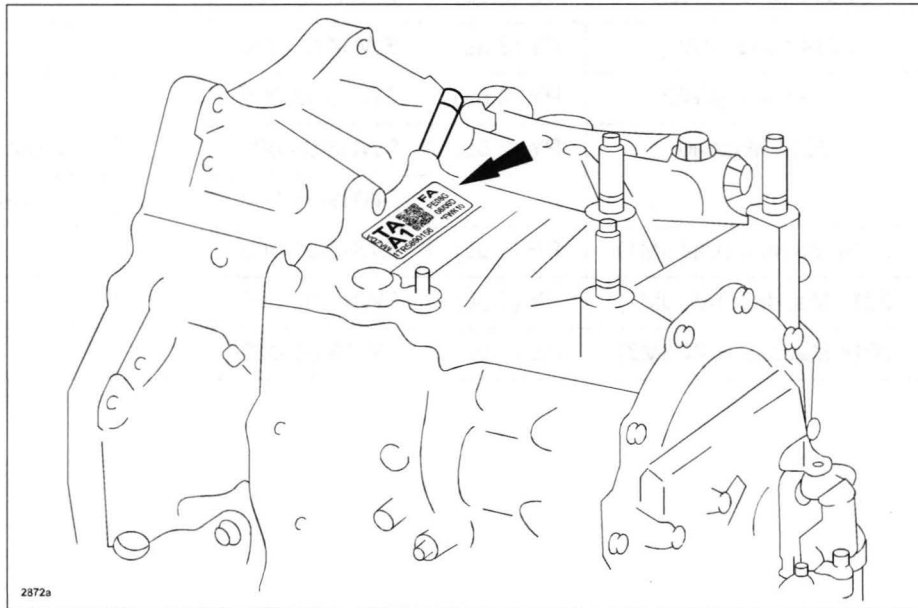
This is caused by a damaged bearing in the transaxle due to improper configuration of the transaxle case. A modification has now been implemented on automatic transaxles with the serial number TR1111680 and higher or TD1104906 and higher. The serial number can be found on top of the transaxle case near the manual shaft lever.

1. Verify customer concern.
2. Replace the 6AT assembly with a new one according to MS3 online instructions or Workshop Manual section 05-17.
3. Verify repair.
