SERVICE BULLETIN RELEASE - 07/29/2014

06-002/14 - MULTI-MODEL - UNUSUAL NOISE WHEN STARTING TO MOVE VEHICLE WHILE STEERING WHEEL IS TURNED TO FULL LEFT POSITION

Subject: UNUSUAL NOISE WHEN STARTING TO MOVE VEHICLE WHILE STEERING WHEEL IS TURNED TO FULL LEFT POSITION	Bulletin No: 06-002/14
	Last Issued: 07/29/2014

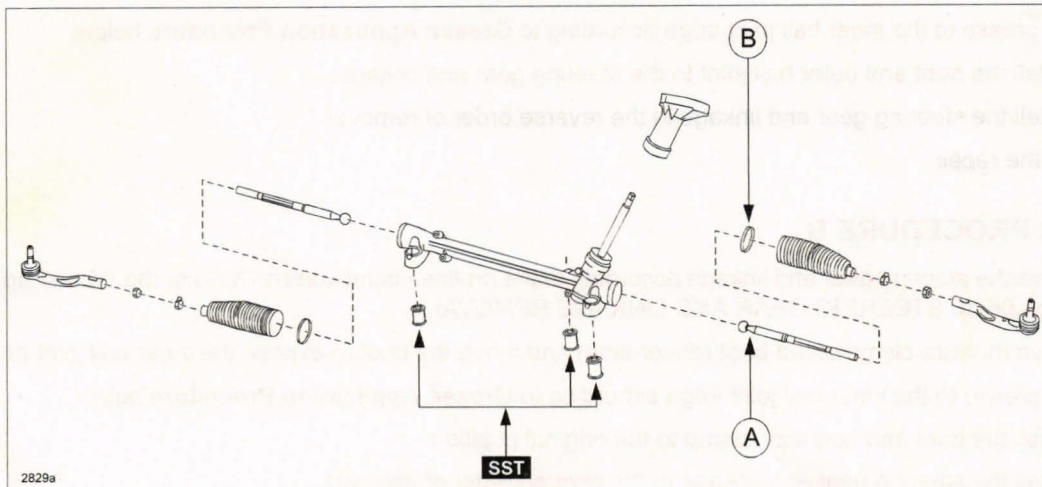
Some vehicles may exhibit an unusual (clacking) noise from under the front of the vehicle. This noise only occurs when starting to move the vehicle while the steering wheel is turned to the full left position.

The noise is caused when the edge of the left side inner ball joint (A) gets stuck with the steering gear housing.

The following modifications have been made to eliminate the noise:

1. The shape of the inner ball joint edge has been changed.
2. Grease has been applied to the inner ball joint edge.

Customers having this concern should have their vehicle repaired using the following repair procedure.
