MAZDA DEALER NOTICE - SERVICE BULLETIN RELEASE

Service Bulletin

CHECK ENGINE LIGHT ON WITH DTC P0191:00 OR P0192:00

Last Issued: 04/29/2014

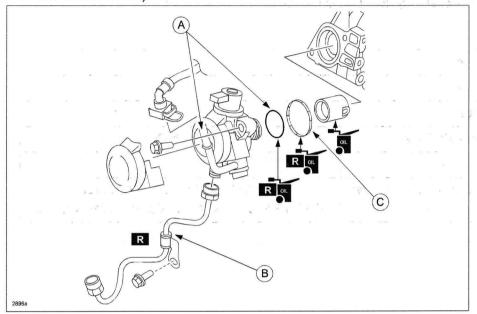
This is caused by the high pressure fuel pump not generating the target fuel pressure (due to a manufacturing error of the inner parts). To correct the problem, production control has been improved.

- 1. Verify customer concern.
- 2. Replace the high pressure fuel pump with a modified one according to the Workshop Manual.
- 3. Replace the high pressure fuel pump (A: fuel pump; B: fuel pipe; C: rubber seal) with a modified one according to the instructions on MS3 online or the Workshop Manual (section 01-14 HIGH PRESSURE FUEL PUMP REMOVAL/INSTALLATION).
