NUMBER: 07-002-14

GROUP: Cooling

Coolant Weepage At EGR Hose

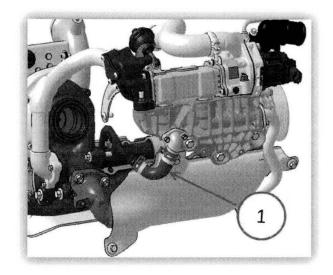
Fig. 1 EGR

The EGR hose may weep coolant.

1 - EGR Coolant Hose

- 2. Lower the belly pan splash shield.
- 3. Lower the rear transmission splash sheild.
- 4. Replace the EGR coolant hose.
