TECHNICAL BULLETIN
LTB00305NAS3
25 MAR 2013

Audible Boom / Vibration at 2,400 - 2,800 RPM

LR4 (LA)	Model Year:	2010-2014
	VIN:	AA510742 Onwards
Range Rover Sport (LS)	Model Year:	2010-2013
	VIN:	AA212147 Onwards

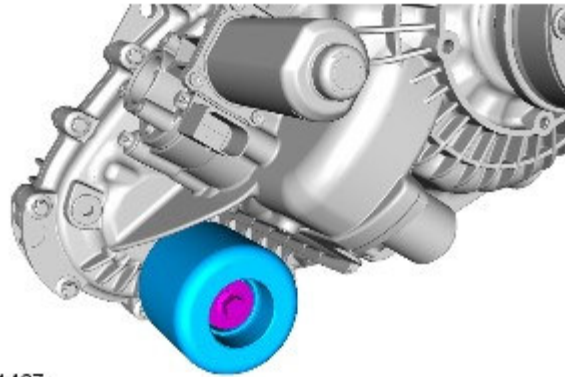
E131467

An audible boom may be heard or vibration may be felt through the floor pan or front seat at 2,400 - 2,800 rpm during medium to heavy acceleration (not during cruise or light load situations).

Cause: This may be caused by powertrain torsion mode where the transfer box is effectively twisting on the rear of the transmission.

1. Raise and support the vehicle (see Workshop Manual section 100-02).
2. Install the damper and bolt to the vacant threaded hole in the transfer case.
 - Tighten the bolt to **75 Nm (55.5 lbf ft)**.
