TECHNICAL BULLETIN
LTB00378NAS2
09 SEP 2014

SECTION: 307-02C

Transmission Oil Cooler Pipe Leak

LR4 (LA)

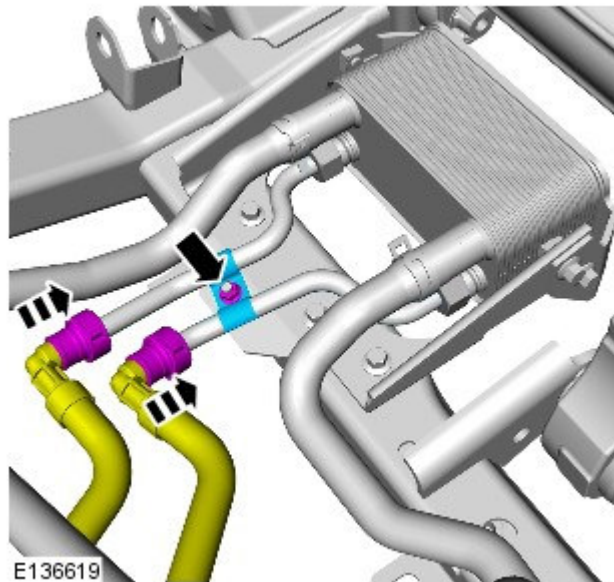
Situation: The transmission oil cooler pipe(s) may exhibit a leak.

Cause: This may be caused by poor bracket paint finish and / or low torque on the saddle clamp nut, allowing the piped to rub through the paint.

8. Install the two transmission fluid pipes.

- Install the new securing clamp and retaining nut.
- Torque: 10Nm.
