SERVICE BULLETIN

APPLICABILITY: 2013MY Legacy and Outback 2.5L Models
 2012-13MY Impreza 2.0L Models
 2013MY XV Crosstrek
 2011-2014MY Forester
 2013MY BRZ

NUMBER: 11-130-13R
DATE: 04/05/13
REVISED: 06/19/13

SUBJECT: Difficulty Starting, Rough Idle, Cam Position or Misfire DTCs
 P0340, P0341, P0345, P0346, P0365, P0366, P0390, P0391,
 P0301, P0302, P0303 or P0304

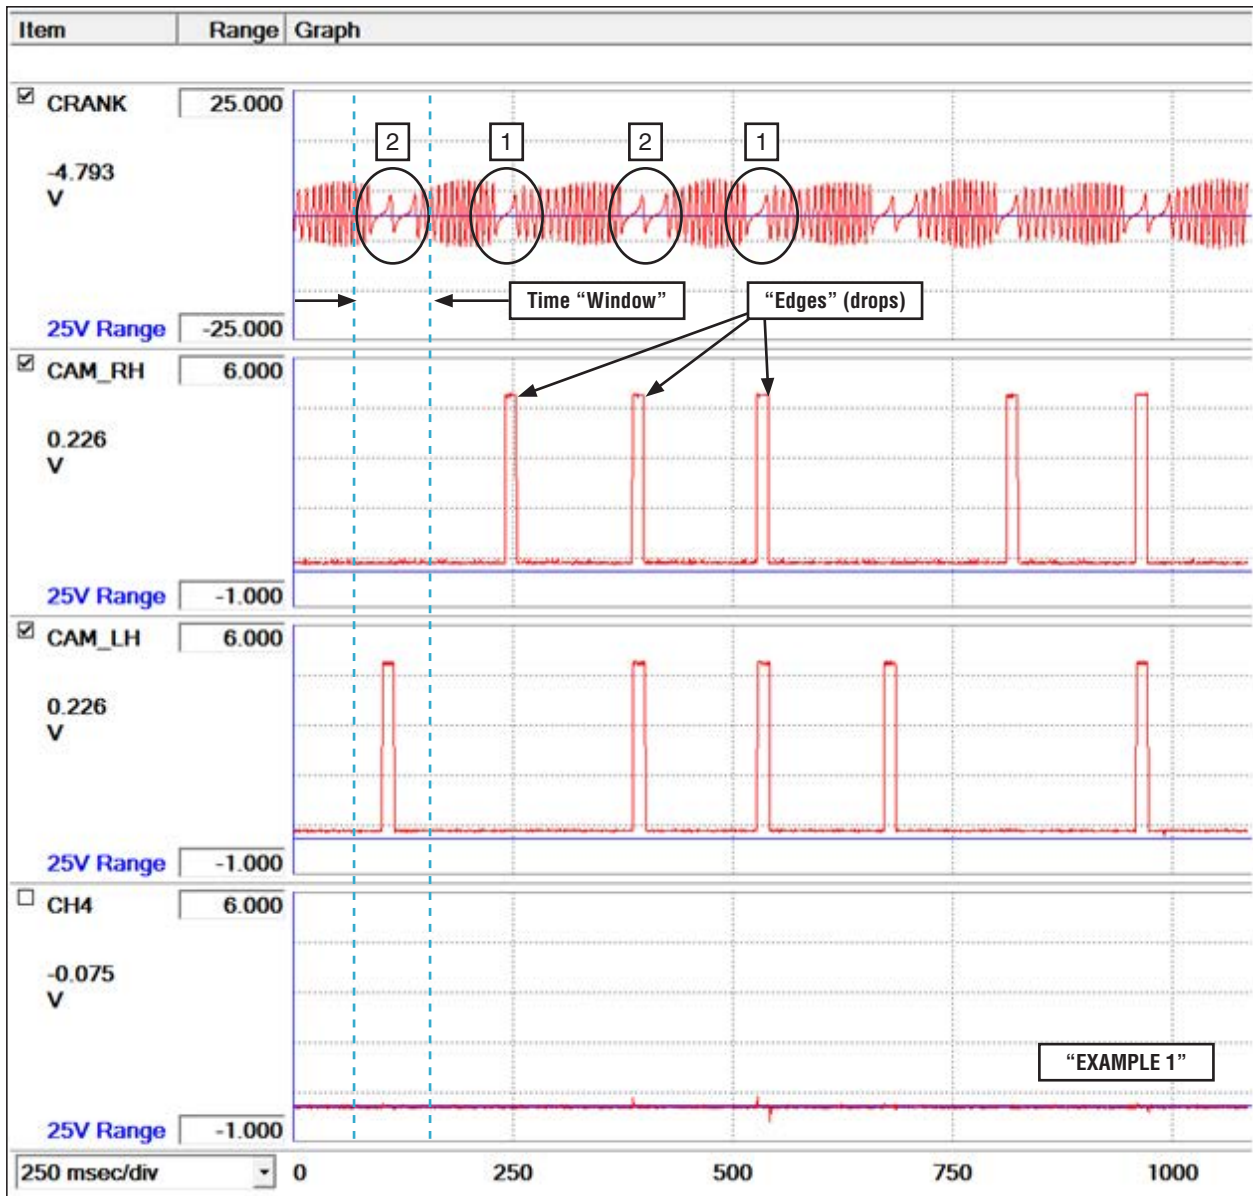
Using the chart above and comparing it to **Example 1**, it can be determined the first cylinder shown in the screen shot is #3 because the crank signal is a "2" and there is an edge signal within the window on the LH but not the RH cam sensor. Next cylinder in the firing order would be #2 as the crank position signal is a "1" and there is an edge signal in the window for the RH but not for the LH, and so on...

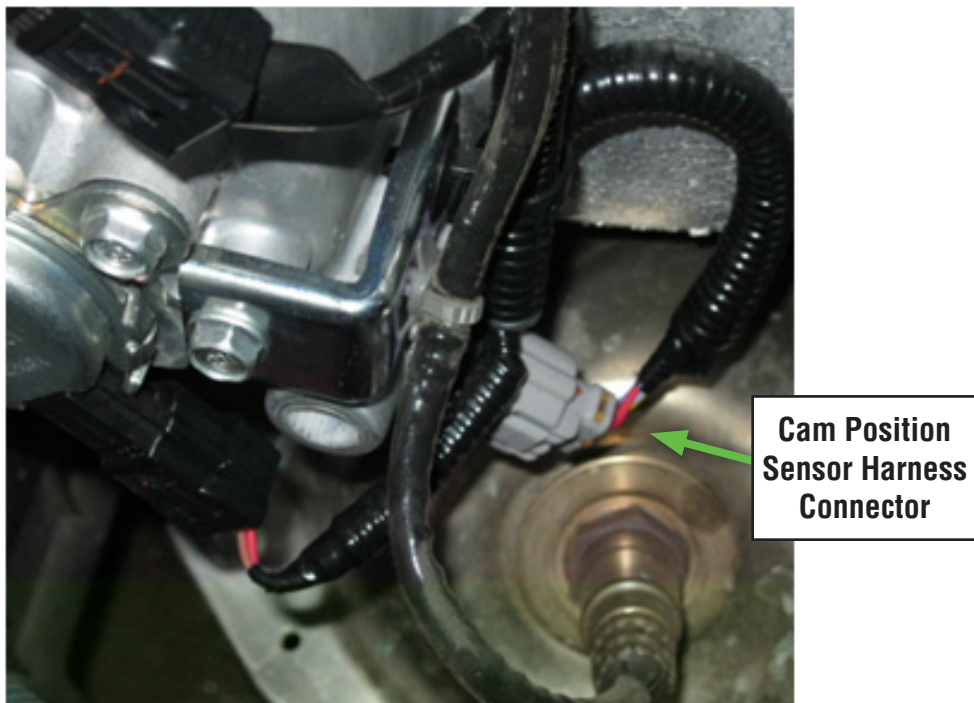
In the event you have a DTC stored for an exhaust camshaft position sensor, the repair procedure has been revised. Due to the position of the right-hand (Bank 1) sensor, measurement of the gap without removing the front catalyst is extremely difficult as shown in the photo below.

1. Confirm the irregular oscilloscope pattern for the corresponding DTC stored.
2. Remove the sensor from the timing cover and install a .2mm thick shim from the applicable kit.
3. Reinstall the sensor, torque the sensor retaining bolt to 6.4 Nm (4.7 ft. lbs. or 56.4 inch-pounds) then recheck the oscilloscope pattern.

If the pattern is normal, the repair is complete. If the irregular pattern persists, repeat Steps 2 and 3 after removing the .2mm shim and installing a .3 mm thick shim. **ONE SHIM ONLY, NO STACKING.** Repeat as necessary increasing the shim thickness .1 mm at a time until a normal scope pattern can be verified.
