**SERVICE BULLETIN**

**APPLICABILITY:** 2010-12MY Legacy and Outback 2.5L NA Models  
 2015-2017 Legacy and Outback 3.6L Models  
 2014-17MY Forester Turbo Models  
 2015-17MY WRX  
 All Above Models Equipped with TR690 CVT

**NUMBER:** 16-103-16R  
**DATE:** 12/14/16  
**REVISED:** 01/08/19

**SUBJECT:** Transmission Fluid Seepage

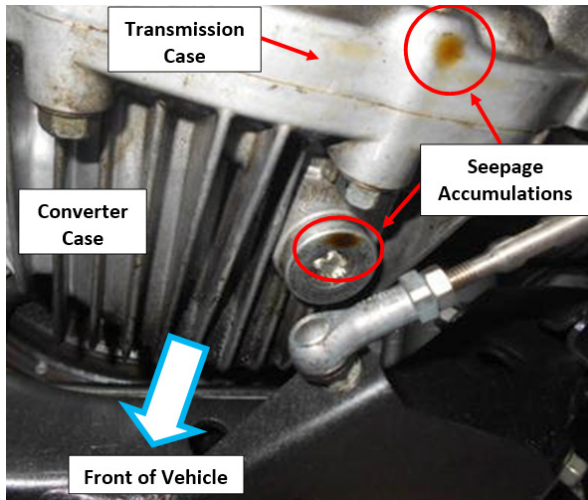
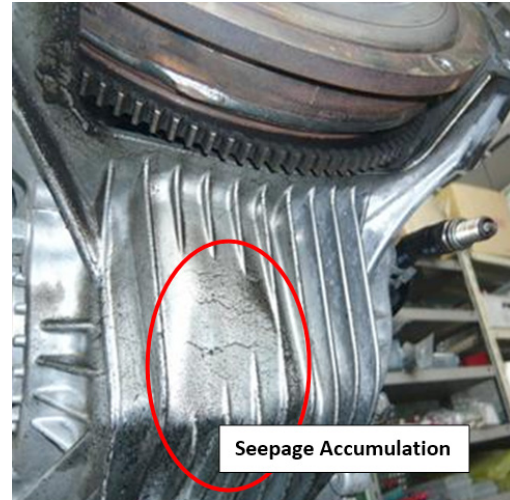
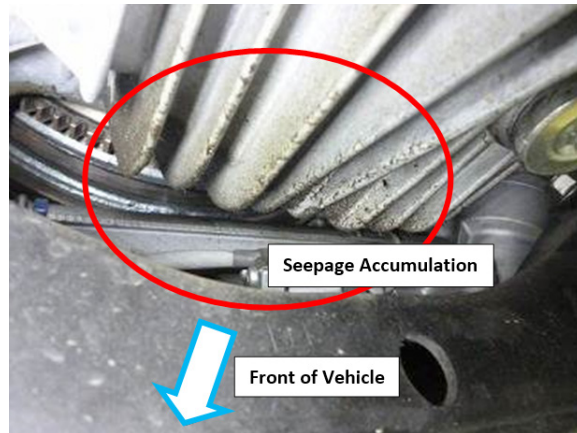
As a first step, during inspection of the customer’s concern, confirm the fluid found to be seeping is CVT fluid (CVTF) and not engine oil. The photos below are examples of where CVTF seepage may be evident.

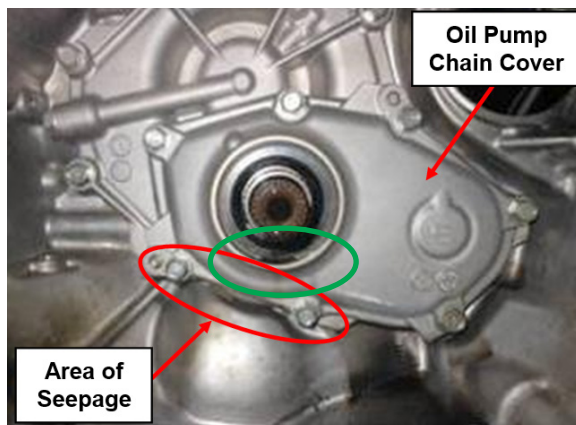
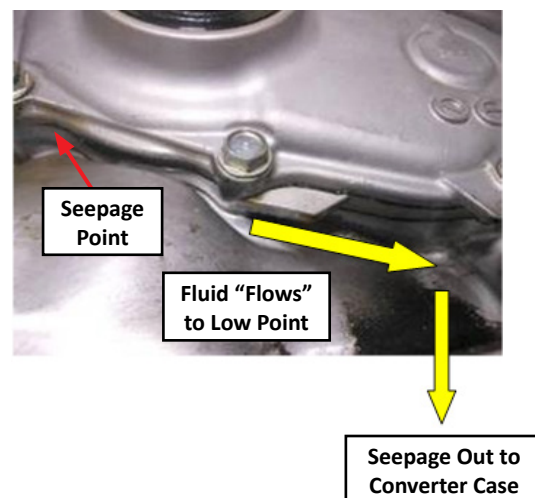
- Once the inspection has confirmed the seepage is CVTF, remove the CVT assembly following the procedure outlined in the applicable Service Manual.
- Remove the torque converter from the CVT and inspect the area of the oil pump chain cover as indicated in the photo below for any accumulation of CVTF and road dirt which may also have collected in the area.

**NOTE:** A small amount of fresh CVT fluid may appear near the 6:00 position of the seal area during removal of the torque converter (GREEN circle).

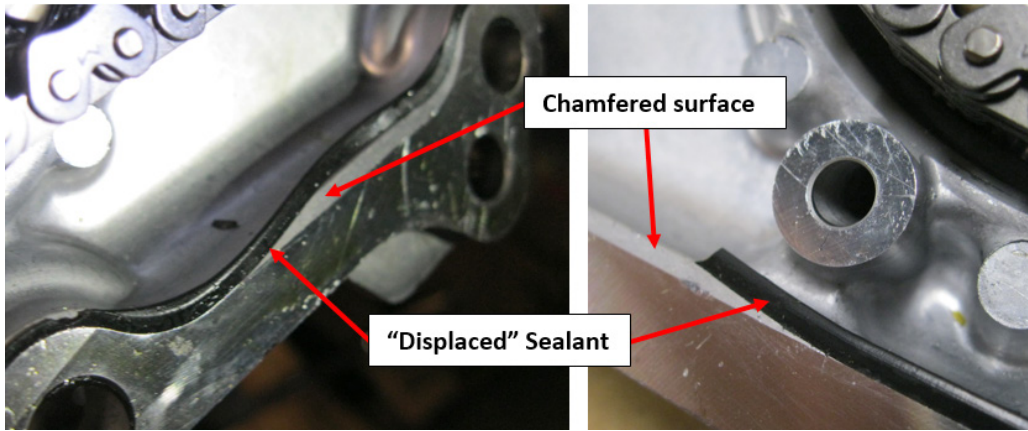
- Take note of how the sealant on the removed cover forms an additional “seal” when it becomes displaced into the chamfer around the inside edge of the case’s machined surface at assembly.

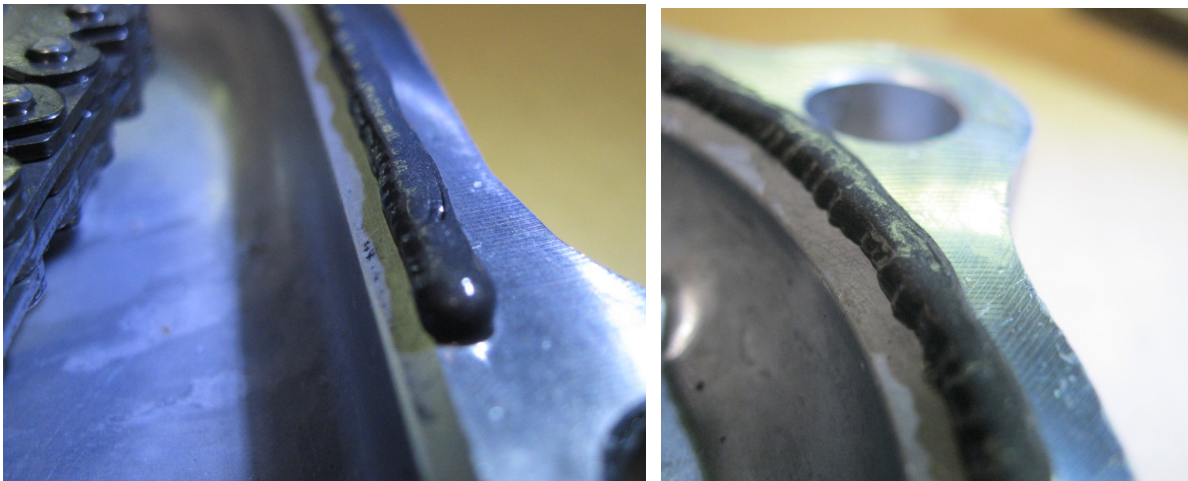
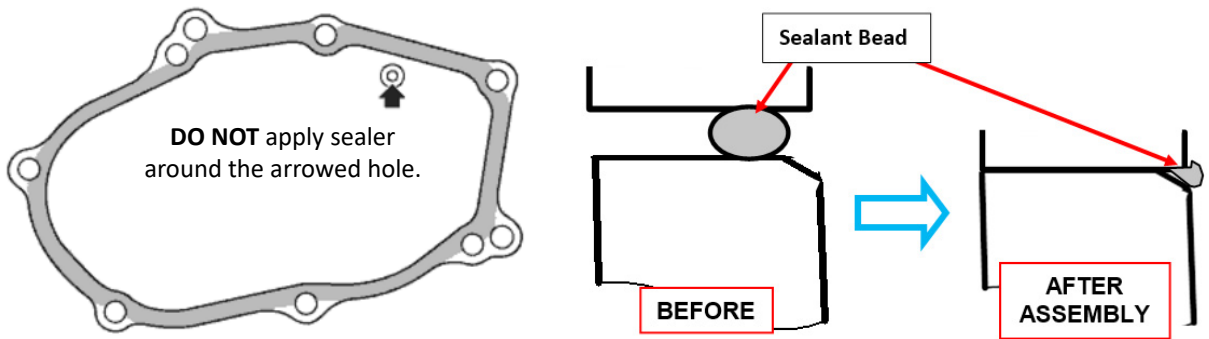
**NOTE:** As shown above, a properly applied, small bead of sealant will fill in the chamfered portion after the cover is installed. Do not use an excessive amount of sealant.

- Once both surfaces and the area surrounding the cover are completely clean and dry, **CAREFULLY** apply the new sealant bead to the cover along the edge of the chamfer as shown below.
