## SERVICE BULLETIN

**APPLICABILITY:** 2015-2017MY Legacy / Outback 2.5 CVT Models **NUMBER:** 16-104-17R  
 2015-2016MY Crosstrek Hybrid (HEV) **DATE:** 02/23/17  
**SUBJECT:** “Bump” Feeling from CVT at Idle in Drive **REVISED:** 05/30/17

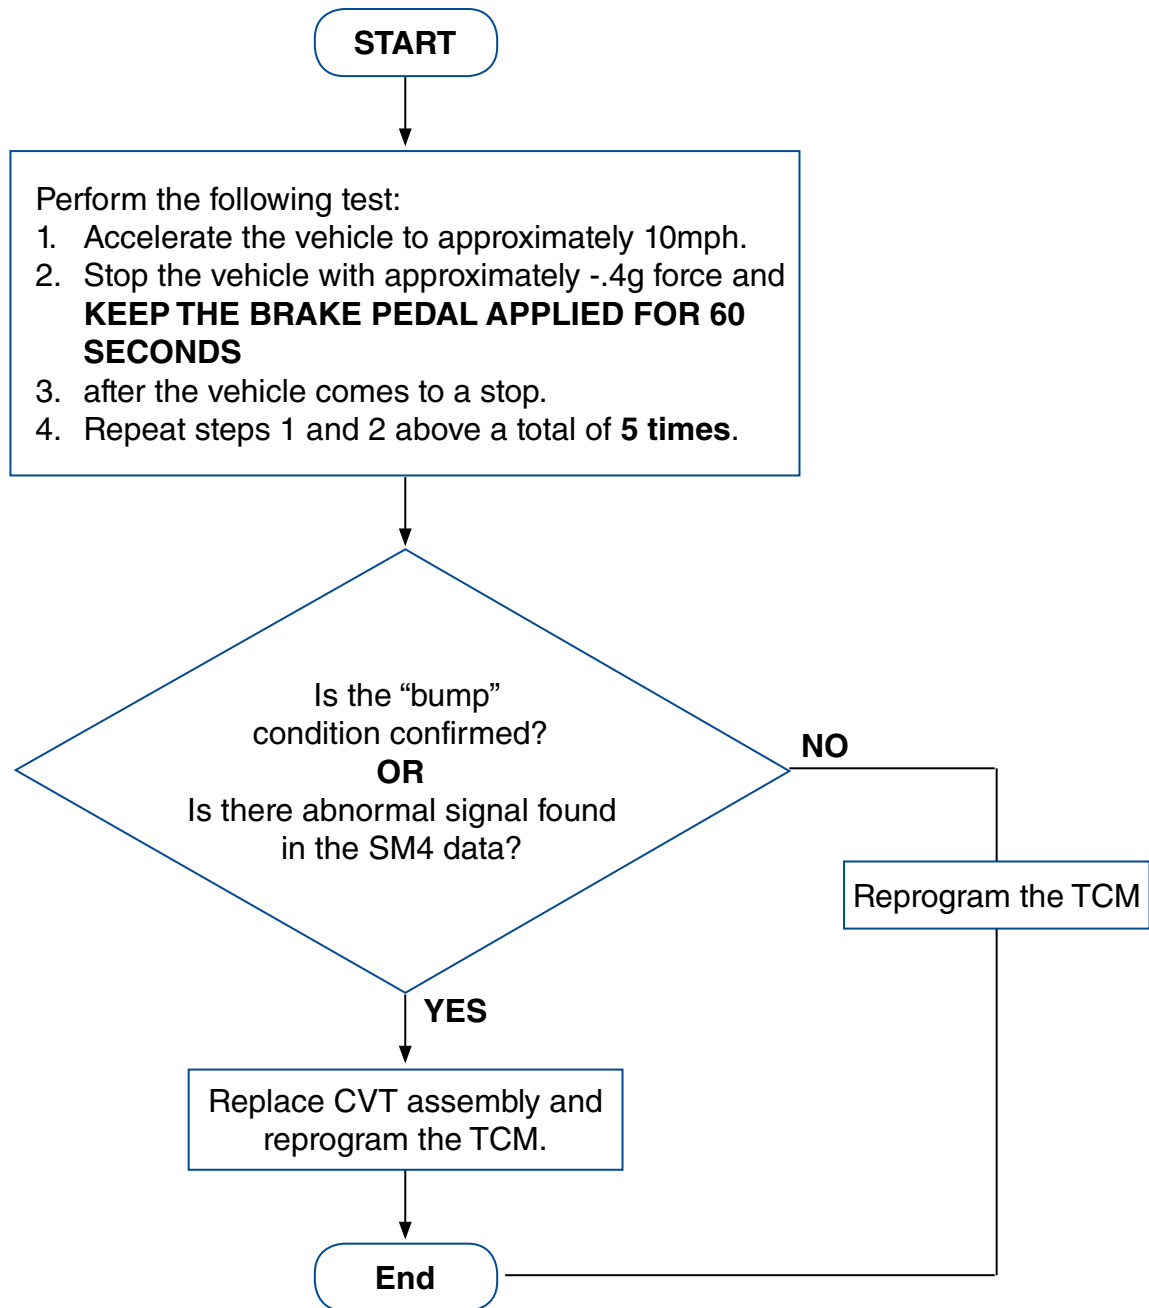
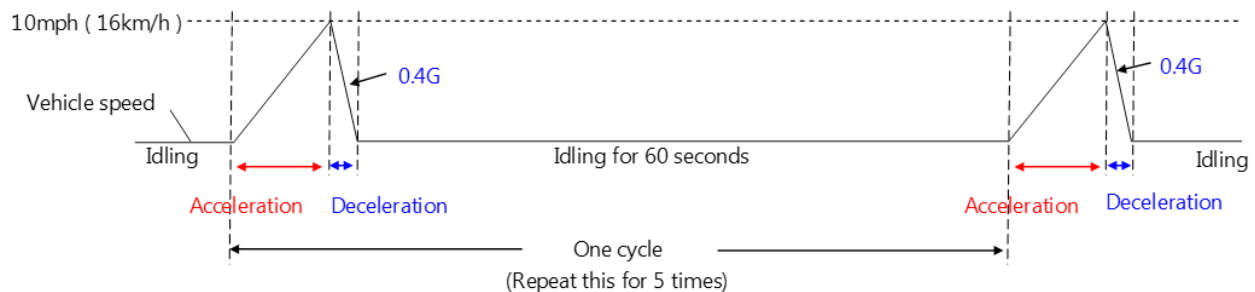
- Perform the test following the flow chart and graph supplied below.

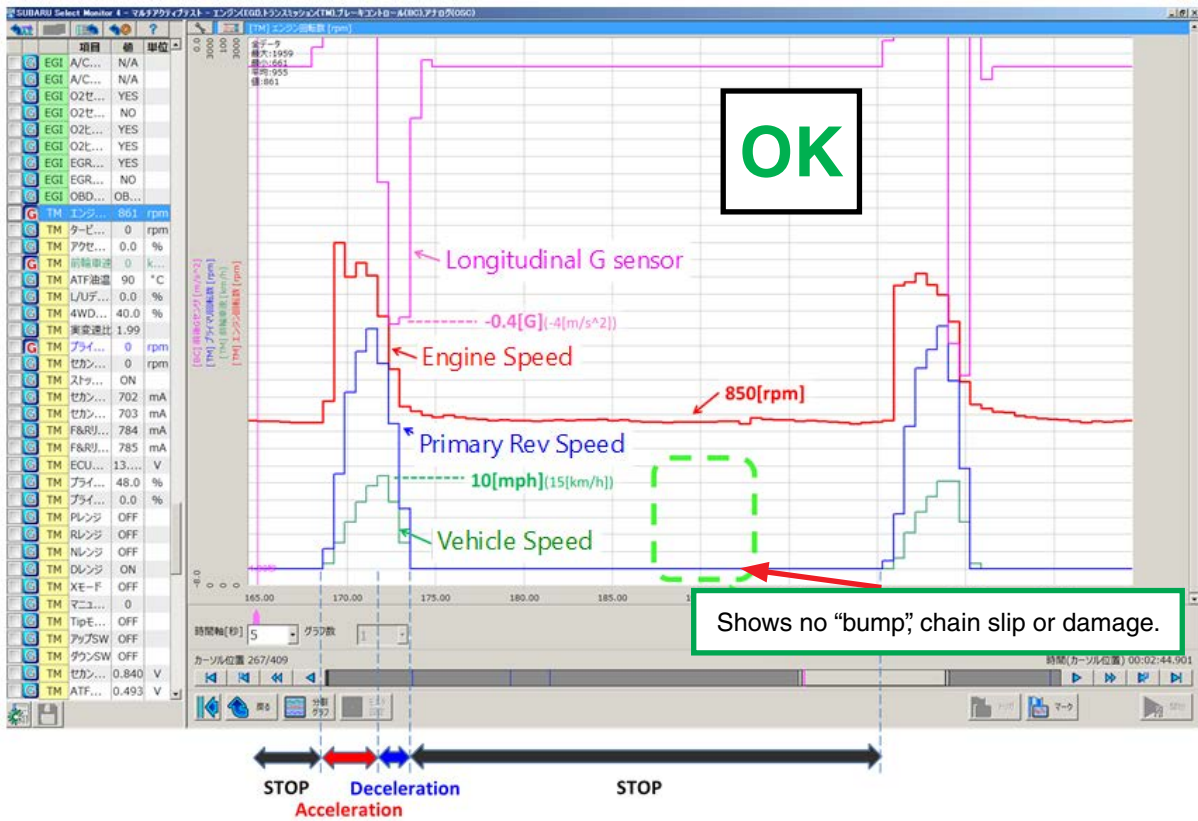
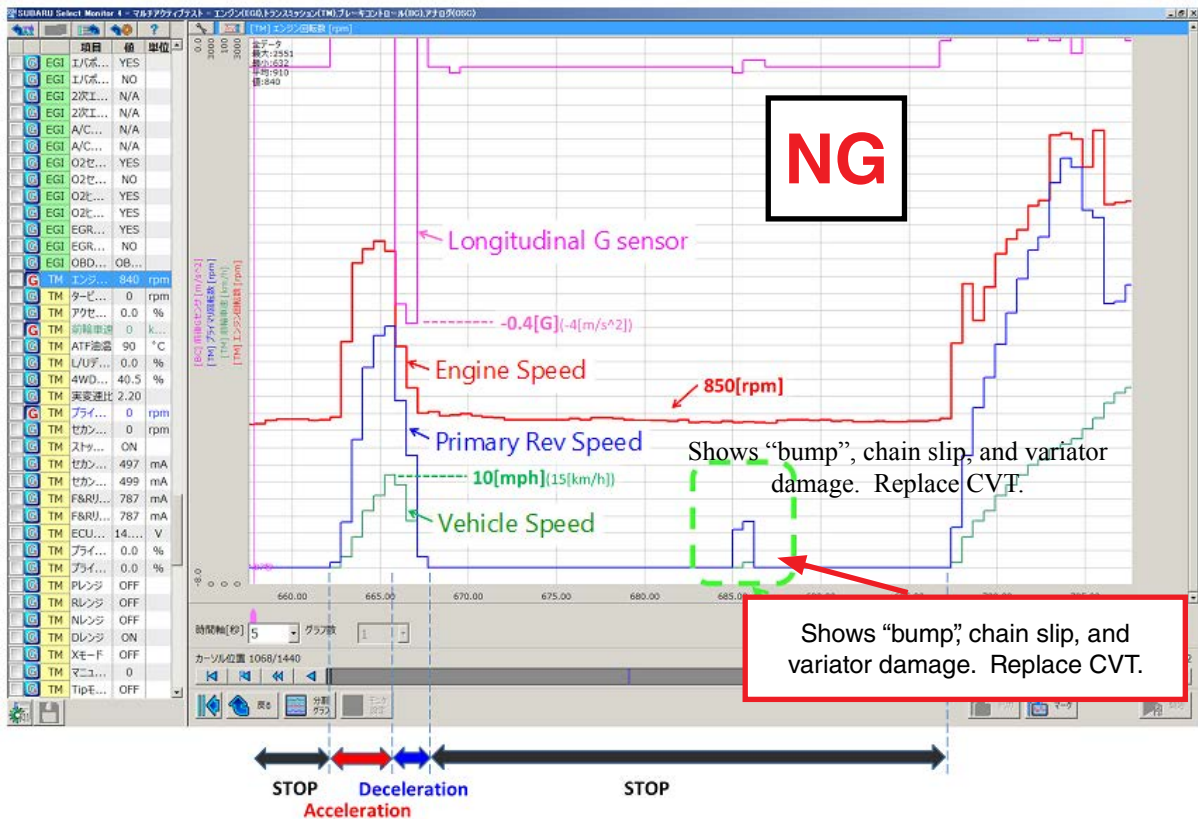
- While performing the testing above, determine if the “bump” condition can be confirmed and / or if the data graph shows any chain slippage. Examples of “OK” and “NG” graphs are supplied below for reference to help make a proper determination.

- If the bump condition is confirmed, there is most likely variator damage requiring CVT assembly replacement. Follow the service procedure in the applicable Service Manual when replacing the CVT assembly is required.
