Technical Bulletin

Section Title: Restraints
 TSB No. TS 06 05212R1

SUBJECT: SPECIAL COVERAGE EXTENSION “ZA”; SPECIFIC “AIRBAG”
 WARNING LIGHT ILLUMINATION (DTC B1312 ONLY).
MODEL(S): GRAND VITARA (JB424, JB627, JB632)
YEAR: 2006~2011

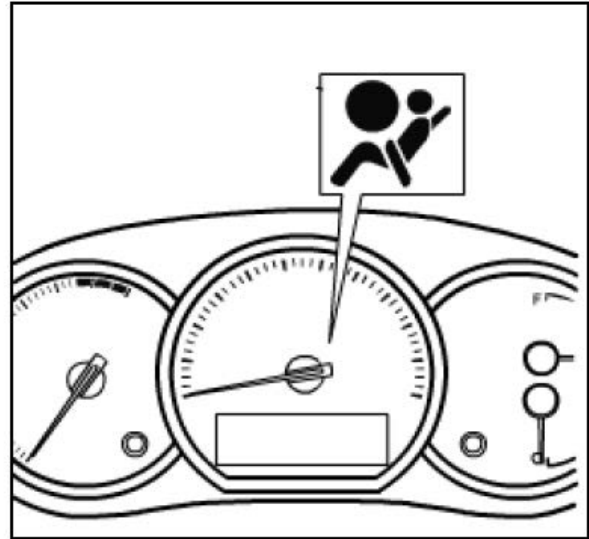
1. Check and ensure there is nothing placed or resting on the front passenger seat.
2. Turn the ignition switch to the "ON" position.
3. Check that the "AIRBAG" warning light remains on after flashing.

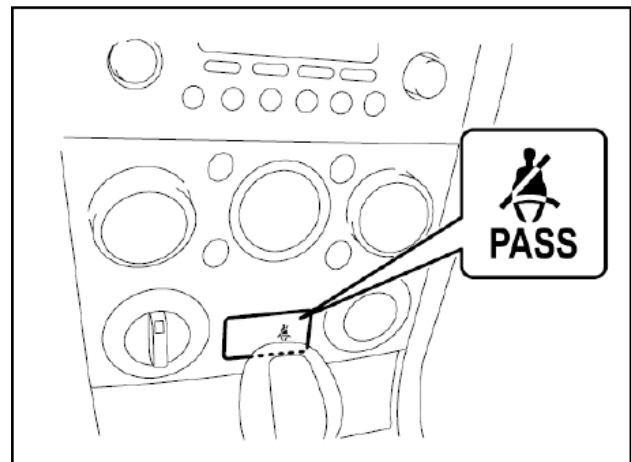
4. Check that the passenger seat belt reminder light is on (illuminated).
 - If the passenger seat belt reminder light is illuminated, go to step 5.
 - **If the passenger seat belt reminder light does not illuminate, DTC B1312 is not the cause of the "AIRBAG" warning light. Refer to the Suzuki Service Manual to determine the DTC stored and diagnose the issue.**

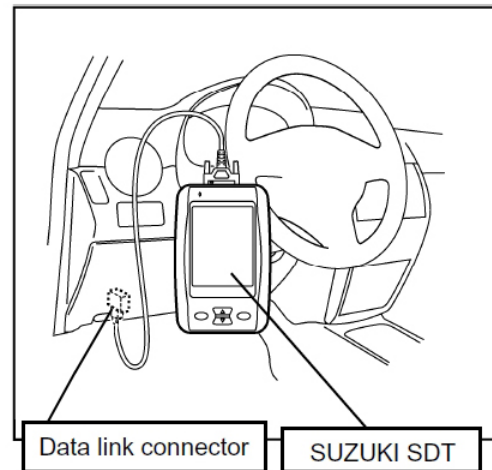
5. Connect SUZUKI scan tool (SUZUKI-SDT) to data link connector (DLC).
6. Read the DTC(s) in the "Airbag" system.

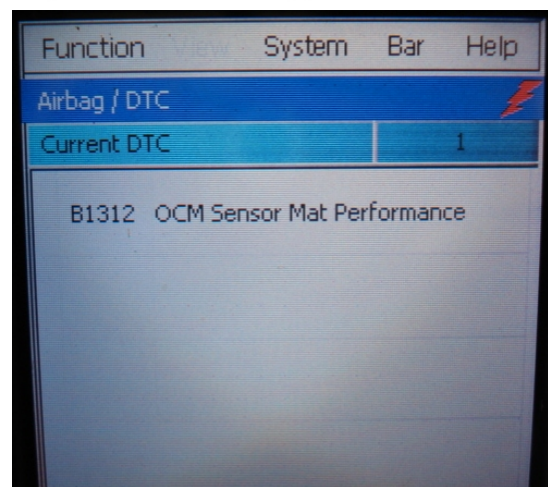
7. Confirm that DTC B1312 is a Current DTC on the SDT.
 - If DTC B1312 is Current, go to step 8.
 - **If DTC(s) other than B1312 are present in Current and or History, or DTC B1312 is present in History only, clear all DTC Codes and re-test. If DTC B1312 does not become set as a Current DTC it is not the cause of the "AIRBAG" warning light. Refer to the Suzuki Service Manual troubleshooting instructions for other DTC(s) stored and diagnose the issue.**

8. Replace front passenger seat cushion assembly with new one (Please refer to the EPC and appropriate Suzuki Service Manual for replacement of the lower seat cushion on the right front passenger seat only).
9. After completing the replacement, erase DTC using scan tool and confirm DTC Code B1312 is no longer present real time in the vehicle.
10. After clearing the "AIRBAG" DTC(s), confirm the following:
 - ✓ "AIRBAG" warning light does not remain illuminated after flashing.
 - ✓ Passenger seat belt reminder light does not illuminate when turning the ignition switch to the "ON" position.
11. The repair is complete. Return the vehicle to the customer.
