Service Category	Engine/Hybrid System			Toyota Supports	
Section	Engine Mechanical	Market	USA	Toyota Supports

YEAR(S)	MODEL(S)	ADDITIONAL INFORMATION
2006 – 2008	RAV4	Drive Type(s): 4WD, 2WD Engine(s): 2AZ Transmission(s): 4AT VDS(s): BD31V, BD32V, BD33V, BD34V, BD35V, ZD31V, ZD32V, ZD33V, ZD34V, ZD35V WMI(s): JTM

Some 2006 – 2008 model year RAV4 vehicles with the 2AZ-FE (2.4L) engine may exhibit an abnormal noise from the idler pulley bearing assembly. The idler pulley bearing, bracket, and washers have been revised to address this condition.

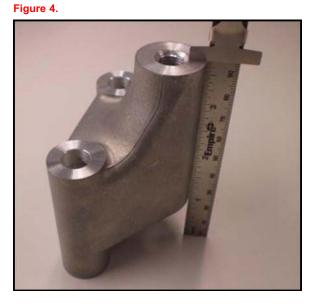
- 6. Measure the idler pulley bracket to determine if replacement is necessary.
 - A. Place the idler pulley bracket on a flat surface as shown and measure the height of the bracket.

Old Bracket = 96.4 mm

New Bracket = 94.8 mm

- B. Does the bracket measure 96.4 mm?
 - **YES** Replace it with the updated part number 16631-28031.
 - NO Reuse the 94.8 mm bracket.
