Turbocharger Failure - Oil Supply Line Blockage

NEW R55 (Cooper Clubman S) with N14 engine

NEW R56 (Cooper S) with N14 engine

NEW R57 (Cooper S Convertible) with N14 engine

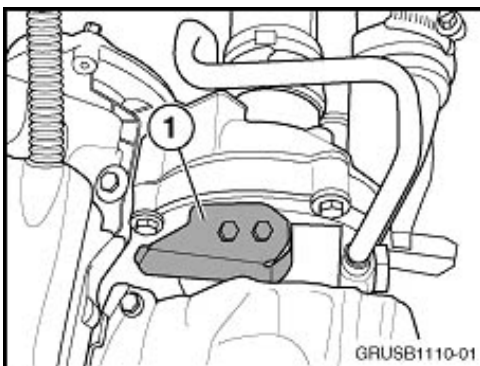
The turbocharger oil supply may be restricted, causing oil starvation and resulting in the seizing of the turbocharger assembly.

Protective cover (1)

Upon replacement of the turbocharger assembly, always remove and inspect the oil supply lines for blockage or restriction. Ensure that the lines are not collapsed or kinked. Replace the lines if a blockage or restriction is detected. Inspection of the oil supply lines will avoid repeated failure of the turbocharger assembly. In addition, a protective cover should be installed on the supply line, as seen in the illustration below.
