SI M11 02 07

**ENGINE - RATTLING NOISE ON COLD START UP/SHORT DRIVES**

Rattle Noise from Engine

R55 Cooper S with N14 engine

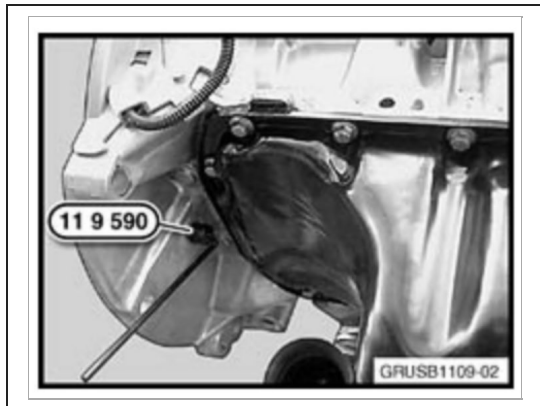
If all of the steps above are unsuccessful in eliminating the noise, please proceed to step 6.
6. Remove the right-hand wheel arch trim to access the crankshaft central bolt.
7. Disconnect the battery and remove the ignition coils and the spark plugs. Turn the engine in the clockwise direction by hand to move the flywheel to approximately 90 before TDC. Rotating the engine counterclockwise may cause an incorrect measurement.

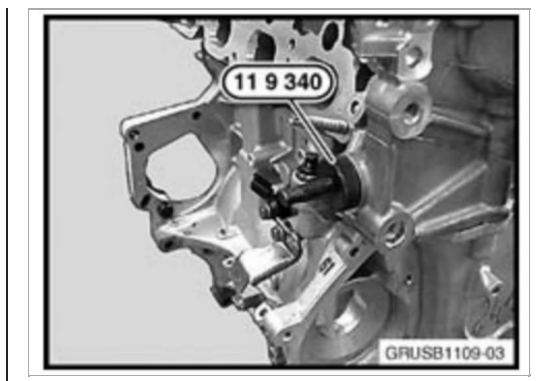
9. Remove the chain tensioner and collect the residual oil with a shop towel.

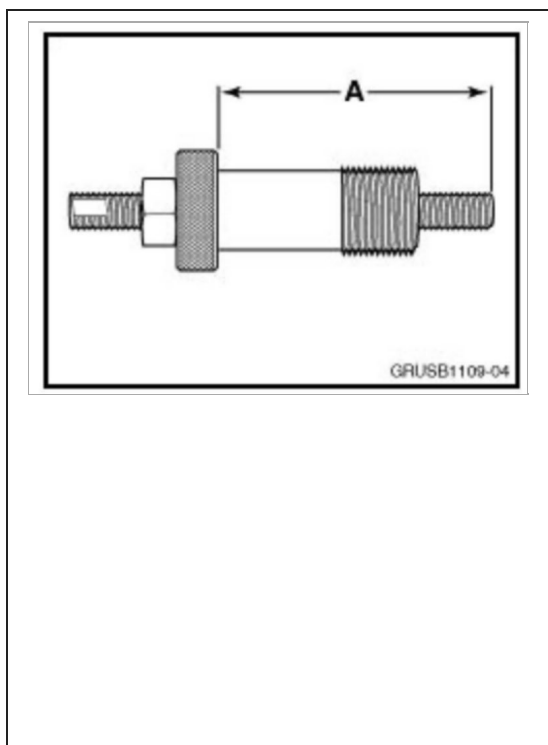
11. Remove the chain tensioner Special Tool 11 9 340 from the engine, with the lock nut still tight. Measure the distance (A), as described in the illustration.

12. **[NEW]** If distance A is less than 72 mm (and the noise can only be reproduced between 1,600-1,800 rpm), only replace the chain tensioner with P/N 11 31 7 607 551.

- 13. **[NEW]** If distance A is 72 mm or greater (and the noise is reproducible both at the 1,600-1,800 rpm range as well as at idle speed when cold), replace the components in the list below (refer to parts list B):
