January 2014 Technical Service

This Service Information bulletin supersedes SI B11 04 13 dated November 2013

Service Action: N14 Engine Check Timing Chain Tensioner and Timing Chain

With the N14 engine

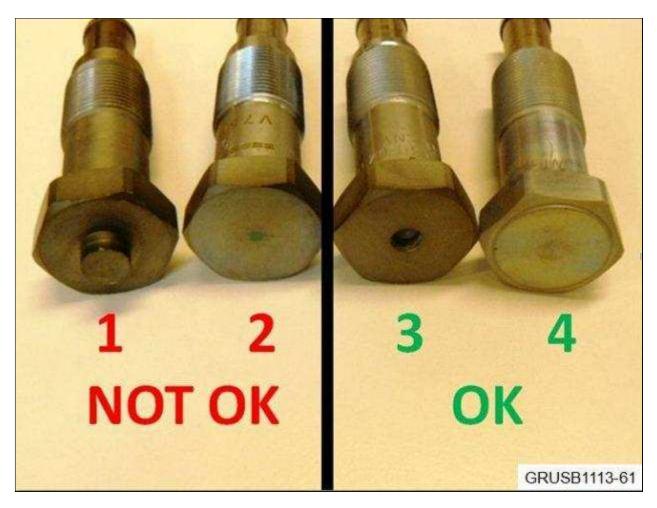
The timing chain tensioner applies pre-tension to the timing chain guide rail mechanism. In some cases, the tensioner spring force may be too low. Depending on the severity of the wear, it may lead to a rattling noise when starting the engine cold or when the engine is idling.

The timing chain tensioner internal tolerances are not consistent.

Item 1: Protruding boss – Not OK	Item 3: Drilled head – OK
,	Item 4: Machined edge in head – OK

- 2. If the engine is fitted with a timing chain tensioner that has a drilled head (item 3) or has a machined head (item 4), do not replace the timing chain tensioner. No further repairs are needed. If the chain tensioner has a protruding boss (item 1) or a flat head (item 2), proceed to step 3.
- 3. Remove the right-hand wheel arch trim to access the crankshaft central bolt.
- 4. Disconnect the battery and remove the ignition coils and spark plugs. Turn the engine in clockwise direction by hand to move the flywheel approximately 90° before TDC. Rotating the engine counterclockwise may cause an incorrect measurement.
