SB-10045302-9207

SI M17 05 12
Cooling Systems

Service Action: Retrofit of the Engine Coolant Temperature Sensor

R60 with automatic transmission (N16 or N18 engine)

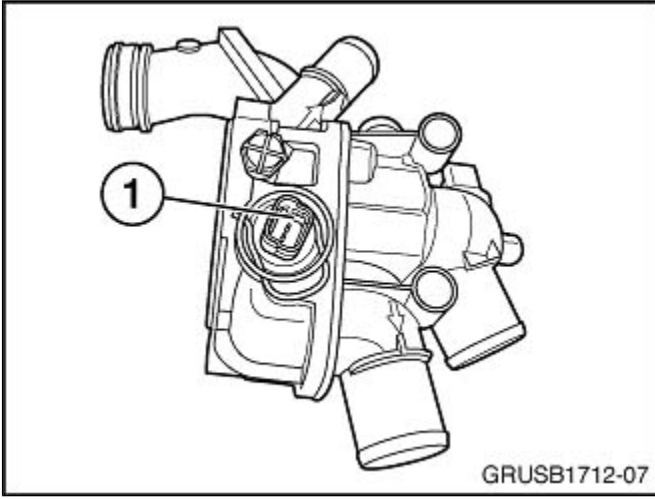
Checking for the updated thermostat:
The 11 53 7 534 521 thermostat has a replaceable engine temperature sensor (1).
