SI M17 07 12
Cooling Systems

January 2013
Technical Service

Service Action: Retrofit of the Engine Coolant Temperature Sensor

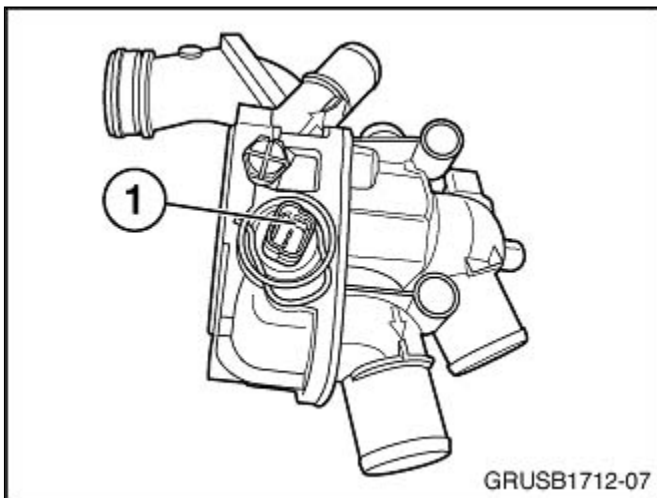
Checking for updated thermostat: The 11 53 7 534 521 thermostat has a replaceable engine temperature sensor (1).

- Replace the engine wiring harness with the 11 53 7 534 521 thermostat.
- Do not install the remote engine temperature sensor. Claim the labor operation “Check for 11 53 7 534 521 thermostat installation” in the Warranty Information section of this bulletin.
- Affix the Service Action label to the B-pillar.
