SB-10046920-4475

SI M17 08 12
Cooling Systems

January 2013
Technical Service

Service Action: Retrofit of the Engine Coolant Temperature Sensor

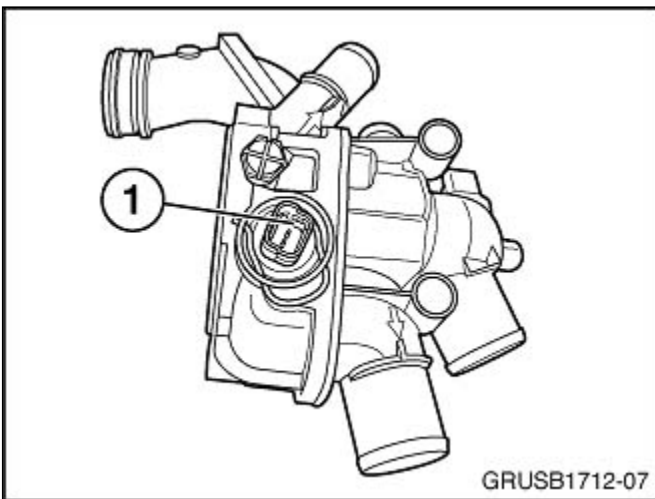
Checking for updated thermostat: The 11 53 7 534 521 thermostat has a replaceable engine temperature sensor (1).

NEW The 11 53 7 534 521 thermostat would need to be installed in conjunction with an engine electrical wiring harness replacement. This thermostat already has an updated, replaceable engine coolant temperature sensor.

- Replace the engine wiring harness with the 11 53 7 534 521 thermostat.
- Do not install the remote engine temperature sensor. Claim the labor operation “Check for 11 53 7 534 521 thermostat installation” in the Warranty Information section of this bulletin.
- Affix the Service Action label to the B-pillar.
