Water Leak At Back Door Hatch

Service Category Vehicle Exterior

YEAR(S)	MODEL(S)	ADDITIONAL INFORMATION
2006 – 2007	Highlander HV	
2001 – 2007	Highlander

Some 2001 - 2007 model year Highlander / Highlander HV vehicles may exhibit water intrusion into the rear of the vehicle due to a cracked body seam sealer just above the back door stay mount area. Use the following repair information to address this condition.

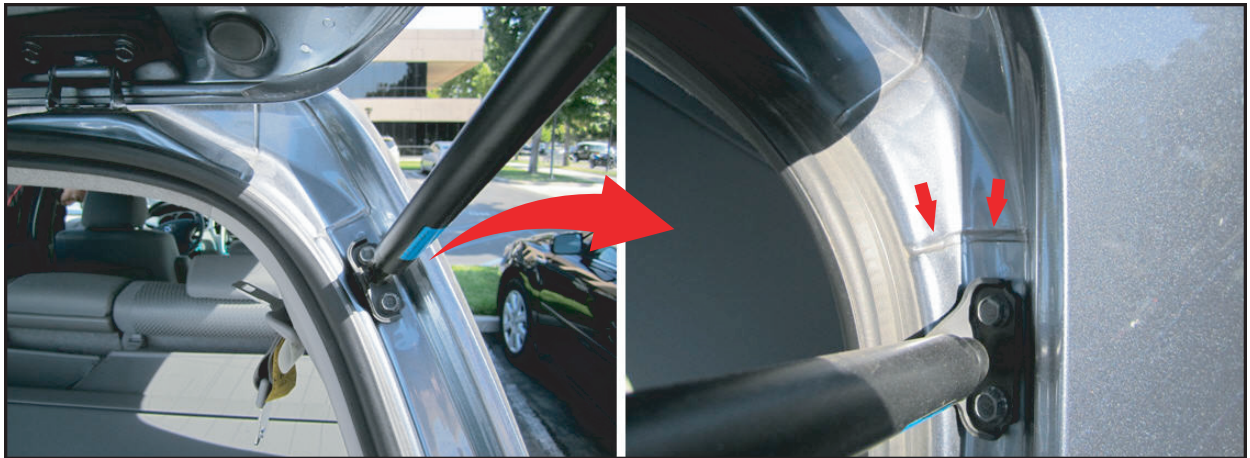
Figure 2.

1. Visually inspect the left and right rear hatch seams above the upper back door stay mounting bracket.

- A. If separation is present, proceed to step 2 of the repair procedure.
 - B. If no separation is present, STOP. The source of water is coming from a different location. This TSB does NOT apply. Continue diagnostics per the Repair Manual.
2. Send the vehicle to the body shop.
 3. Repair the back door seam area by removing the left and right rear hatch stays, back door weatherstrip, and the interior left and right roof side rail garnish sub-assembly in the recommended repair procedures below.

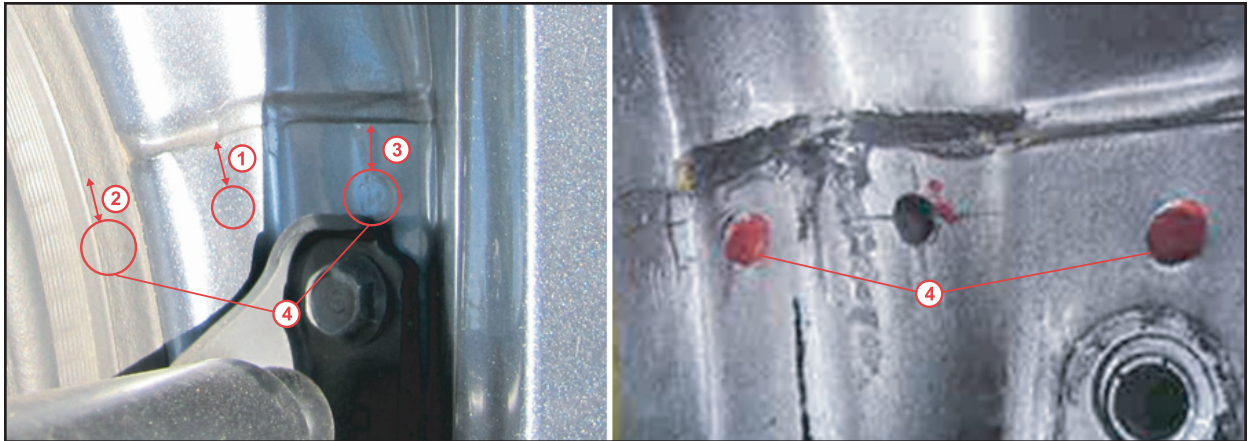
Figure 4.

1	6mm Down and Centered
2	4mm

3	8mm
4	Original Spot Welds

8. Mark the location for an additional plug weld on the left and right side as shown in Figure 4 (left side image shown as reference).

Location of original spot welds are 4mm and 8mm from edge of the metal. Additional 5mm hole should be centered between the original 4mm and 8mm spot welds. Location of additional weld should be 6mm from the top edge of the sheet metal.

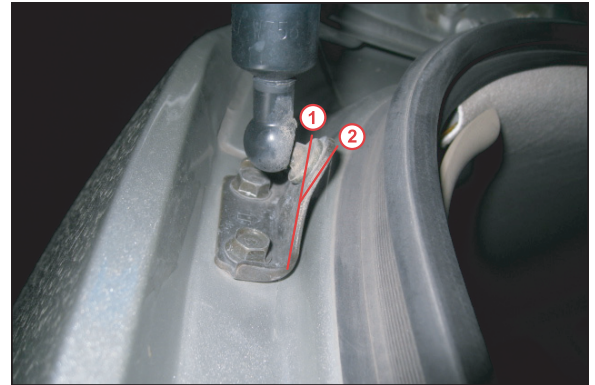
1	Correct
2	Incorrect

12. Apply seam sealer to the weld location and repaint the rear hatch area according to the paint manufacturer's recommendations.
13. Inspect and replace any deformed rear hatch stay brackets as shown in Figure 6.
