Field campaign

Торіс	V8 engine coolant circulation - de-gas circuit – heater performance - one way valve orientation over check (SC13/05)				
Market area	rea Worldwide Bentley (1WBE)				
Brand	Bentley				
Transaction No.	2032308/1				
Campaign number	E781				
Note					
Туре					
US code

E781

V8 engine coolant circulation - de-gas circuit – heater performance - one way valve orientation over check (SC13/05)

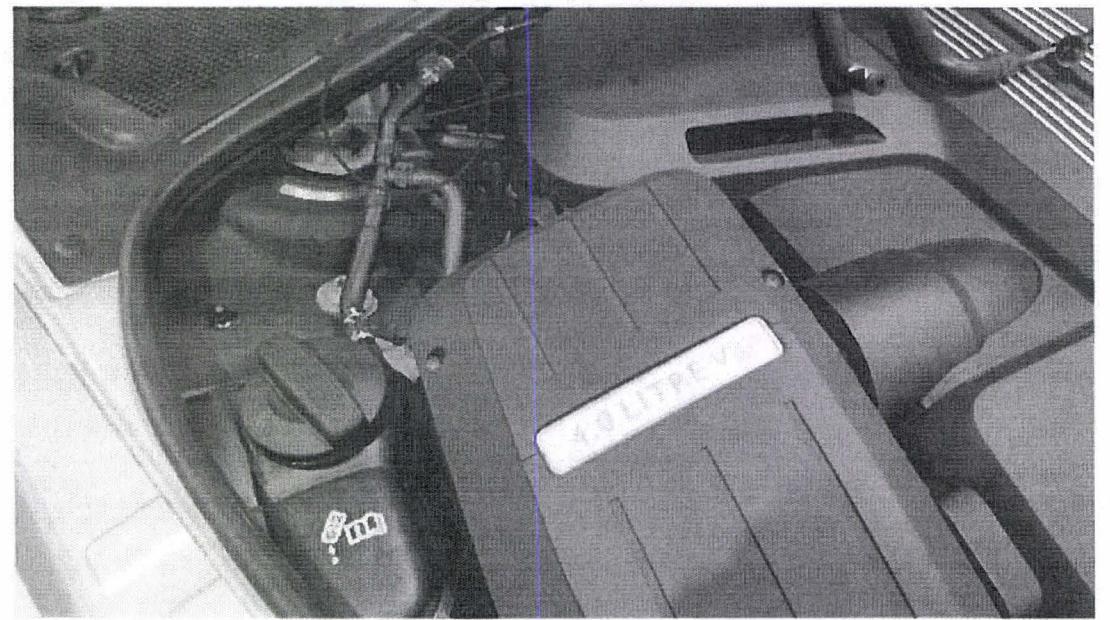
Figure 1

2. Referencing figure 1 locate coolant hose (A) containing the one way valve

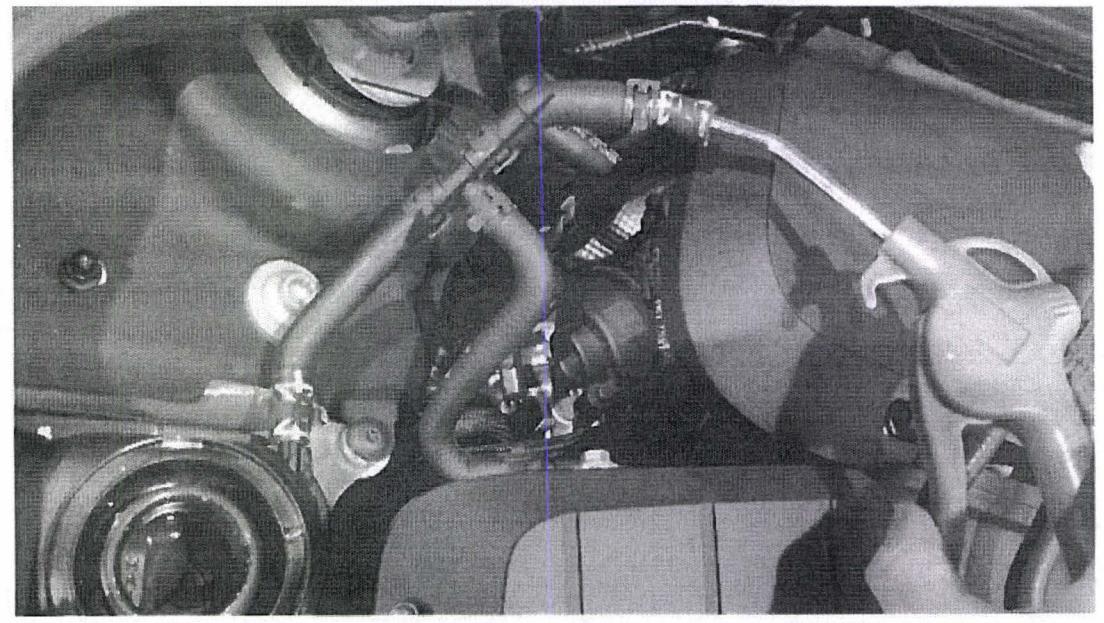
3. Disconnect coolant hose (A) from the steel pipe

4. To check the orientation of the one way valve ensure the expansion tank cap is removed then apply light air pressure to hose (A). If the air flows freely in the direction of the green arrow, towards the expansion tank, then the one way valve is correctly orientated in this hose. If the applied air pressure is restricted and does not flow then the valve is not orientated correctly and a replacement hose must be fitted

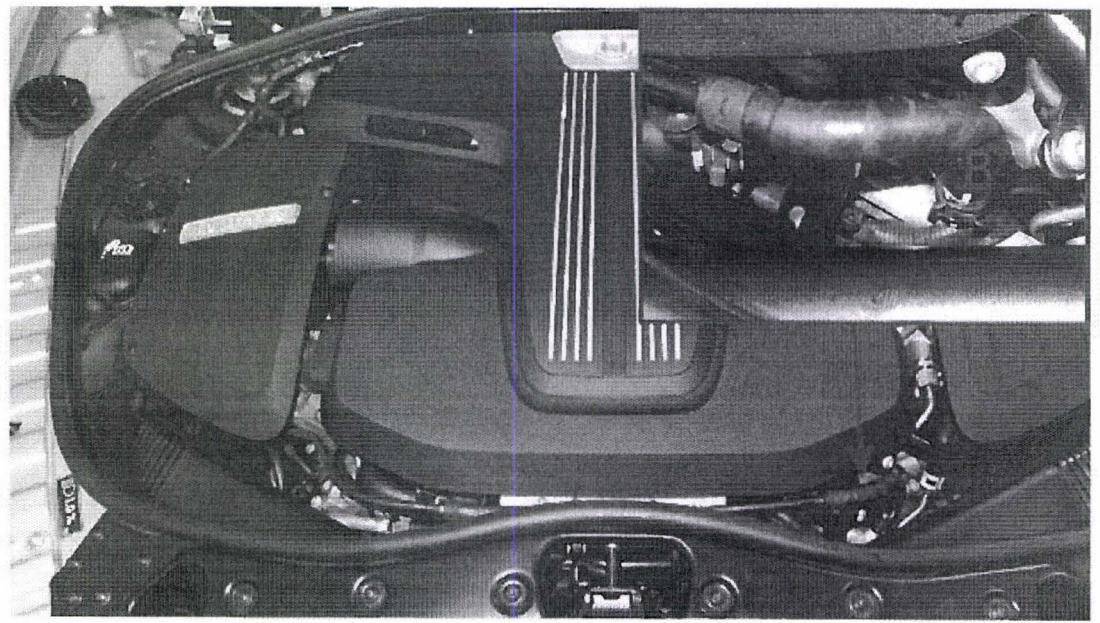
Figure 3

5. Referencing figure 3 locate the coolant hose (B) containing the second one way valve

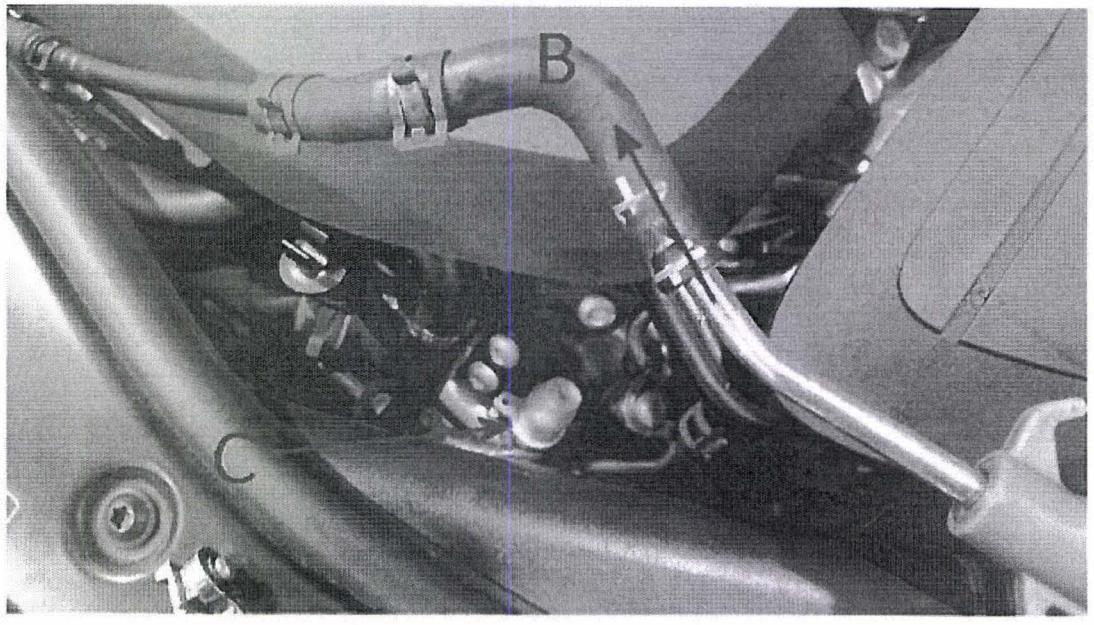
Figure 4

- 6. Disconnect coolant hose (B) from the stub pipe (C). Temporarily fit a blanking plug to the stub pipe to minimise coolant loss
- 7. To check the orientation of the one way valve ensure the expansion tank cap is removed then apply light air pressure to hose (B). If the air flows freely in the direction of the green arrow, evident as air exhausts at the expansion tank, then the one way valve is correctly orientated in the hose. If the

applied air pressure is restricted and does not flow then the valve is not orientated correctly and a replacement hose must be fitted

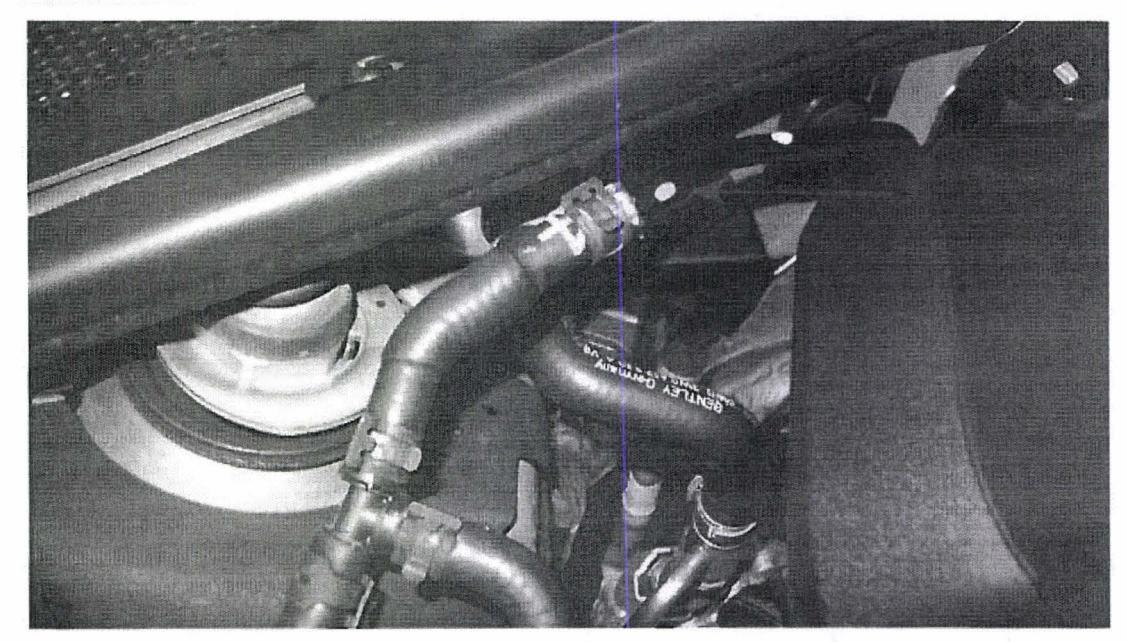
Figure 8

Yellow paint completion mark on steel pipe

If the vehicle is not already listed as repaired in the "Repair history" (in Elsa pro), check for the campaign identification mark, yellow paint mark located on the steel pipe (Figure 8), should neither be evident carry out the required work in accordance with these instructions
