TSB-	Model	Carnival/Sedona [VQ](), ()	
KIA MOTORS		Group	Engine Electrical System(11)	
	LUCAI	TSB No.	KCE11-11-P280- VQ;C21VA	
Subject Glow Plug and	Published	1/11/2012		
Inspection/Replace	cement	TSB Type	Service Action	
		Area & Distributor	U.K (C21VA)

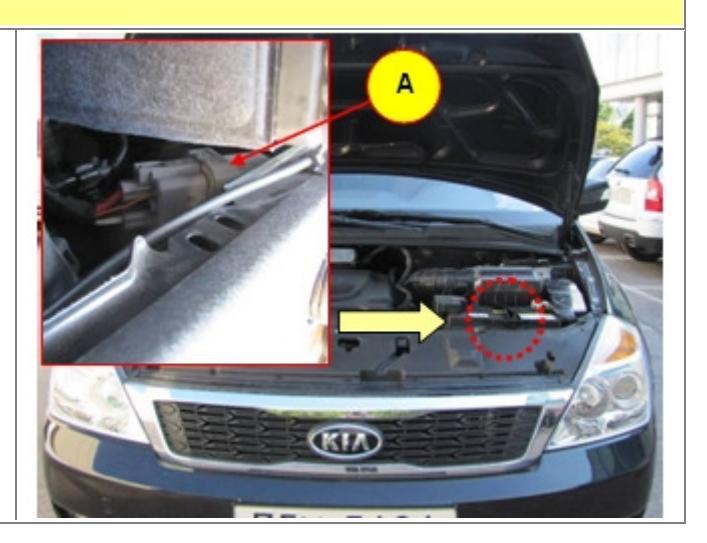
1. Open the hood, and then locate the glow relay (A).

Flashlight and mirror are useful to check the lot number of the glow relay.

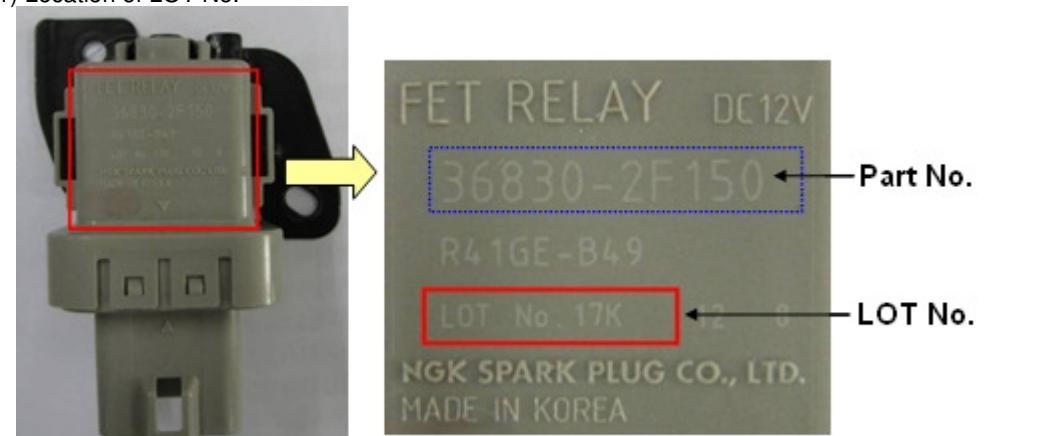
1) Location of LOT No.

2. Check the LOT No. of the glow relay.

2) Following is the affected lot number range. * Affected production range : 16B ~ 180 (June 2, 2011 ~ Aug. 20, 2011)

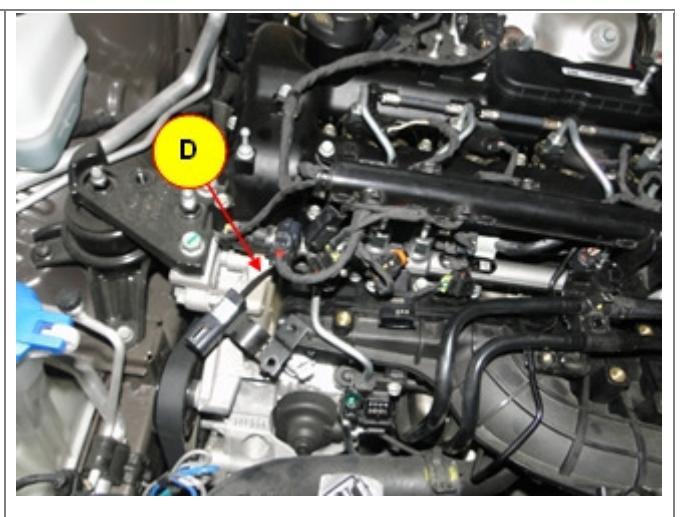
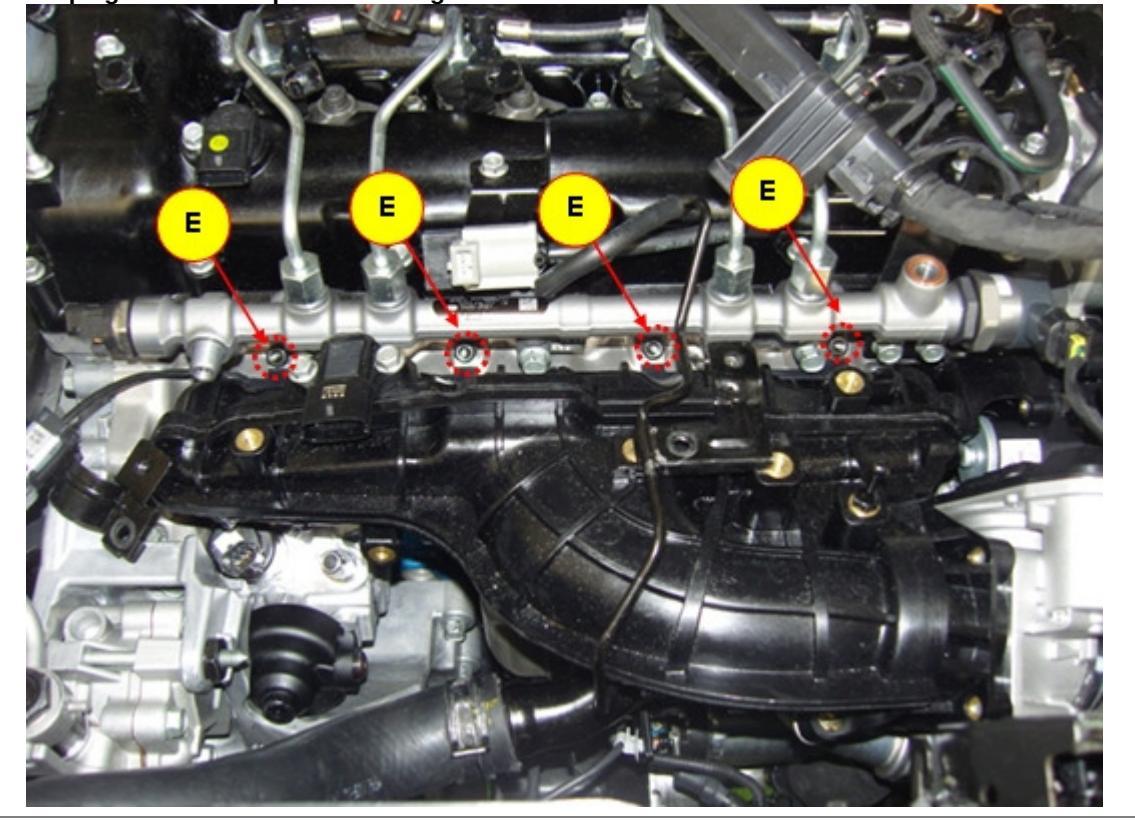
This photo shows the removed engine assembly to help technicians understand the Service Procedure. **E: Glow plug connector & plate mounting nuts.**

Remove the glow plug connector & plate
 (D) by loosening mounting screws (E: 4 EA).

The current glow plug plate should be reused when reinstalling.

0. 8 ~1. 5N.m (0. 1 ~ 0. 15kgf.m, 0. 6 ~ 1. 1lb-ft)

2) Remove the glow plugs. (F: 4EA)	
 3) Install new glow plugs to the engine assembly. Tightening Torque: 15 ~19 N.m (1.5 ~ 2. 0 kgf.m, 11 ~ 14. 5 lb-ft) 	
6. Reinstall all the removed parts in reverse of removal.	
7. Using GDS, erase the stored DTCs P0684, P0670
