# Service Bulletin

**SUBJECT: STARTER MOTOR B+ CABLE ATTACHMENT**

**MODELS: 2011- 2013 CHEVROLET CAPTIVA**

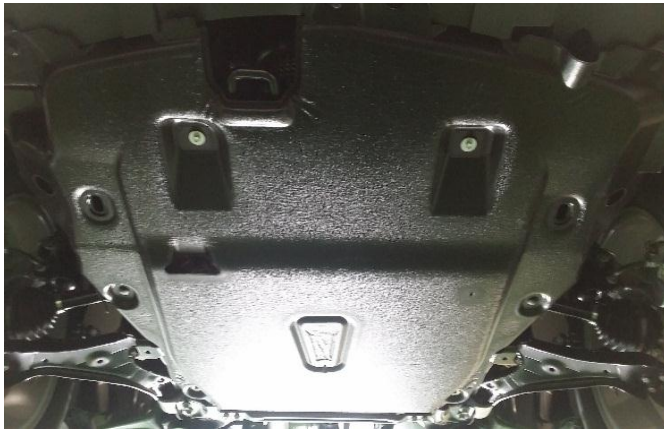
1. Open the hood.
2. Disconnect the negative battery cable.
3. Raise and suitable support the vehicle.
4. Remove the engine shield.

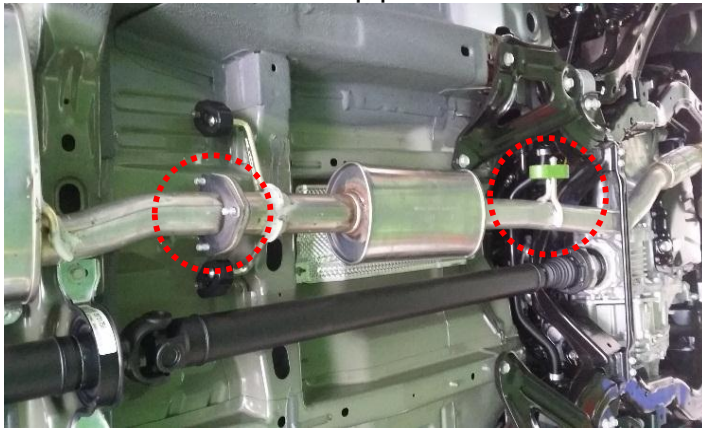
5. Disconnect front exhaust pipe from each connection area to secure working space.

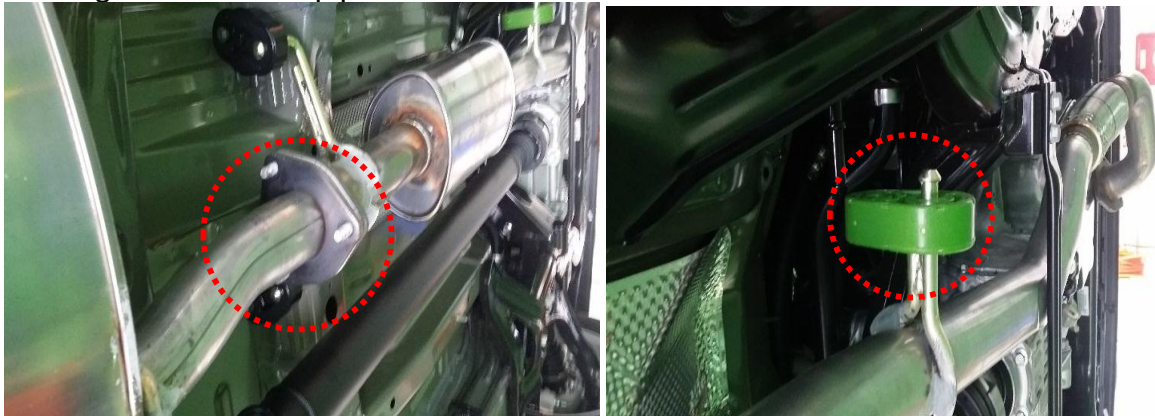
. Unfasten the exhaust resonator 3 nuts and remove front pipe from the exhaust isolator for moving front exhaust pipe.

**NOTE:** Do not need to remove the exhaust resonator 3 nuts. The exhaust resonator gasket can be reused because of no any damage on the gasket.

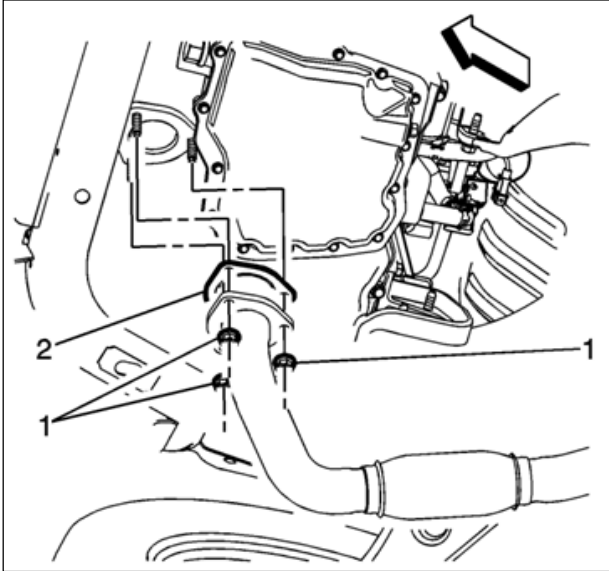
. Remove the exhaust particulate filter 3 nuts.

**NOTE: Discard the exhaust particulate filter gasket. Use the new gasket for the filter installation.**

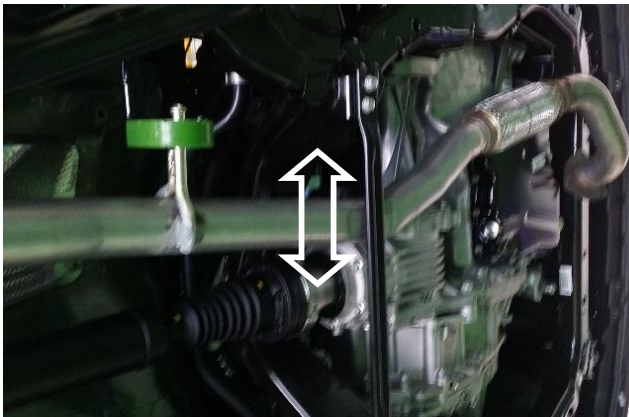
. Hang the front exhaust pipe on the underbody brace and secure working space for a hand accessible by moving the pipe.

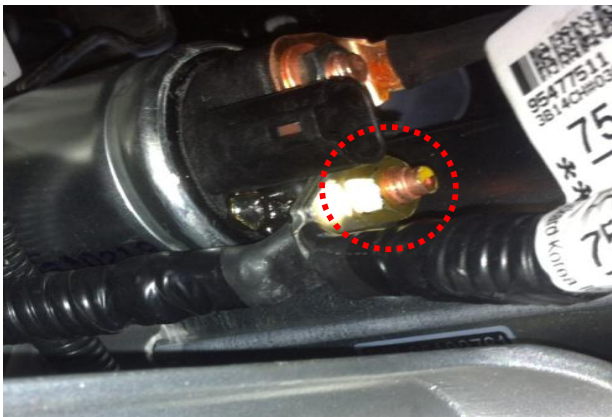
6. Remove the B+ cable nut and clean up the B+ stud if there is any contamination such as dust or oil.

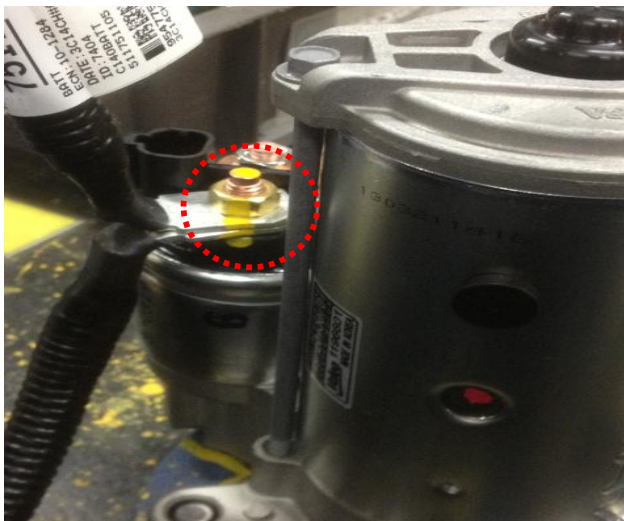
[ " I " Marking ]

- 7. Install new B+ cable nut and mark ' I ' on the nut.  
. **Tighten** the nut to 10 N.m.

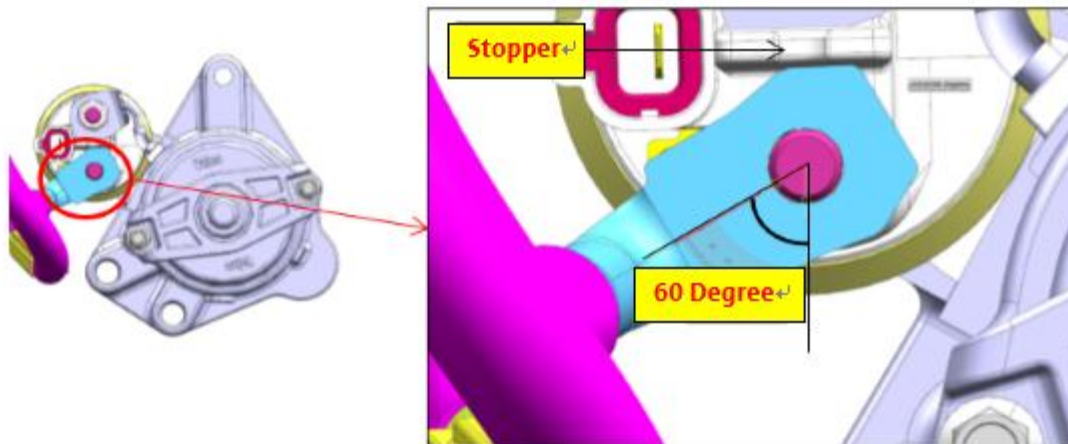
- A/T & M/T (Non-Stop& Start)

**IMPORTANT:** Keep the terminal stack condition properly and keep the angle as requested.
