Service Information

Category BD	Repair Guidance	Ref. No. R073/15	Page 1 of 14
Coverage <input type="checkbox"/> Distributor only <input checked="" type="checkbox"/> Please inform your dealers		Date Issued August 7, 2015	
Please convey this information to your <input checked="" type="checkbox"/> Warranty Dept. <input checked="" type="checkbox"/> Parts Dept. <input checked="" type="checkbox"/> Training Dept. <input checked="" type="checkbox"/> Field Rep.	<input type="checkbox"/> Director <input checked="" type="checkbox"/> General Manager	Date Revised	
Applicable Model CX-5 (KE), Mazda6 (GJ), Mazda3 (BM): with SKYACTIV-D 2.2	Applicable Countries or Specifications Europe

Subject: Lack of acceleration “SKYACTIV-D 2.2” Prior Approval is required

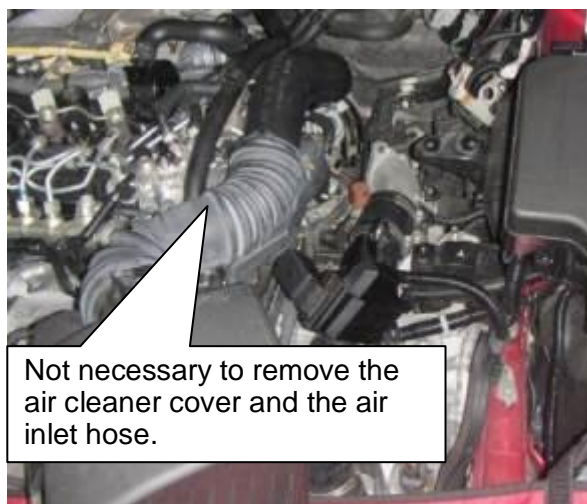
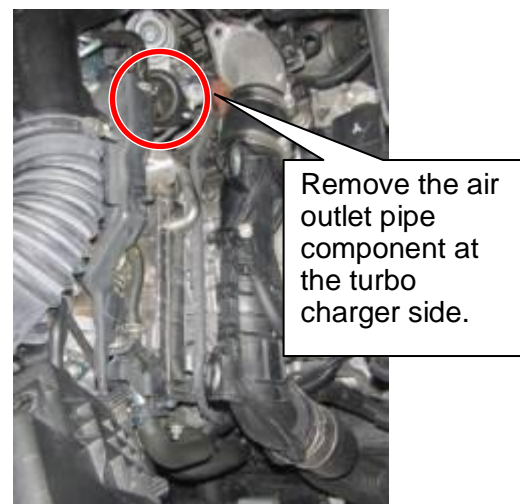
1. Remove the battery, fresh air duct, air cleaner element, air cleaner case and battery tray.
2. Remove the air outlet pipe component from the small turbocharger and set it aside.

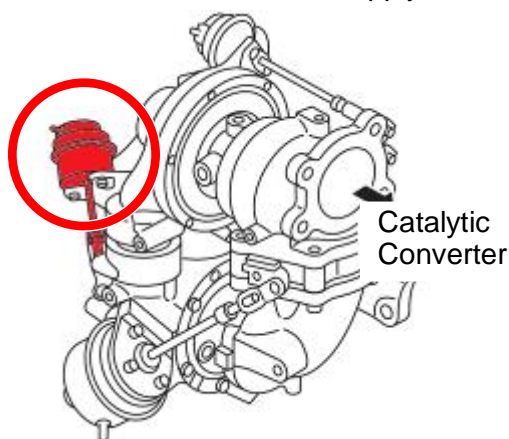
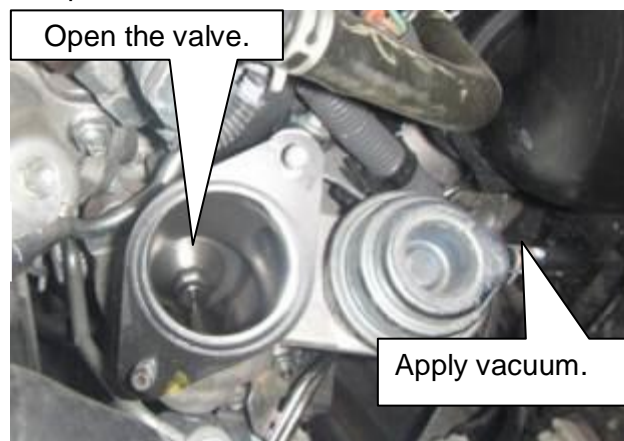
3. Connect a hand-operated vacuum pump (e.g. Mityvac) to the compressor bypass valve vacuum actuator and apply vacuum to open the valve.

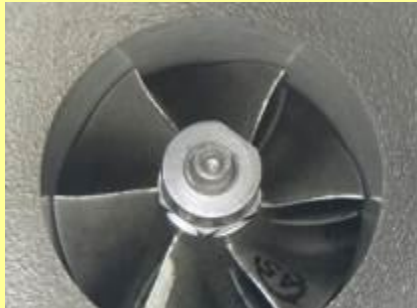
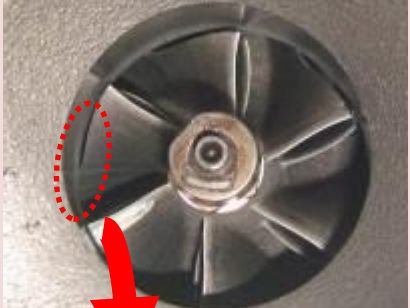
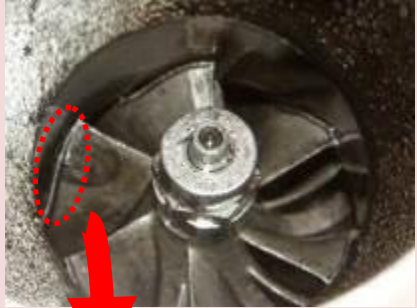
4. Insert a fiberscope into the compressor bypass valve housing and inspect the small turbocharger blades for any damage on the outer edge.

OK (No damage on blades)	NG (Damage on blades)	
No deformation on outer edge.	Saw-toothed deformation on outer edge	Entire outer edge deformed.

JUDGMENT:

If **NO DAMAGE** is found on the outer edge of any blades:

➔The small turbocharger is **OK**. Go to **STEP 1B** and inspect the large turbocharger for damage on the housing/ blades.

If **ANY DAMAGE** is found on the outer edge of any blades:

➔The small turbocharger is **NG** and the turbocharger assembly needs to be replaced. Go to **STEP 2**.

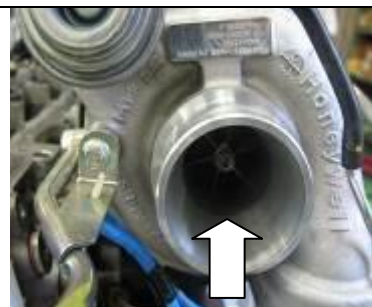
1. Remove the air inlet hose to large turbocharger.
2. Visually check the housing inside wall, in the area where the turbine blades are located, for scratch marks using an inspection mirror.
3. Inspect the large turbocharger blades for any damage on the outer edge.

Visual inspection on the inside wall of housing

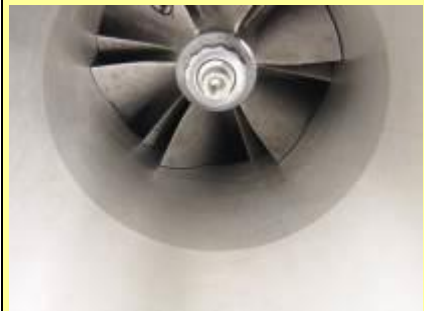
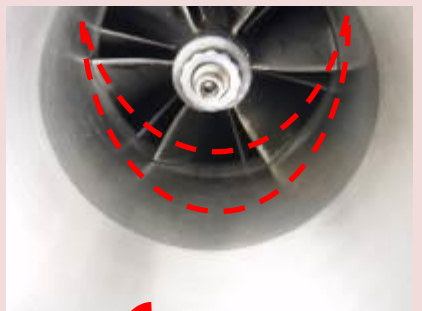
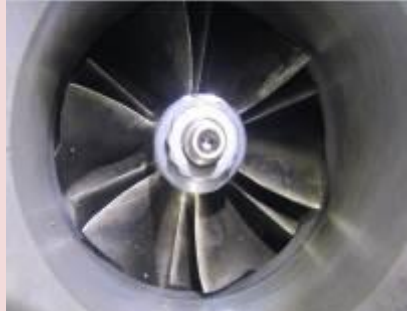
OK (No scratches or damage on blades)	NG (Scratches and/ or damage on blades)	
No scratches and no damage on blades.	Scratches causing the housing to appear whitish	Saw-toothed deformation on the outer edge of blades

If **ANY DAMAGE** is found on the housing inside wall and/ or the outer edge of any blades:

→The large turbocharger is NG and the turbocharger assembly needs to be replaced. Go to STEP 2.

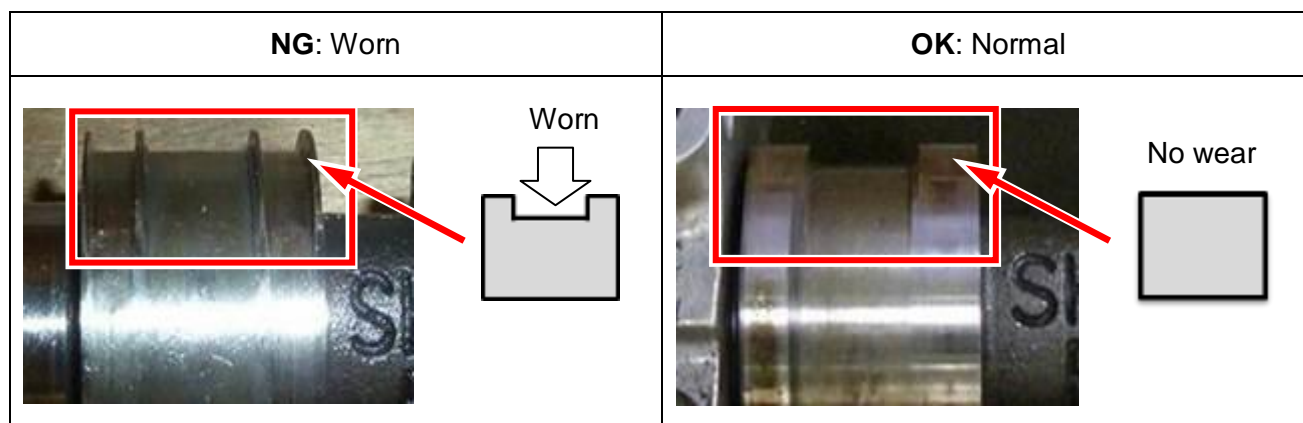
1. Remove the cylinder head cover, and check the high lift cams of the exhaust camshaft for wear.

If the high lift cam on the exhaust camshaft is worn:

➔ **The exhaust camshaft is NG. Go to STEP 4.**

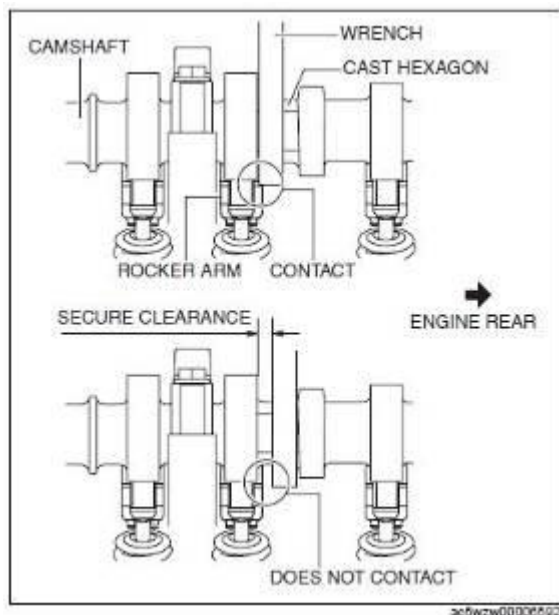
CAUTION: When rotating the camshaft using a wrench on the cast hexagon, the wrench may contact the rocker arm and damage the rocker arm. To prevent damage to the rocker arm when holding the camshaft on the cast hexagon, use a wrench on the rear side of the engine as shown in the figure to secure a clearance between the cam.

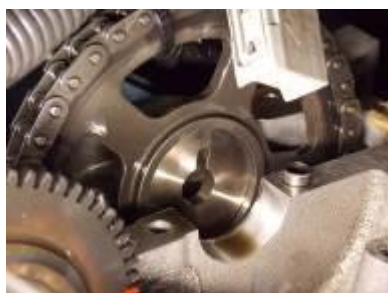
Service Point 1: Exhaust camshaft sprocket installation

When installing the exhaust camshaft sprocket, make sure to correctly align the sprocket groove with the camshaft locating pin. Otherwise the locating pin might be pushed in, causing damage to both sprocket and pin. This might result in misalignment between camshaft and crankshaft (DTC P1336 might get logged in the PCM) and in the worst case to engine damage.

Camshaft sprocket
groove damaged

Camshaft locating
pin pushed in

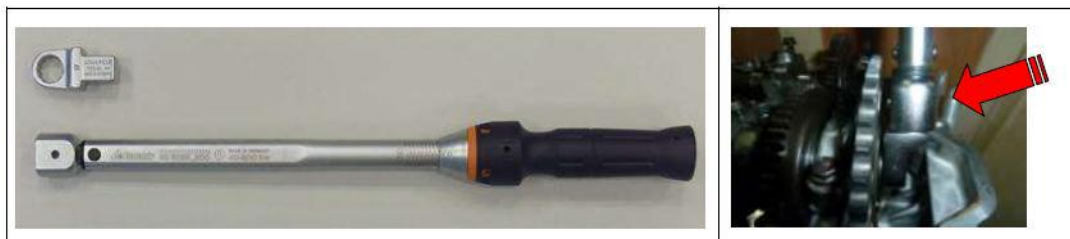
Service Point 2: Exhaust camshaft sprocket fixing bolt tightening

Thin head type torque wrench is recommended in SI MME/T001/14.

—Too low tightening torque results in engine damage.

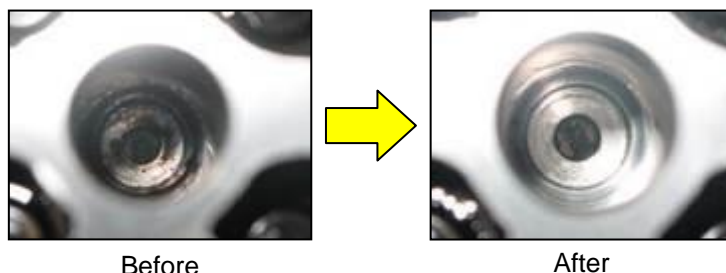
Service Point 3: Fuel injector bore cleaning

The cleaning procedure is announced by SI MME/E004/12, and the cleaning kit is introduced by SI MME/T005/12.

—Improper cleaning results in combustion gas leakage.

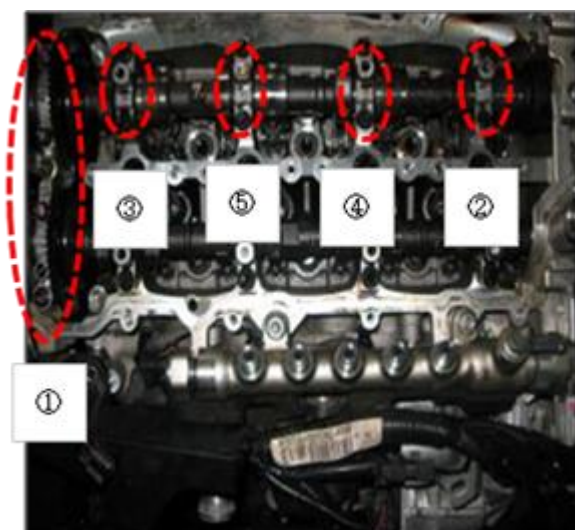
1. Loosen the exhaust camshaft cap bolts in two or three passes in the order shown in the figure, and remove the exhaust camshaft caps.

CAUTION: Do not remove the camshaft cap at the engine rear side. If removed, the O-rings must be replaced with new ones, and adhesive sealant must be applied to the contact surface.

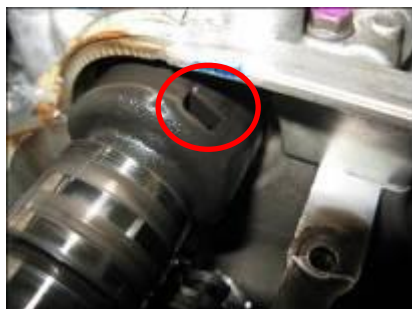
2. Turn the exhaust camshaft until the groove driving the supply pump is in the position shown in below picture (piston no.1 in TDC position).

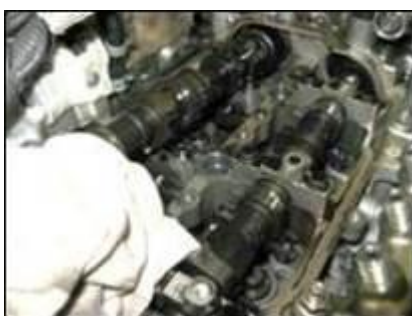
3. Hold the exhaust camshaft on the front side (sprocket side) and slightly lift the front part of the camshaft.

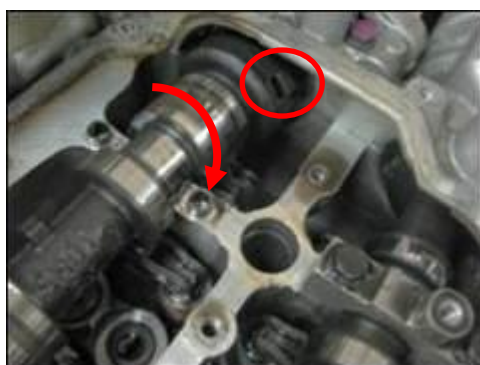
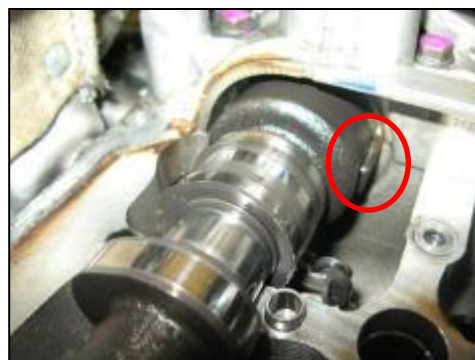
4. Turn the exhaust camshaft clockwise until the groove driving the supply pump is in the horizontal position.

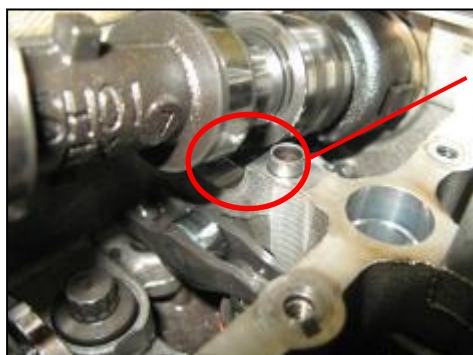
5. Pull the exhaust camshaft out from the supply pump connection and remove it from the cylinder head.

Make sure that the cam lobes do not touch the cylinder head journals during removal.

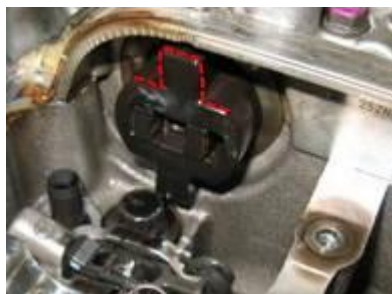
3. Position the supply pump connection as shown in below picture.

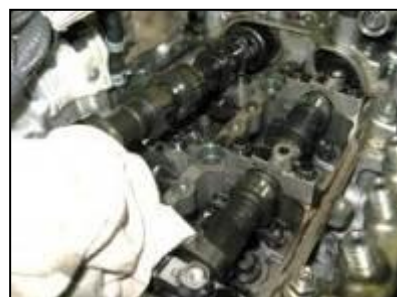
4. Hold the exhaust camshaft on the front side (sprocket side) and insert it into the supply pump connection.

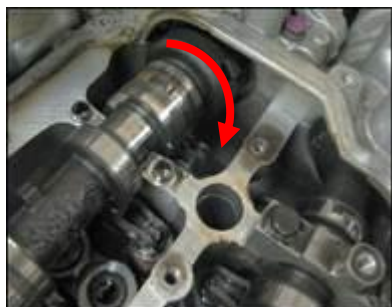
5. Turn the exhaust camshaft clockwise until there is no more interference between cam lobes and cylinder head journals, and then place it on the cylinder head.

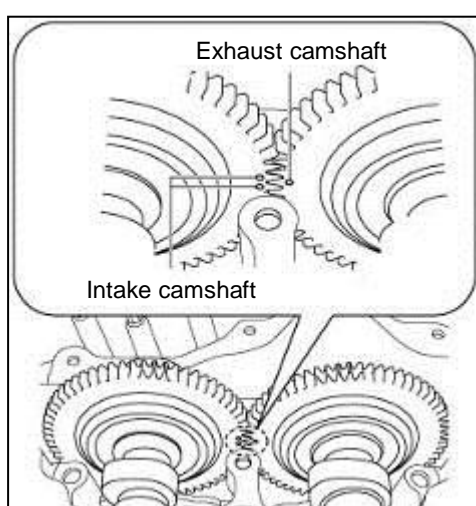
6. Align the alignment mark of the exhaust camshaft with that of the intake camshaft.

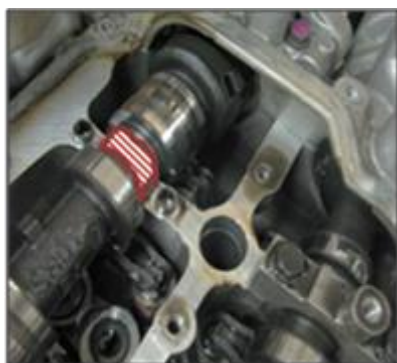
7. As shown in the figure, apply gear oil (SAE No. 90 or equivalent) or engine oil to the center area of each journal of the camshaft.

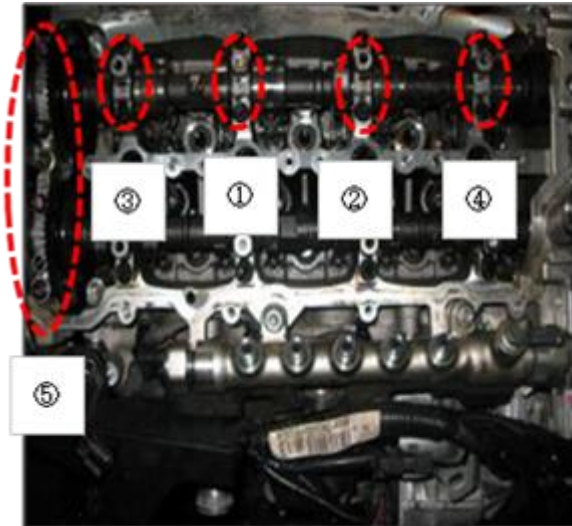
9. Install the camshaft caps in the marked number order, and temporarily tighten the camshaft cap installation bolts in two or three passes evenly.
10. Tighten the camshaft cap installation bolts in two steps in the order shown in the figure.
